PBA Consulting

Tree Survey to BS5837:2012
at
69 Patshull Road,
London NW5 2LE

Report Date: 31 July 2018

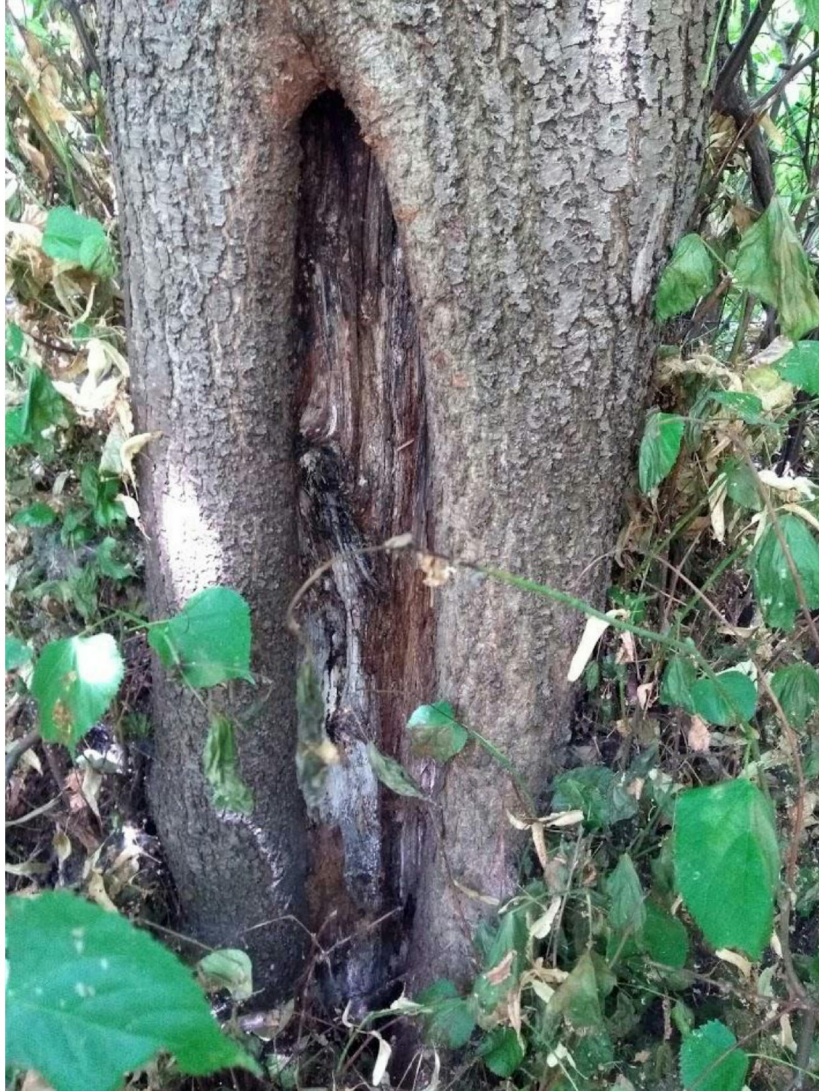
Photo 1

| Tree Ref. No. | Species | Ht. (m) | Stem dia. (mm) | Crown Spread (m) | | | | Ht. to 1st branch (m) | No. of stems | Age Class | Condition (G-F-P-D) | Structural condition & Notes | Management recommendations | Est. ret. Span (yrs) | RPA (m) | RPA Area (m ²) | BS Cat |
|---|---|---|---|---|---|---|---|---|---|---|---|--|--|---|---|---|---|
| T2 | Lime | 13 | 400+ | 5 | 5 | 5 | 3 | 2.5 | 1 | M | Unable to make full assessment | Partial survey as dense epicormic growth impedes access and visual. Large longitudinal wound on South side of trunk from ground level up to approx. 1.6m height. Reaction wood formation around wound. Significant proportion of dead wood within crown on south side. | Remove epicormics growth from basal area and lower crown to allow full visual tree assessment VTA to be undertaken. | - | 4.8 | 72.4 | C1 From partial inspection |

Trunk wound and associated decay upon T2

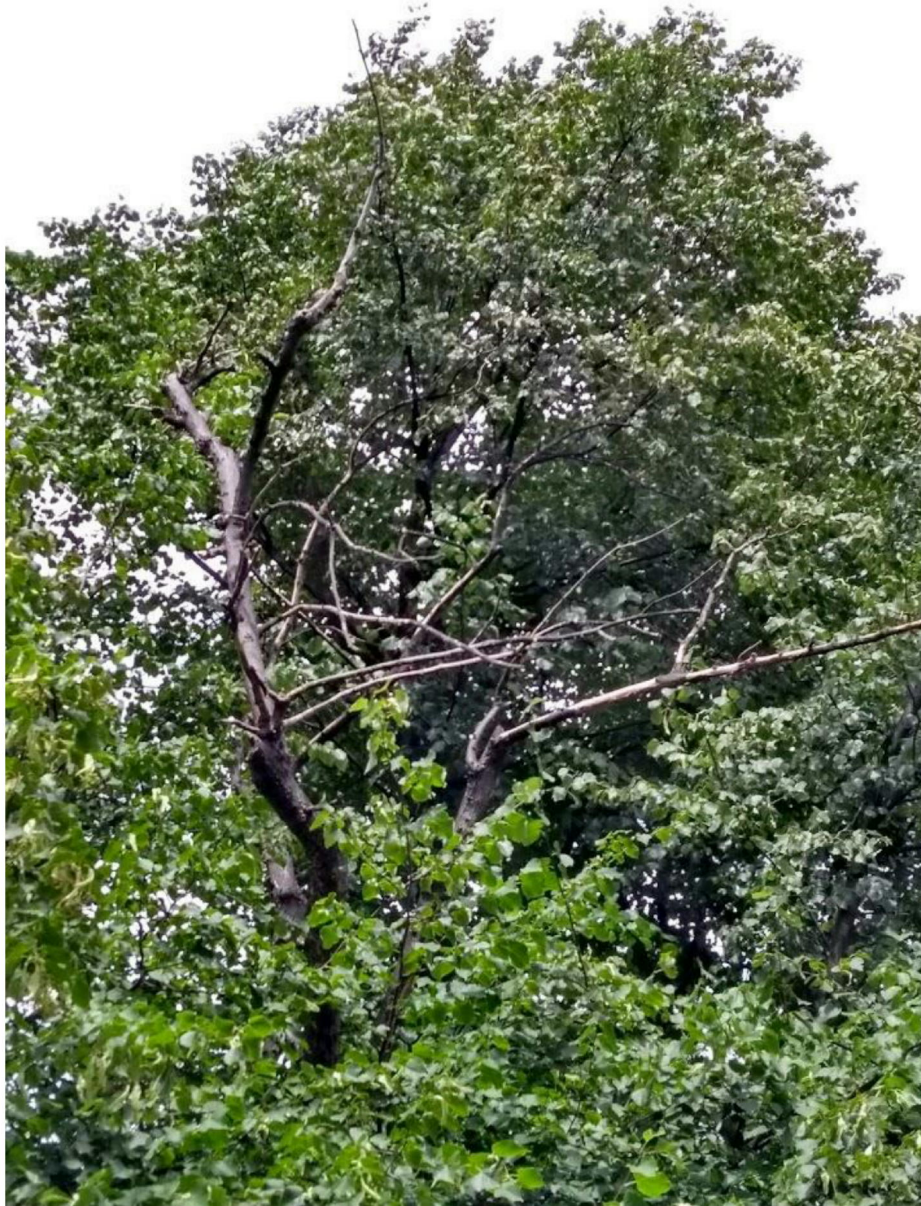
Photo 2

Dead wood in crown of T2. Dead wood is same side as and in line with trunk wound.

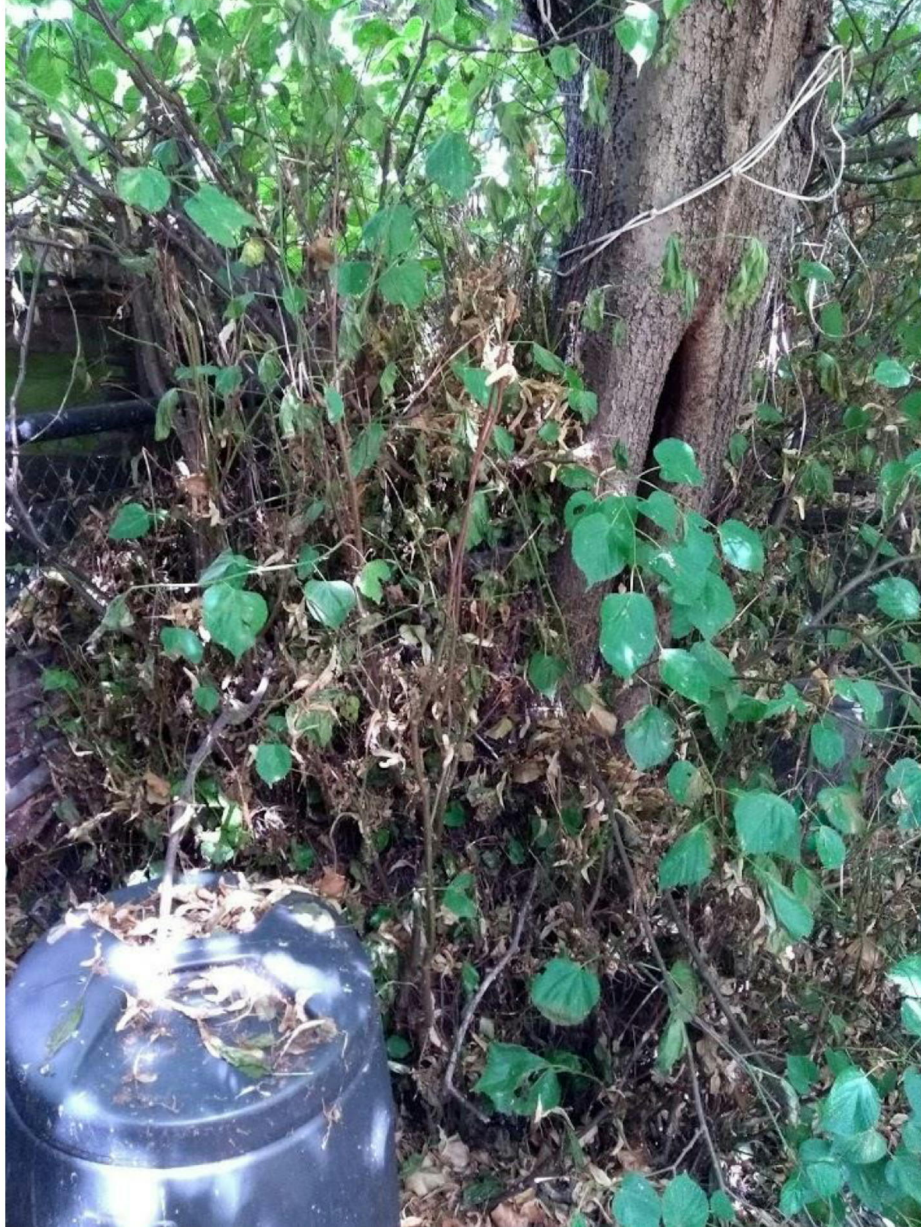
Photo 3

Dense epicormic growth making access and full inspection not possible T2

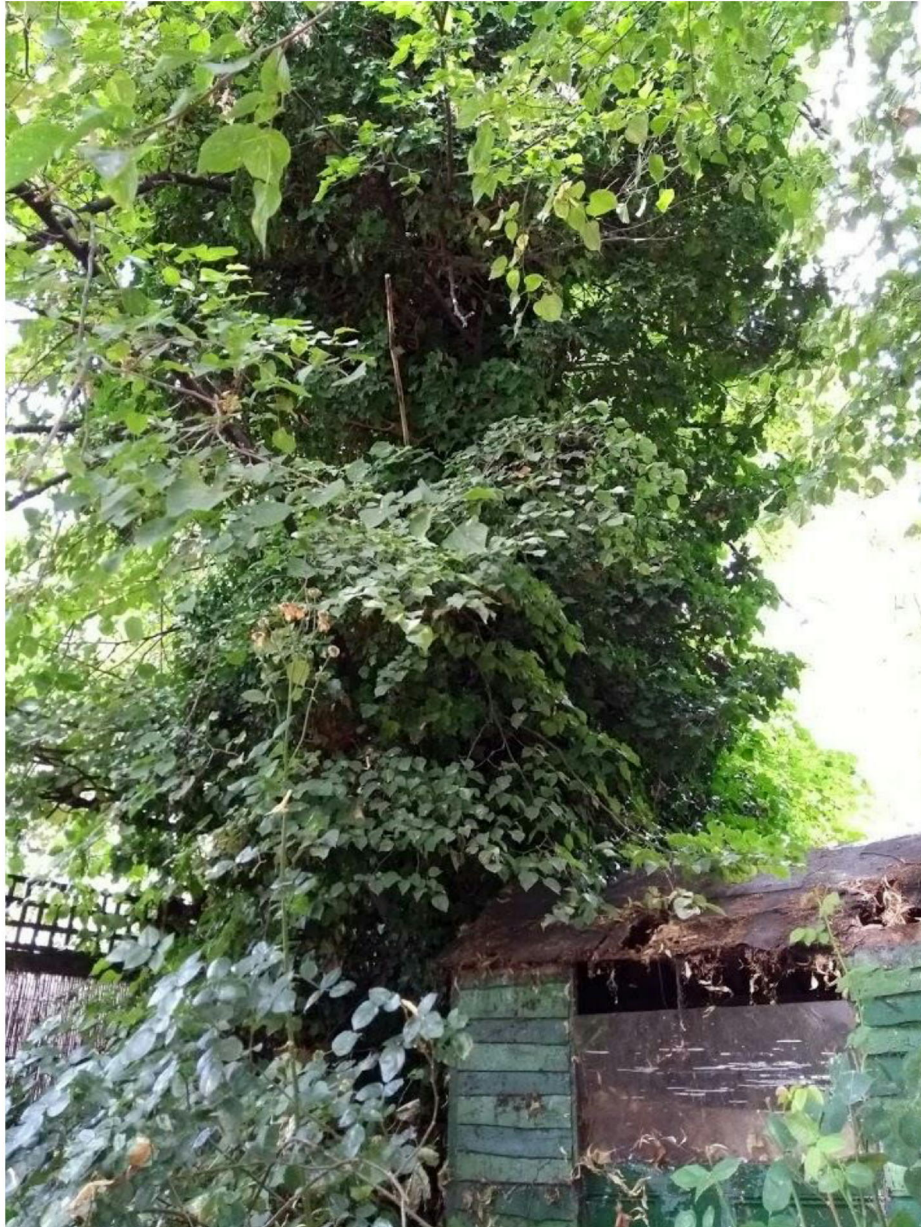
Photo 4

| Tree Ref. No. | Species | Ht. (m) | Stem dia. (mm) | Crown Spread (m) | | | | Ht. to 1st branch (m) | No. of stems | Age Class | Condition (G-F-P-D) | Structural condition & Notes | Management recommendations | Est. ret. Span (yrs) | RPA (m) | RPA Area (m ²) | BS Cat |
|---|---|---|---|---|---|---|---|---|---|---|---|--|--|---|---|---|---|
| T3 | Lime | 14 | 400+ | 5 | 5 | 3 | 4 | 4 | 1 | M | Unable to assess | Very dense Ivy growth throughout. Ivy and epicormic impede inspection of this tree. Deadwood on North, North Eastern side. | Sever Ivy at base, allowing Ivy to die of and then strip from tree. Remove basal epicormic growth to give full access around trunk and allow VTA to be undertaken. | - | 4.8 | 72.4 | C1 From partial inspection |

Very dense Ivy throughout and epicormic impedes access and inspection of T3.

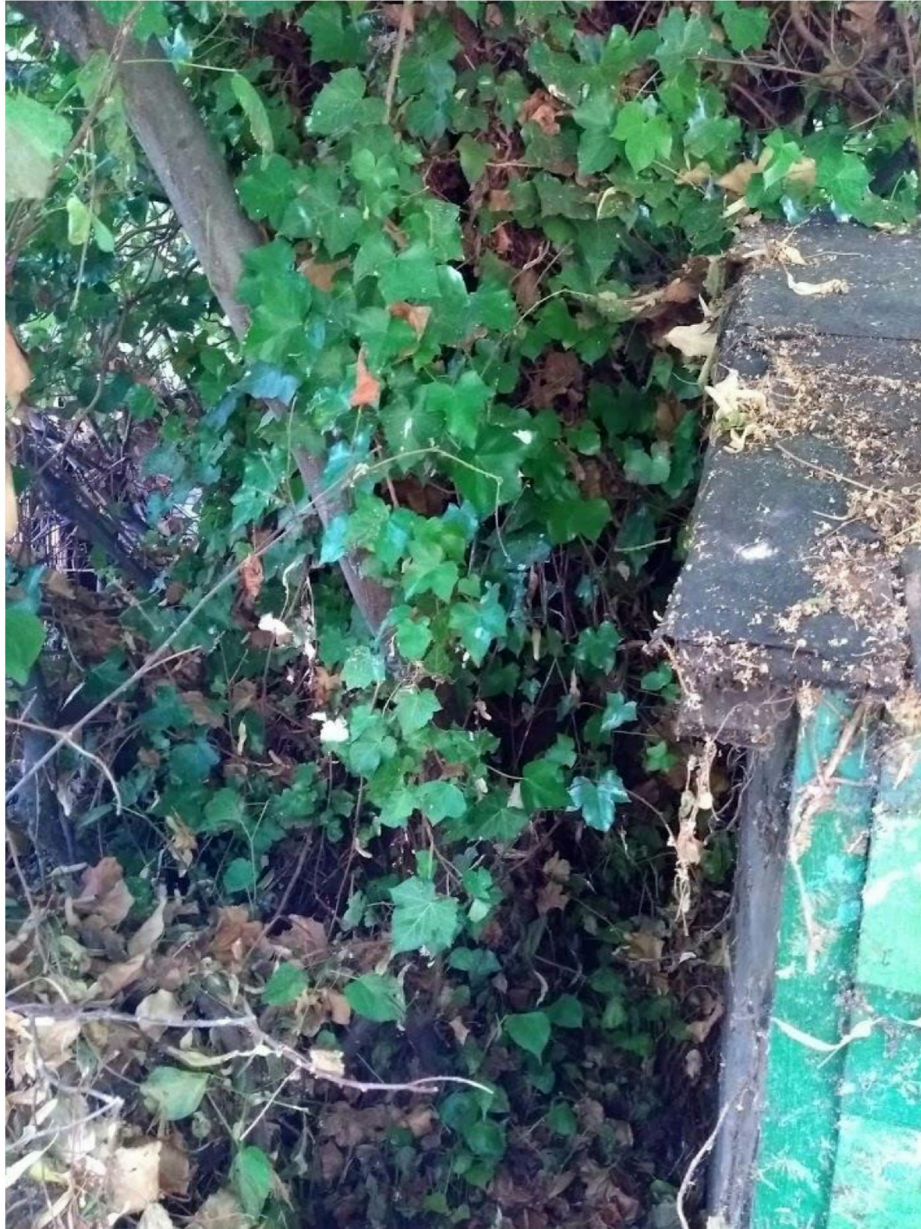
Photo 5

Very dense Ivy and epicormic growth throughout T3

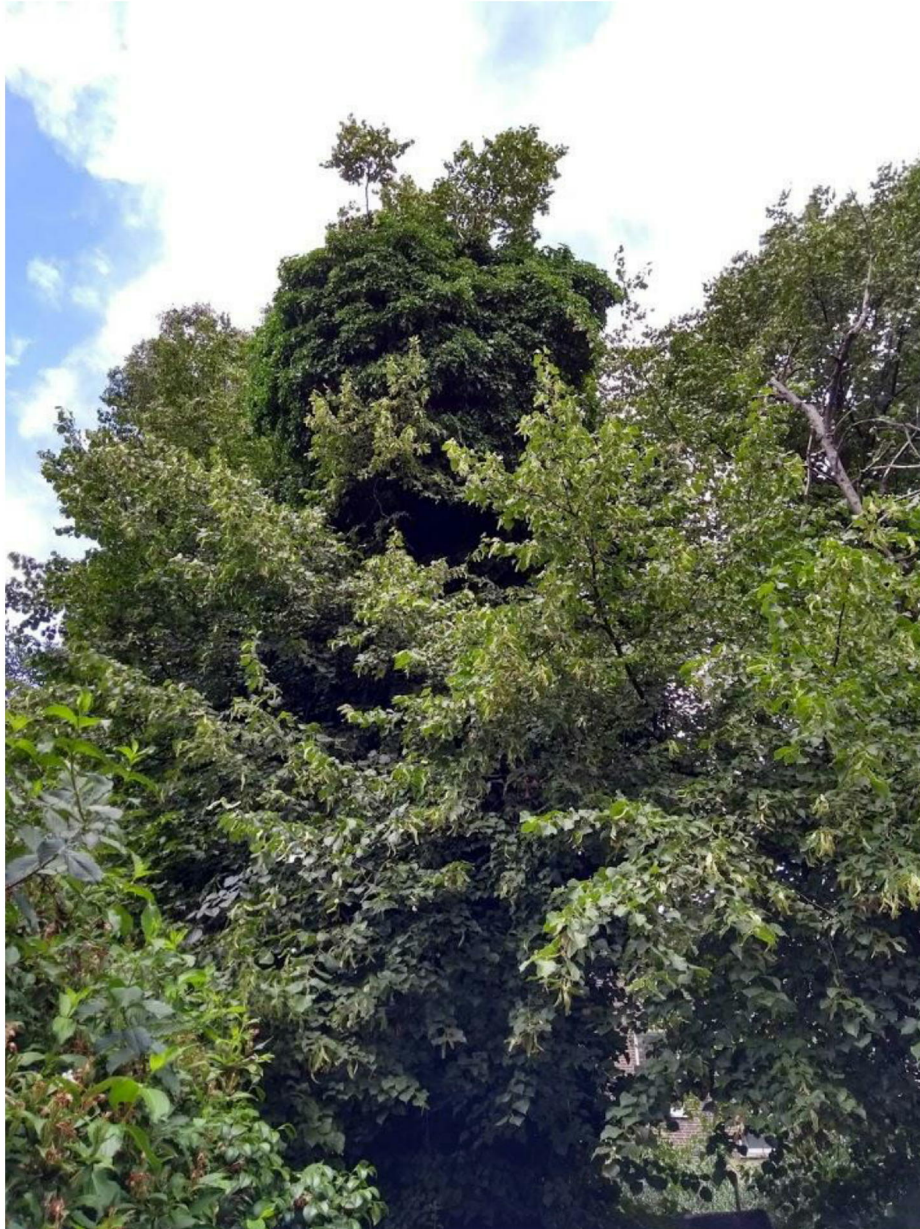
Photo 6

Very dense Ivy visible throughout from base to top of tree T3.
