# MEDIUS HOUSE - STRUCUTRAL METHOD STATEMENT

Report to Discharge Condition 44

15-21

Façade Survey DMAG-1521-02-FS October 2018

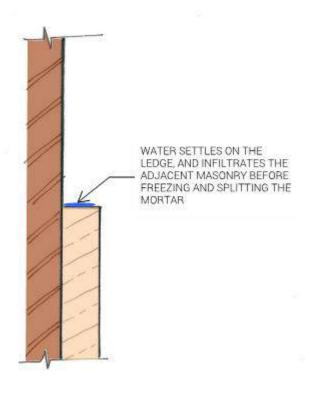
There are multiple areas where water has settled on ledges in the façade, where the stone steps out creating features and sills. The water has then infiltrated the neighbouring masonry and frozen, causing expansion which has cracked the mortar and masonry above.

Figure 1: Water settling on ledges

It is proposed that the ledges are sanded off on the top, in order to create a fall so water does not collect in these areas in the future. Local mortar repairs will also be necessary to repair existing damage.

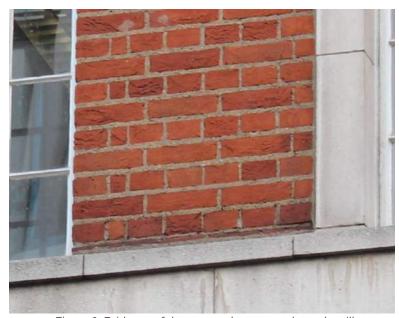
Figure 2: Evidence of damage to the mortar above the sill

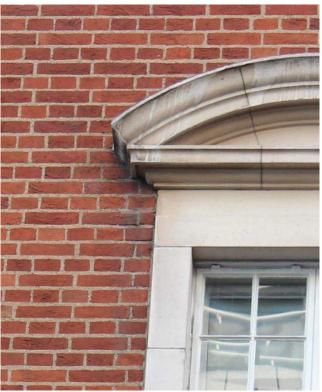
The facade has decorative stone work around some of the windows. Where there are porticos, rainwater has washed down the sides and washed mortar out of the joints.

Figure 3: Water damage down the side of the windows

The mortar will need repair and repointing prior to the frame demolition. This should be completed periodically as part of the building's regular maintenance.

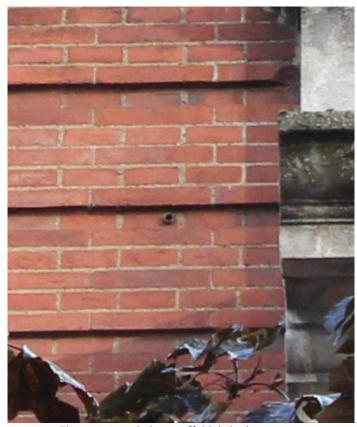
Across the façade, there are multiple existing scaffold ties. Some are obvious whilst others have been previously masked with infill grout. These can remain in situ.

Figure 4: An existing scaffold tie in the masonry

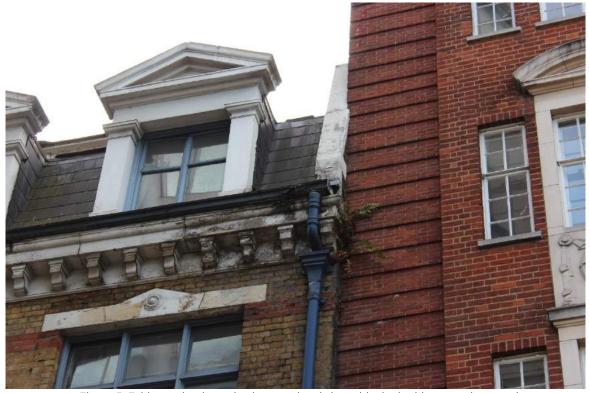
There is evidence the rain water down pipe has been blocked in the past, which has created overflow issues. There are currently plants growing in the gutter work at high level. This has caused significant damage to the surrounding brickwork, and the brickwork going down the drainpipe. There is washout of the mortar and cracks to the bricks. It is recommended that the gutter is cleared regularly, and repair work is undertaken such as repointing and helifix repairs where cracks are evident.

Figure 5: Evidence the downpipe has previously been blocked, with vegetation growing

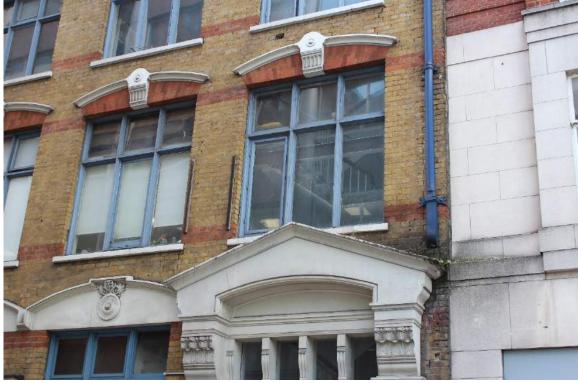
There are also a number of cracks beneath the windows on Bucknall street warehouse elevation, which highlights there may be further structural issues with this façade. We would therefore recommend an internal survey is undertaken of the structure, and how the façade is tied to the frame.

Figure 6: Bucknall St warehouse, showing cracks behind the drain and around the windows
