Flat A, 1 New Square, Lincoln's Inn

Internal alterations, replacement windows and rooflights.

PHOTOGRAPHIC REPORT

August 2017

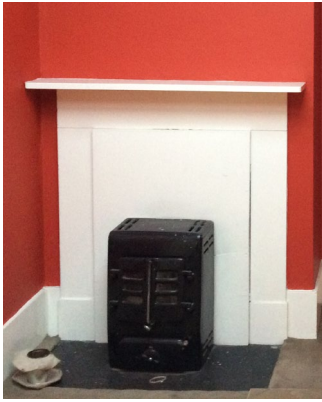
Coal stove

The fireplace surround and coal burning stove is not an original feature and appears to be a 19th century addition to the apartment.

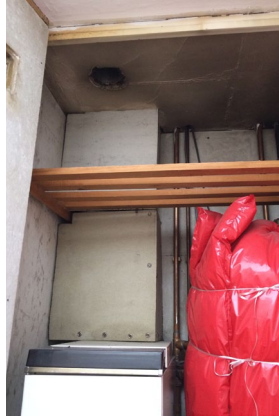
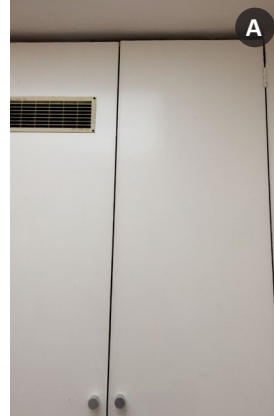
Boiler Cupboard
Asbestos lined boiler cupboard recently removed following an asbestos survey.

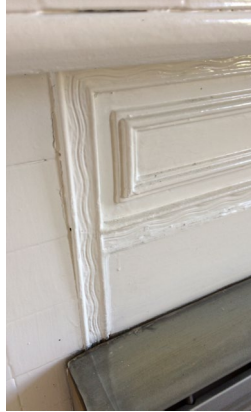
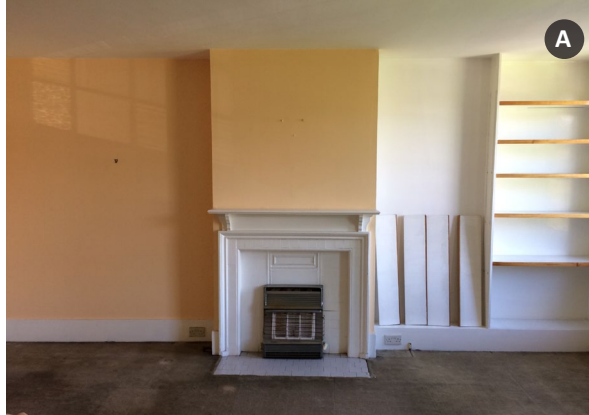
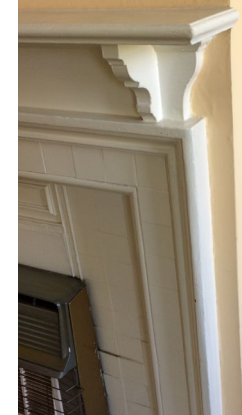
Fire place surround

The fireplace surround origin is unknown. The gas fire within is an 19th century feature.
