Surveying Services
QuestGates Ltd

Date: 17 October 2018

TYPE: ENGINEERS PRELIMINARY REPORT
CLAIM: Subsidence

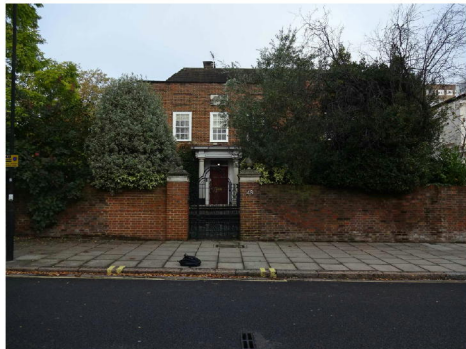
Front elevation of Property
