Drainage Investigation Report

48 Queens Grove, London, NW8 6HH

Site Investigation Report

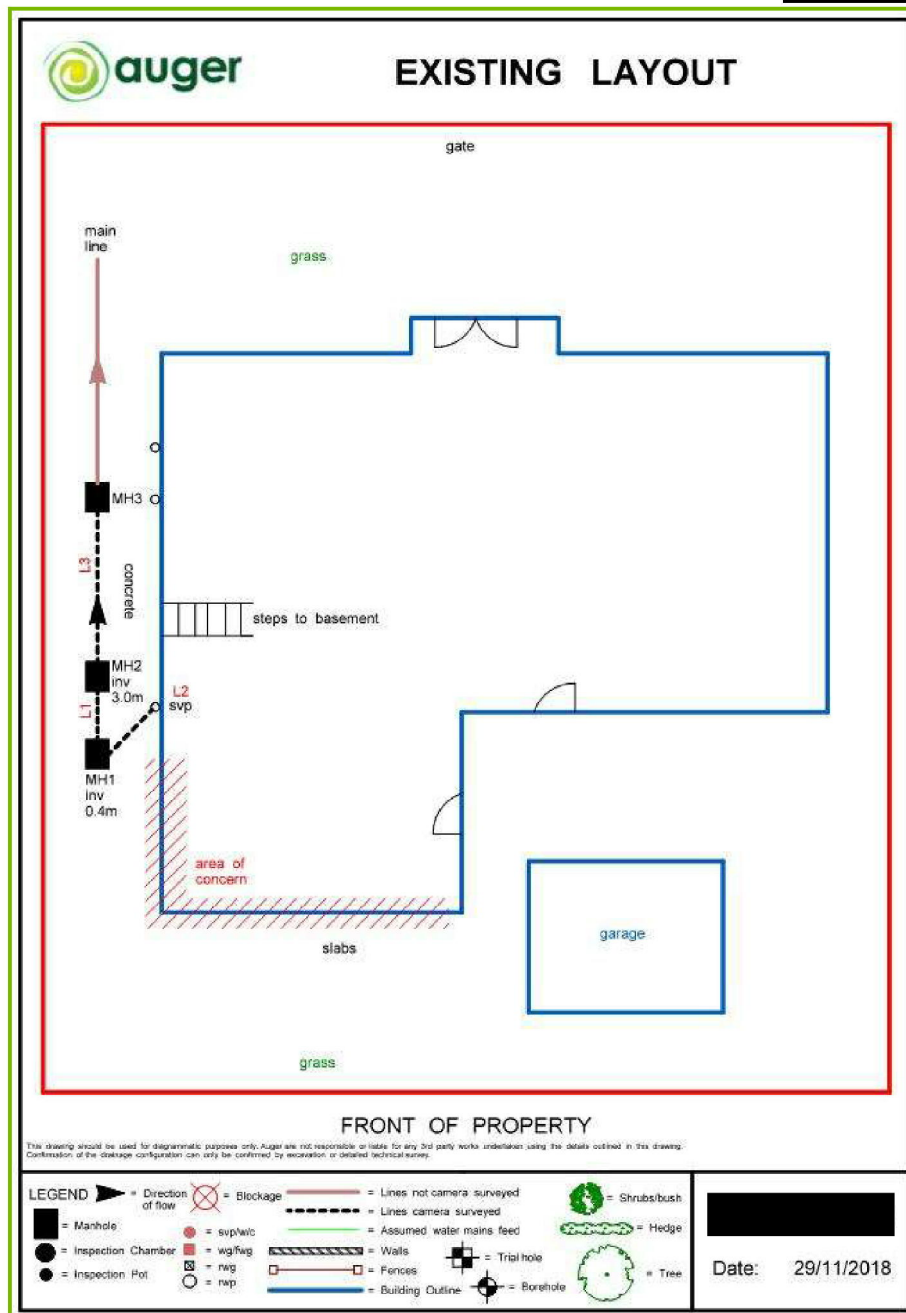
Line 3 - Manhole 2 downstream to manhole 3
Our survey revealed a 10% build-up of silt and debris in the pipework. However, this does not currently appear to be affecting the function of the drain.

1) Our survey of lines 1 and 2 revealed no significant defects which could be allowing water to escape in the area of concern.

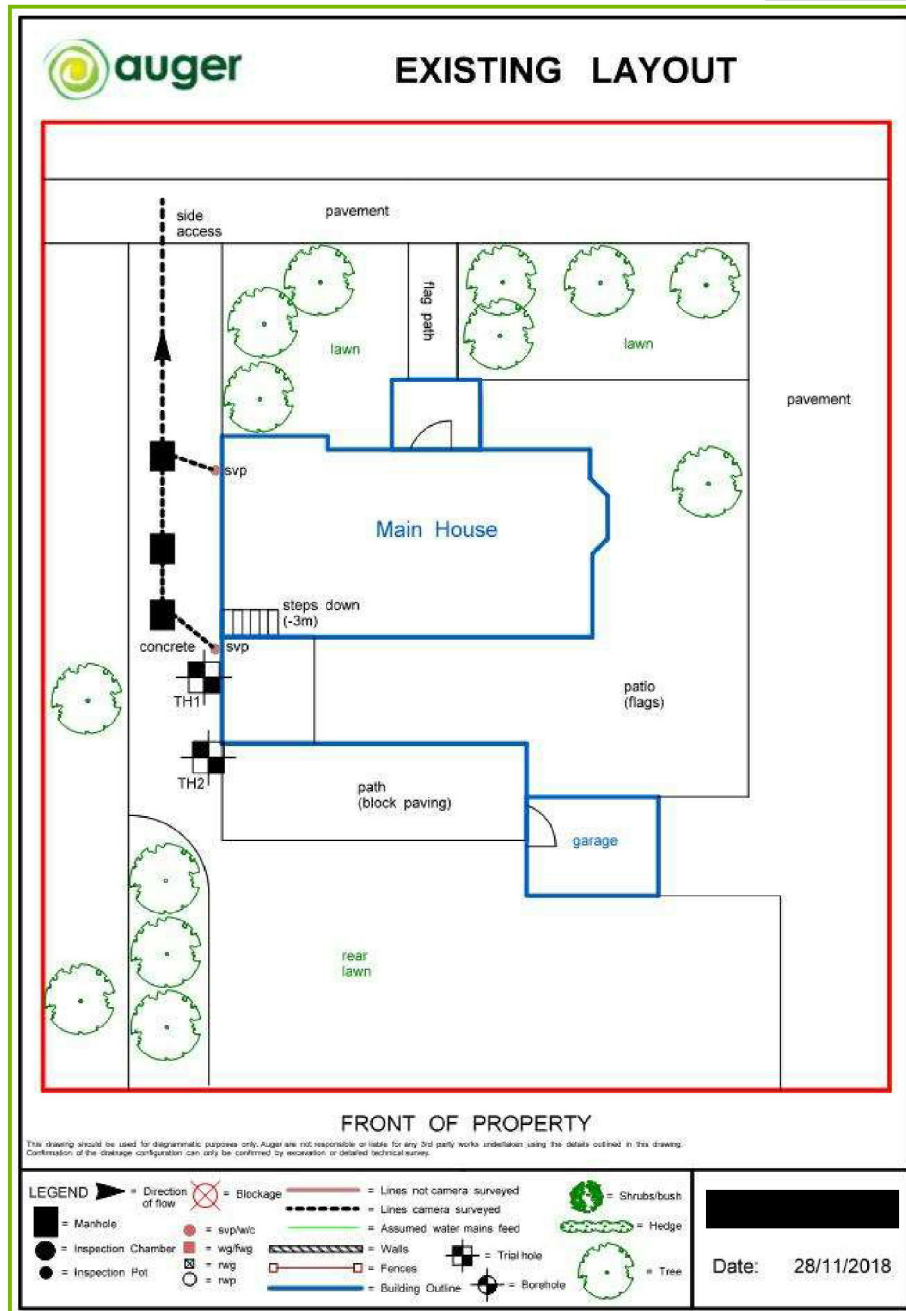
Findings	<p>Please be advised that we probed to a depth of 2.0m for both trial holes but could not locate the top of the footings.</p> <p>It was noted that the trial holes were adjacent to a basement which is approximately 3.0m below ground level. We therefore believe that internal excavations inside the basement would be required to expose the footings.</p>
	<p>We will now refer the claim back to Questgates Subsidence and await your further instruction on how to proceed.</p>

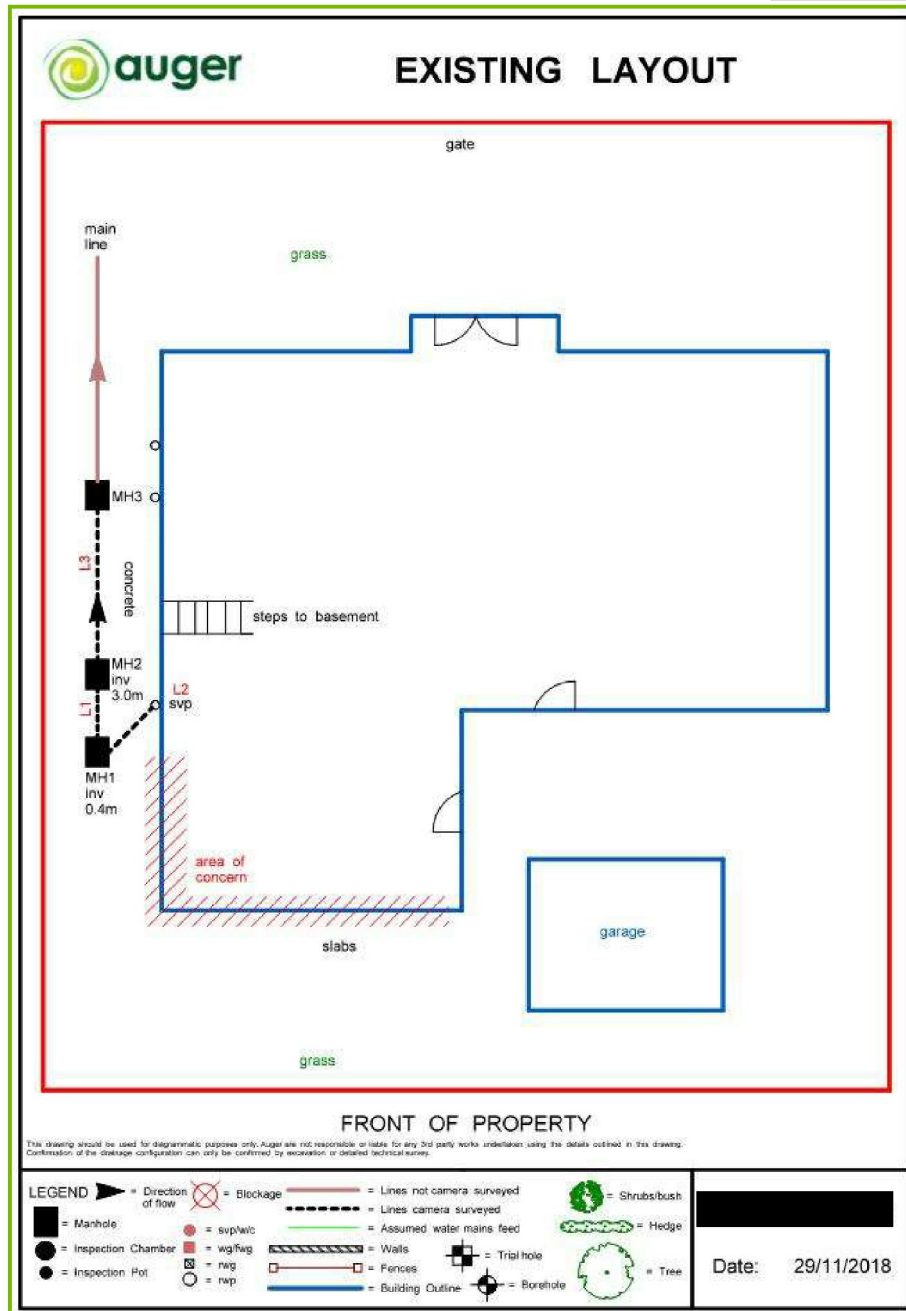
Line 3 - Manhole 2 downstream to manhole 3
Our survey revealed a 10% build-up of silt and debris in the pipework. However, this does not currently appear to be affecting the function of the drain.

1) Our survey of lines 1 and 2 revealed no significant defects which could be allowing water to escape in the area of concern.
