**Level and Crack Monitoring**

Date of Issue: 10/01/2019

Occupier:	Removed for data protection purposes
Address:	5 Froggnal Close
Address:	
Town:	London
County:	
Post Code:	NW3 6YB
Contact Name	Removed for data protection purposes

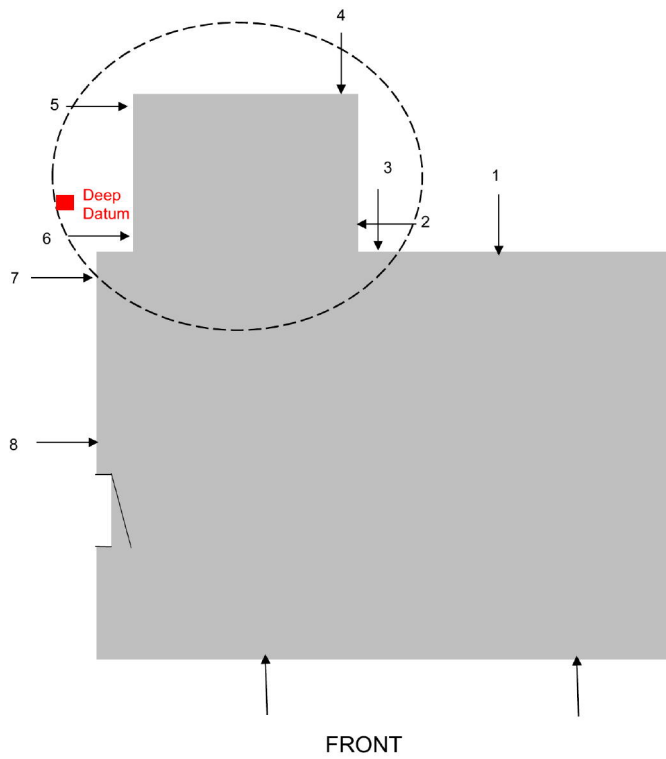
**Level and Crack Monitoring - Site Sketch**

- 1 EXT LH elevation below extension rear window
- 2 INT above dining room patio doors
- 3 INT below rear left window music room
- 4
- 5
- 6
