## **Simon Pryce Arboriculture**

### **Report**

**Site:** 46 Dartmouth Park Road, London, NW5 1SN

**Subject:** Safety inspection of horse chestnut tree in the rear garden

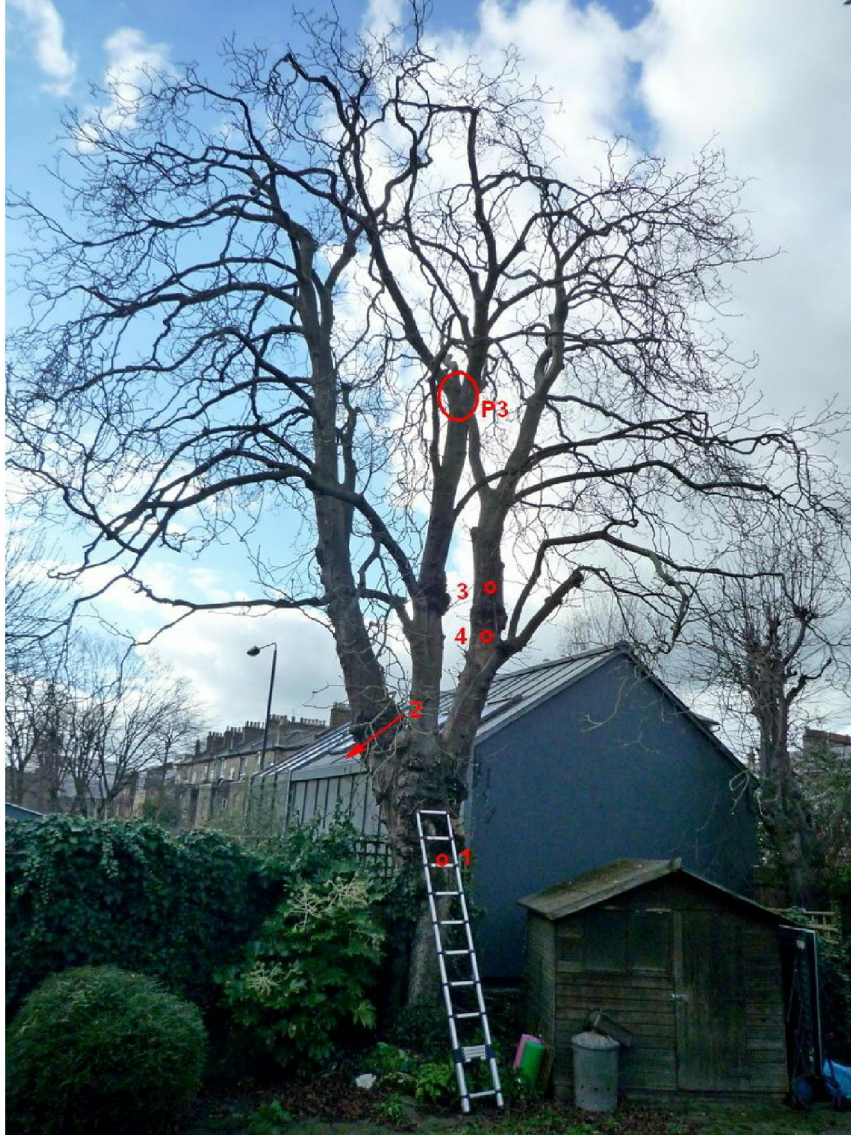
- 3.1 The tree is a mature specimen approximately 14m high with a single vertical trunk about 680mm in diameter that divides at about 4m into three main limbs that ascend to form the main framework of the crown. The tree has been reduced lightly and reshaped and had the crown thinned. This has been done to a good standard and a natural shape and branch structure has been retained. There are some young shoots near the pruning cuts, but these are not particularly dense or vigorous, given the time since the tree was pruned
- 3.2 The tree has a number of large outgrowths or cankers, which are common in red chestnuts and quite often associated with decay. Some of these had visible signs of decay in the canker or nearby and the tree was climbed to inspect these in more detail. The first photograph of the tree shows the locations of these features and the points where it was test drilled.

- 3.4 There are signs of decay under the large canker visible under the ladder in the photograph and one in the fork just above. The trunk was test drilled into a wound just below this and shows some evidence of decay in to about 140mm. Beyond that the timber is sound, but there is a sharp dip in resistance at about 25cm, probably due to decay spreading down from above.

1) View of the tree from the garden. Numbers 1 - 4 show the places where it was test drilled. P3 indicates the branch junction shown in photo 3.

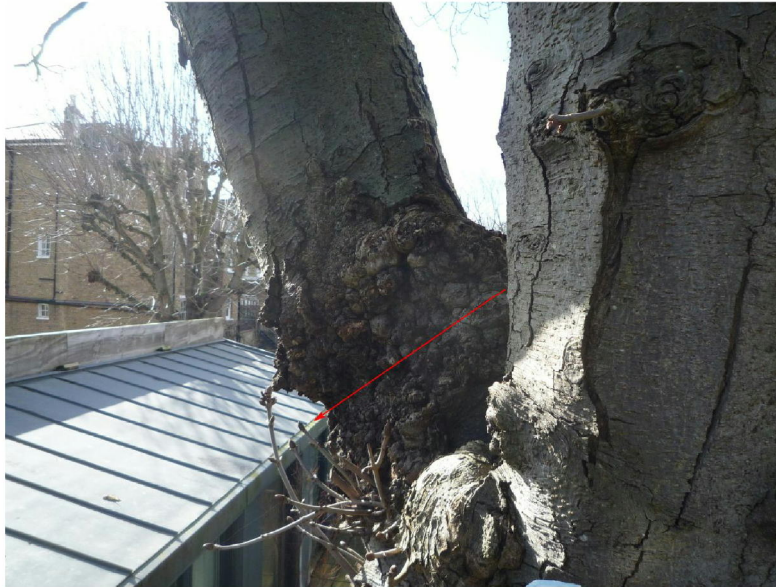
- 3.5 This is on the left in photograph 1. The upper parts are generally in reasonable condition, but there is a large canker round most of the base just above the attachment to the trunk, shown close up in photo 2. This appears reasonably sound externally, but is much wider across than it is deep. This was test drilled from the fork at the top of the trunk outwards and angled down, as shown in the photograph, revealing major severe decay just below the canker.

2) Large canker at the base of main limb facing the house. Red arrow shows approx. line of test drill 2.

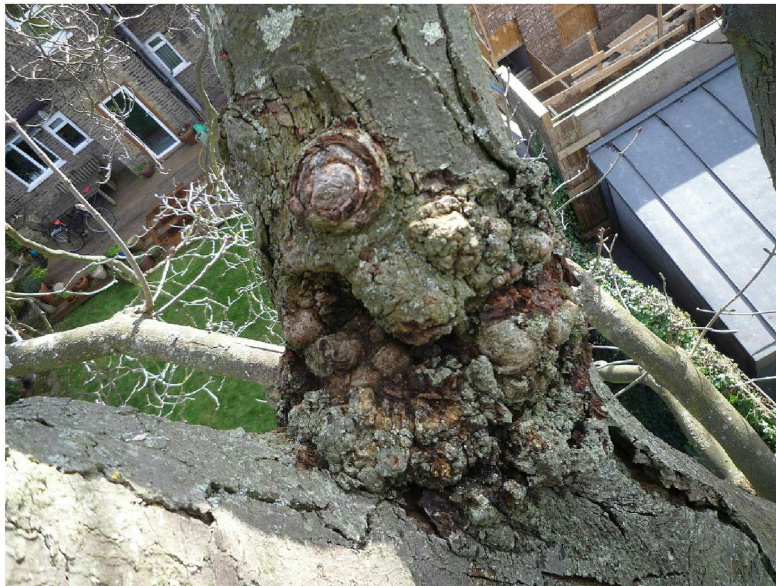
- 3.6 This is the central limb in the photograph. There are no major cankers visible from the ground, but there are several old pruning cuts with decay and one of the main lateral limbs at about 10m has a canker on the top, indicated by P3 in the main photograph and shown close up in photograph 3. There are no obvious signs of decay but the canker has weakened the attachment point of the branch, exacerbated by it developing with an uneven groove across the top.

3) Canker at the base of high branch. Indicated by P3 in photo 1.

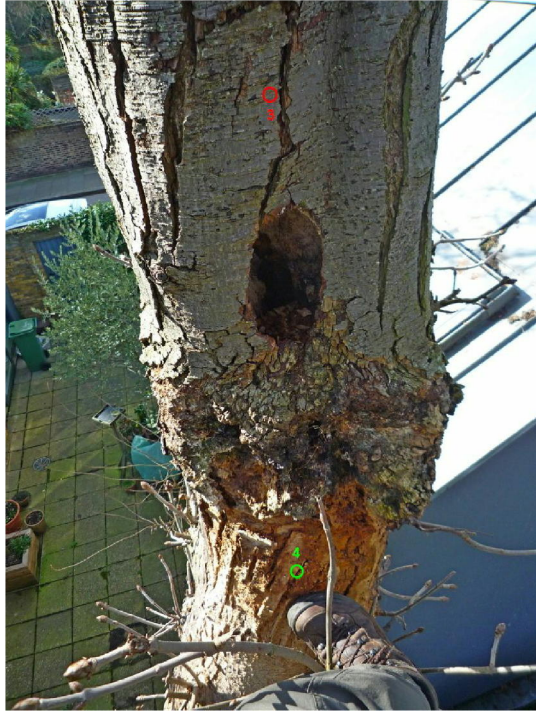
- 3.7 This is on the right in the photograph and has a large canker encircling a large part of the trunk at about 5m above ground shown in photograph 4. The trunk has been weeping and there is brown staining below the canker. Liquid this colour is probably caused by bacterial infections, which do not cause major harm in themselves. However immediately above the canker is a decay cavity about 90mm wide by 200mm wide and 150mm deep, i.e. almost to the centre of the limb. The timber inside is soft and decayed and it was possible to push a 70mm knife blade fully into the back of the cavity with little effort.

- 3.8 There are no signs of callus growth round the edges of the cavity and teeth marks round the edges and fragments of wood inside indicate that it is being used by grey squirrels.

3) Limb over the adjacent house showing canker and decay cavity above. Test drill 3 was above the cavity, no.4 through the brown stained area below the canker. (Lower one shown green to stand out against the background)

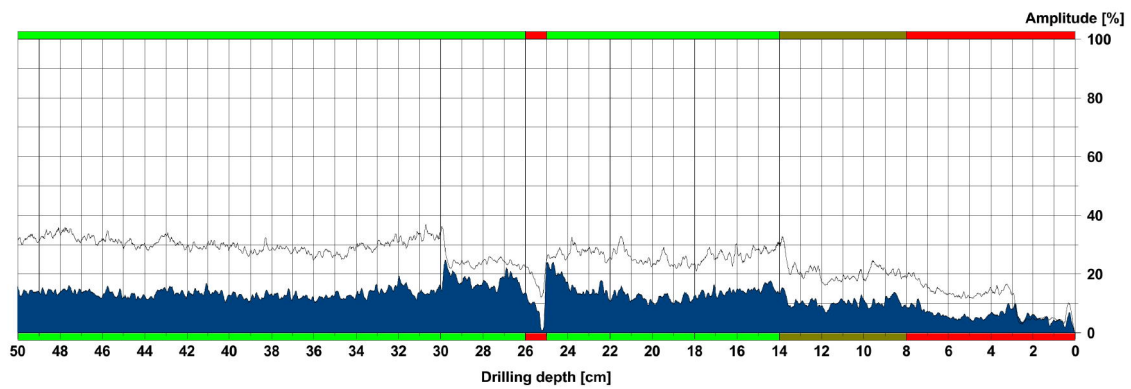
█	From	0,0 cm	to	8,0 cm	:	Decay
█	From	8,0 cm	to	14,0 cm	:	Suspected decay
█	From	14,0 cm	to	25,0 cm	:	Sound wood
█	From	25,0 cm	to	26,0 cm	:	Decay
█	From	26,0 cm	to	50,0 cm	:	Sound wood
█	From	0,0 cm	to	0,0 cm	:

Into wound in the trunk below the large canker. Suspected decay to about 14cm. Sound after that apart from sharp drop in resistance at 25cm, probably a small decay pocket

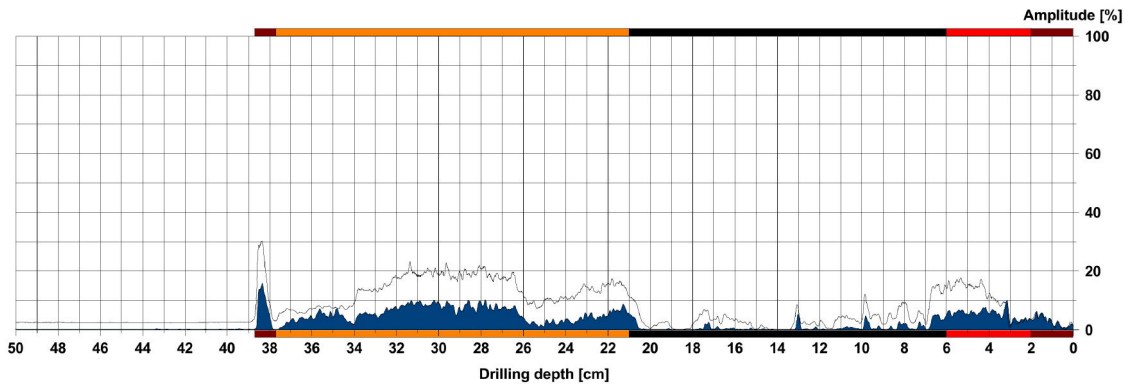
█	From	0,0 cm	to	2,0 cm	: Bark
█	From	2,0 cm	to	6,0 cm	: Decay
█	From	6,0 cm	to	21,0 cm	: Cavity
█	From	21,0 cm	to	37,7 cm	: Incipient decay
█	From	37,7 cm	to	38,7 cm	: Bark
█	From	0,0 cm	to	0,0 cm	:

From NW through canker at the base of the large stem above the side boundary growing toward no.46. Decay all the way through, very severe or cavity in the centre.

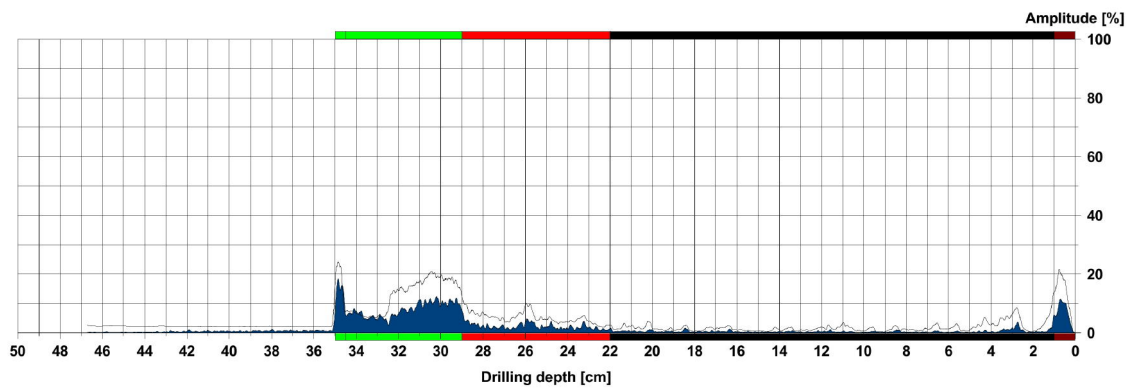
- 3.9 This limb was test drilled above the cavity and below the canker and the readings are attached. Chart 3 shows very extensive severe decay above the cavity with little sound wood supporting the parts of the limb above. Chart 4 from below the canker is harder to interpret; there is more sound wood than above the cavity, but there is significant decay.

█	From 0,0 cm to 1,0 cm : Bark
█	From 1,0 cm to 22,0 cm : Cavity
█	From 22,0 cm to 29,0 cm : Decay
█	From 29,0 cm to 34,5 cm : Sound wood
█	From 34,5 cm to 35,0 cm : Sound wood
█	From 0,0 cm to 0,0 cm :

From NE into limb overhanging the adjacent house just above the cavity opening. Severe and extensive decay / cavity

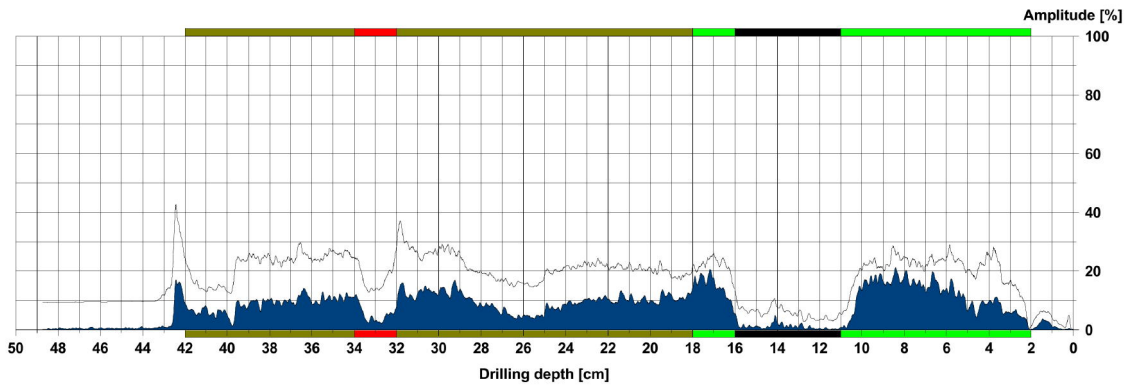
█	From	2,0 cm	to	11,0 cm	:	Sound wood
█	From	11,0 cm	to	16,0 cm	:	Cavity
█	From	16,0 cm	to	18,0 cm	:	Sound wood
█	From	18,0 cm	to	32,0 cm	:	Suspected decay
█	From	32,0 cm	to	34,0 cm	:	Decay
█	From	34,0 cm	to	42,0 cm	:	Suspected decay

Below cavity in limb over adjacent house.  
System limited by not allowing more than six assessment categories, so bark has been omitted. Pattern complex, indicating some sound wood with significant decay.
