**REGENTS CANAL 140 -
146 CAMDEN STREET
VISUAL SURVEY REPORT**

JANUARY 2019
1858-BRL-01-XX-RP-C-0001

CLIENT	ROK Planning Ltd					
PROJECT TITLE	Regents Canal 140 - 146 Camden Street					
SUBJECT	Waterway Wall Inspection					
DOCUMENT TITLE	Visual Survey Report					
DOCUMENT REF	1858-BRL-01-XX-RP-C-0001					
REVISION RECORD						
REV	STATUS	DATE	SUMMARY OF CHANGES	PREP	CHK	APP
P01	S3 – Suitable for review & comment	11/01/2019		NN	JM	ID
P02	S2 – Suitable for information	22/01/2019		NN	JM	ID
P03	S2 – Suitable for information	20/02/2019	Additional survey information of Section 4 - Concrete Covered Masonry Wall	NN	ID	ID

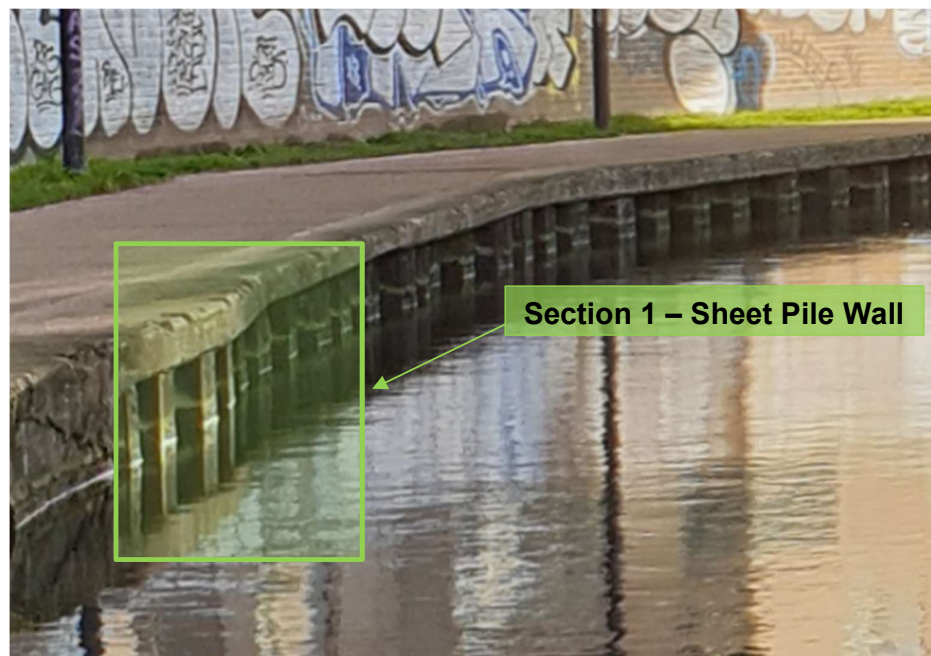
Figure 3.1: Photograph indicating Section 1- Sheet Pile Wall above water

3.1.2 The sheet piles were observed to have light surface corrosion on the non-submerged section, while minimal marine growth could be observed throughout the submerged section. During the visual inspection of this section no evident defects were identified. The sheet piles appear to be straight with no perforation, dents or buckling of the steel observed.

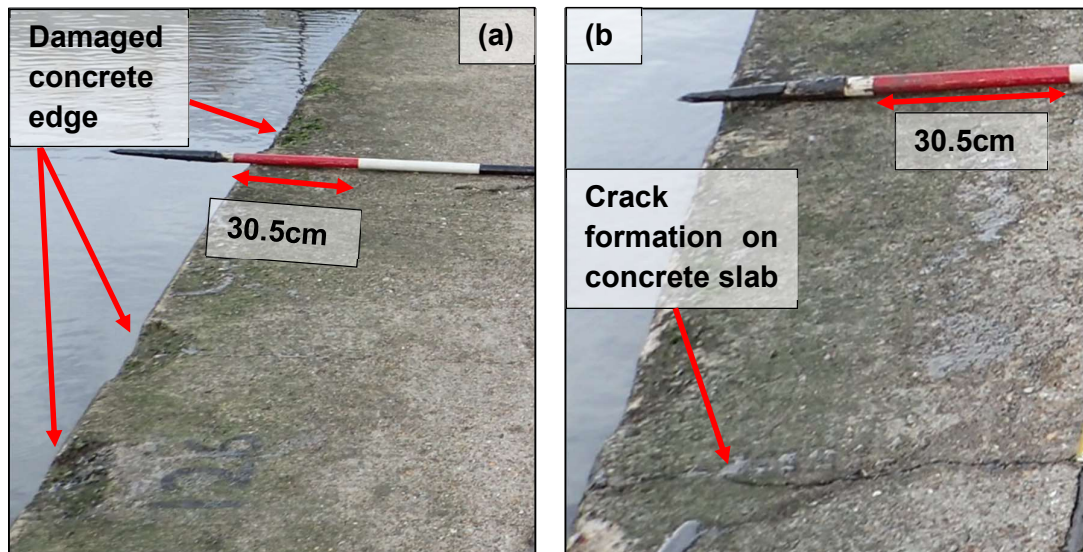
3.1.3 Localised damage was observed on the concrete edge in multiple locations, as shown in Figure 3.2. It is thought to be due to local impacts from the canal faring vessels. Additionally, a crack was identified on the top surface of the capping beam. However, due to the size and direction, the damage is thought to be a result of early thermal cracking, or settlement, and is not considered to be an issue

caused by degradation or external event. . Overall the condition of the concrete slab of this section is considered fair.

Figure 3.2: (a) Damaged edge and (b) crack of concrete slab for Section 1 - Sheet Pile Wall

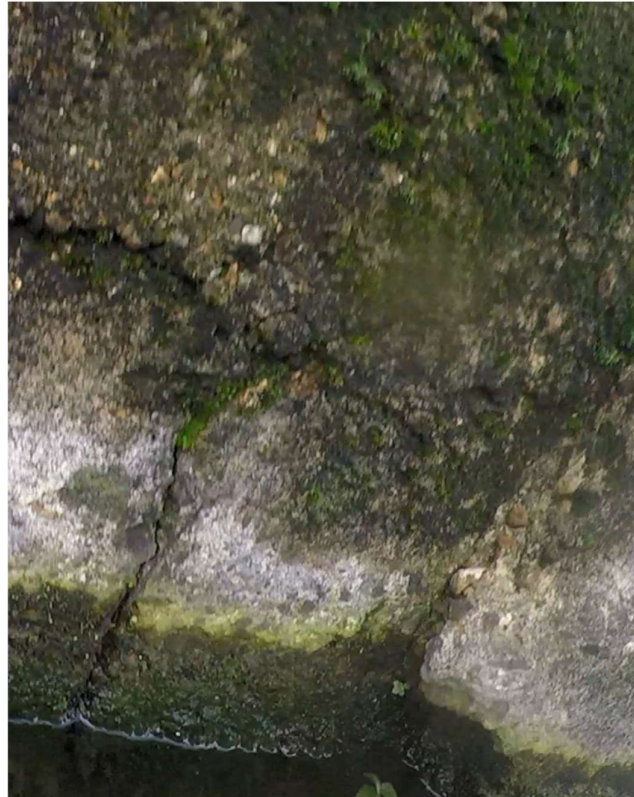
3.2.2 The capping beam extends below the water level and its total height is approximately 70cm. During the inspection of the beam, a number of cracks were observed. It is believed these have been caused by the settlement of the masonry wall and are not thought to be a source of concern. The condition of the capping beam is considered fair. A typical crack is shown in Figure 3.4.

Figure 3.4: Typical formation of cracks on the concrete capping beam of Section 2 Wall

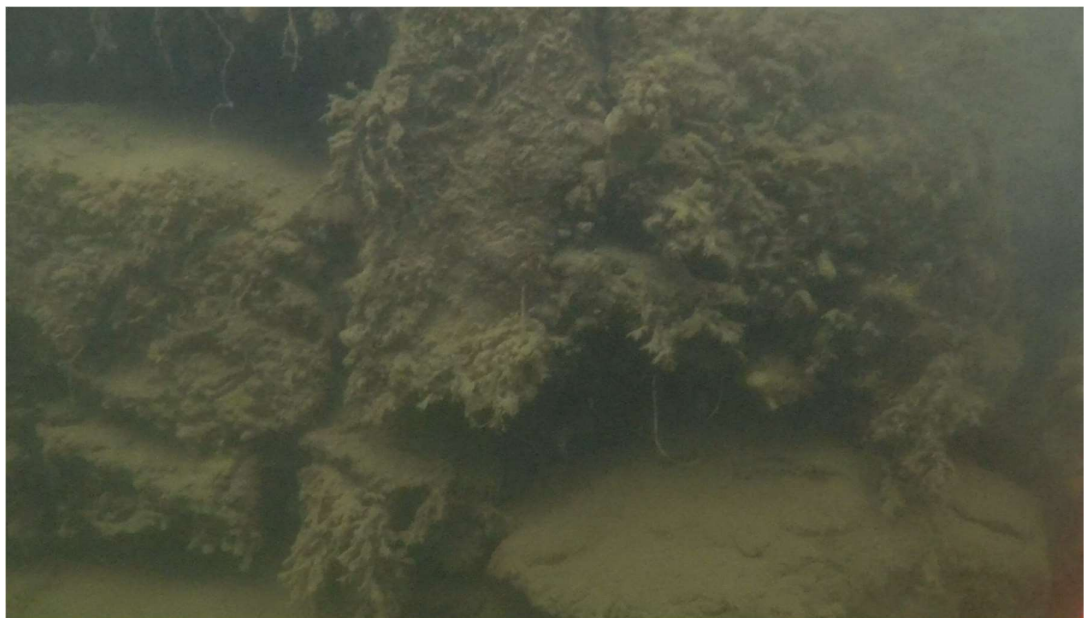
3.2.3 The front face of the masonry blockwork wall was found to be in poor condition. The mortar between the joints is completely eroded, leaving large gaps between the blocks, as shown in Figure 3.5.

Figure 3.5: Typical gaps between blockwork due to mortar loss

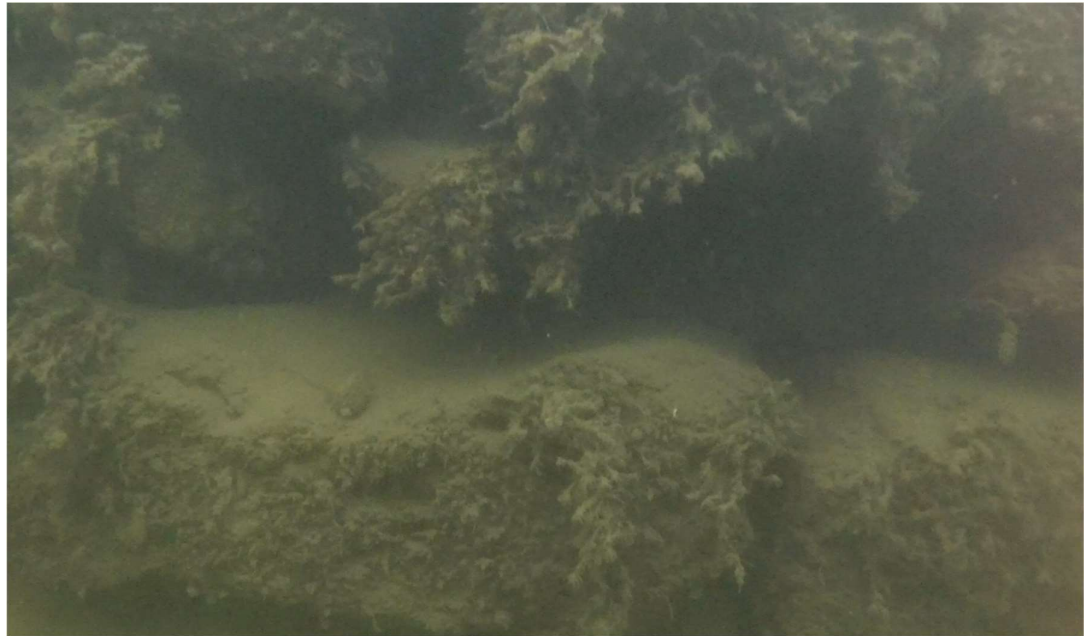
3.2.4 Additionally, large gaps were identified on the front face of the wall at numerous locations. These gaps are thought to be missing/displaced masonry. An example is shown in Figure 3.6. The location of the identified gaps are presented in Table 3.1 and in Appendix A.

Figure 3.6: Identified large gap on the masonry blockwork wall

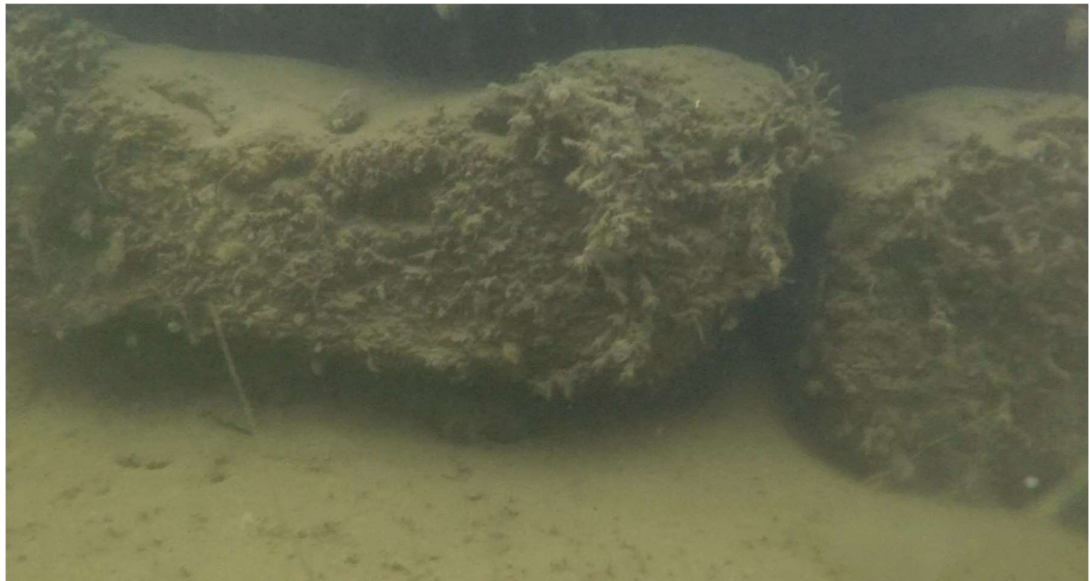
3.2.5 Finally, a visual inspection of the toe of the wall was also performed. The main findings were that the majority of Section – 2 shows signs of minor localised scouring as shown in Figure 3.7. The gaps at bed level may also be due to eroded mortar between blocks above and below the bed level, but this could not be confirmed.

Figure 3.7: Scouring at the base of Section - 2 Masonry Blockwork Wall

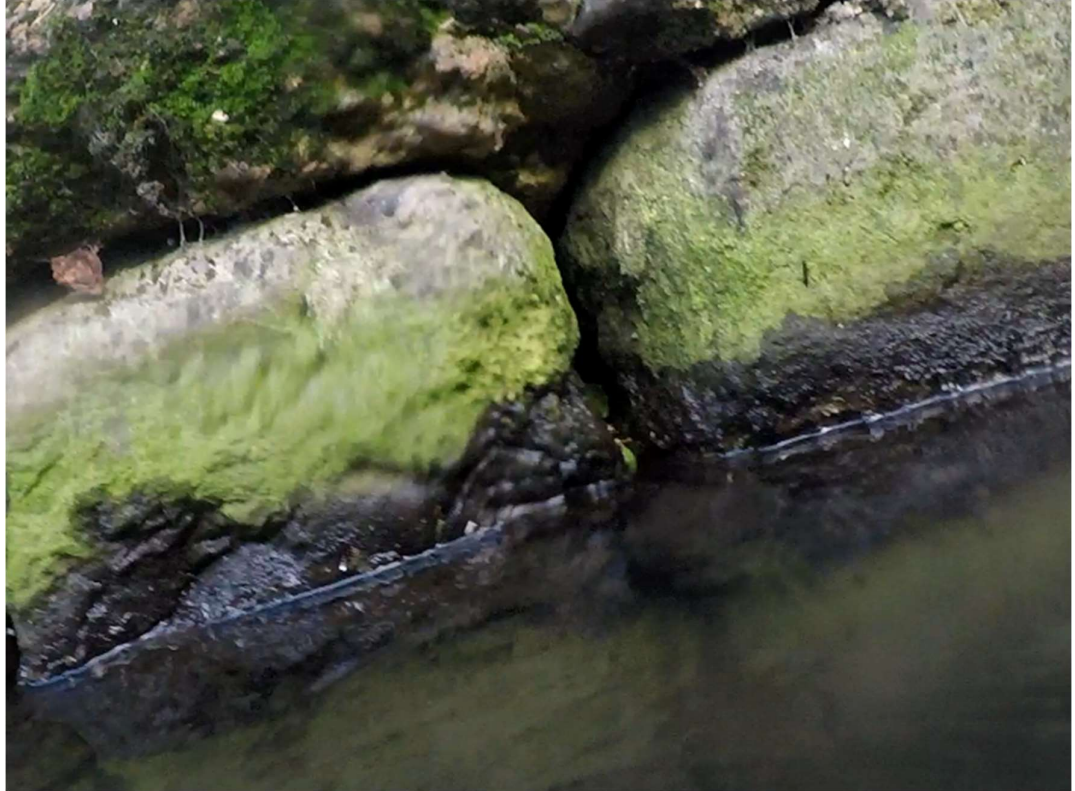
3.3.2 As can be observed from Figure 3.9, 20-50mm gaps have developed between the concrete capping and the masonry blockwork wall below. This is believed to be due to a combination of settlement of the masonry wall, washout of the grout and freeze-thaw action. These caps are not thought to be source of concern.

Figure 3.9: Formation of large gaps between masonry blockworks and concrete topping of Section 3

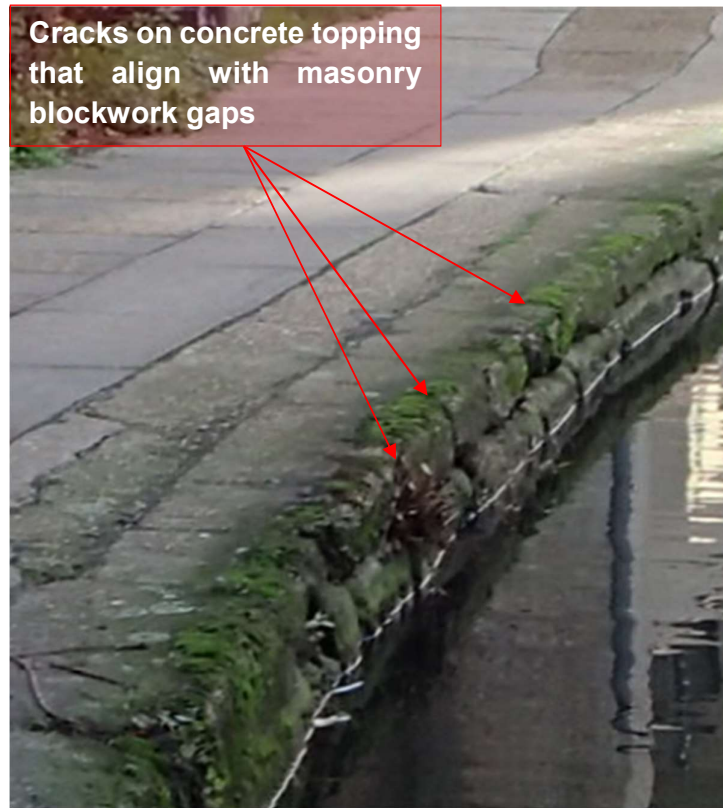
3.3.3 In addition, during the inspection multiple cracks were identified on the concrete topping as shown in Figure 3.10. The reason for this is believed to be due to the settlement of the masonry blocks, as the cracks coincide with the existing gaps between the masonry blocks. Generally, the condition of the concrete topping is considered fair.

Figure 3.10: Cracks on concrete topping of Section 3

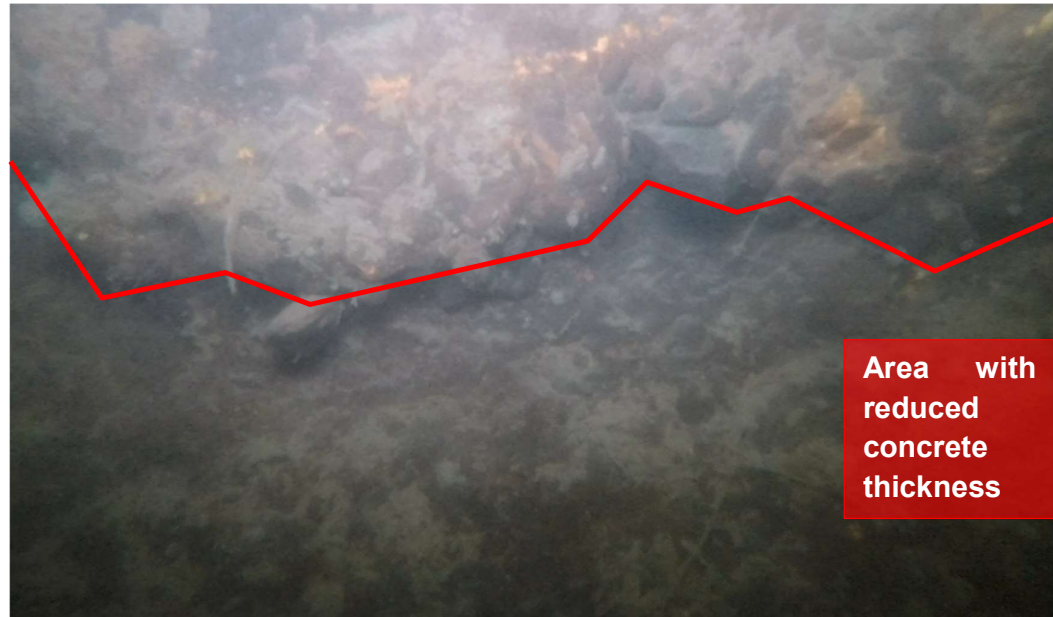
- 3.4.5 Within the first 1.5-3m (eastern side) of the section, a discontinuity in the concrete layer was observed, and the overall thickness of the concrete appears to be reduced. Following the discontinuity, the rest of the wall section (last 6m of its west side) it was observed that the concrete façade has almost completely disappeared. The reason for this is unclear but is believed to have detached from the wall.

- 3.4.6 A segment of the concrete's discontinuity is shown in Figure 3.12. The discontinuity starts at a water depth approximately equal to 45cm, and is continuous until the bottom of the wall at the canal bed.

Figure 3.12: Photograph indicating a segment where the concrete layer is discontinued and its thickness is reduced.

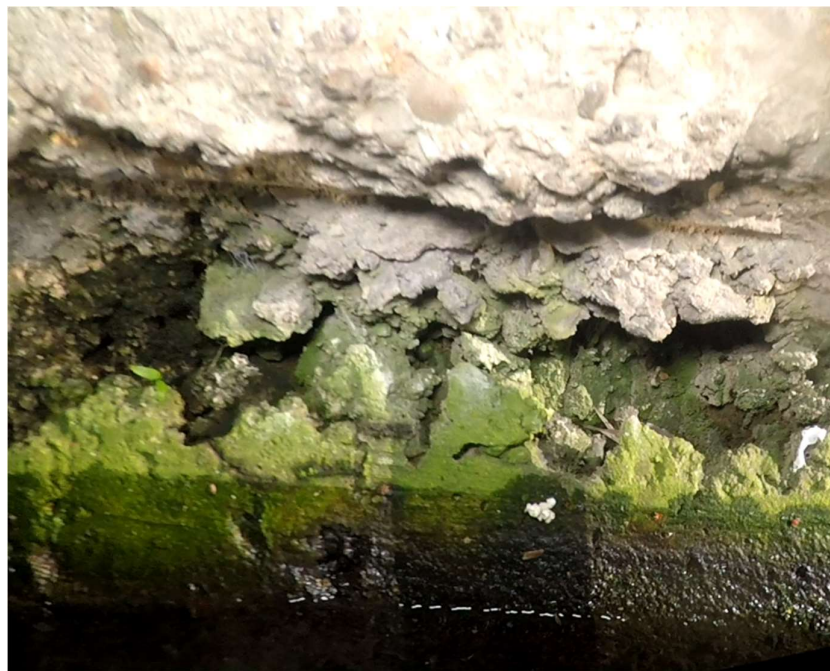
3.4.10 Finally, the concrete walkway that is also part of the wall was found to be in good condition. Within the first 1-2m of Section 4 (eastern side) the concrete above the water level was damaged locally as shown in Figure 3.14. In addition, the concrete on the top edge of the wall along the full length of the Section was found to have localised damage, possibly due to vessel impacts.

Figure 3.14: Photograph indicating the local damage of concrete extending above water level of Section 4
