DAMP INVESTIGATION

113 ALBERT STREET, LONDON

JOB NO. 148.30

26 FEBRUARY 2018

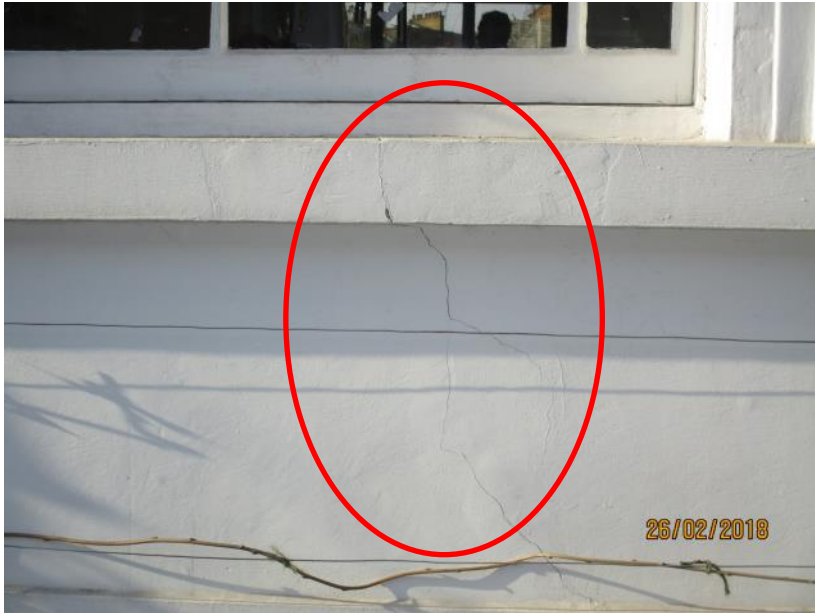
Fig 1:

East elevation, upper ground floor; showing vertical crack through render and decorative finishes, allowing water penetration into the structure

*Allowance should be made for patch repair in a flexible colour matched sealant to all cracks in the façade render and decorative finishes. Consideration should be given on future planned refurbishment and redecoration to specialist repair to the existing cracks, to reduce the risk of them opening up and admitting wind driven rainwater between normal redecoration cycles*

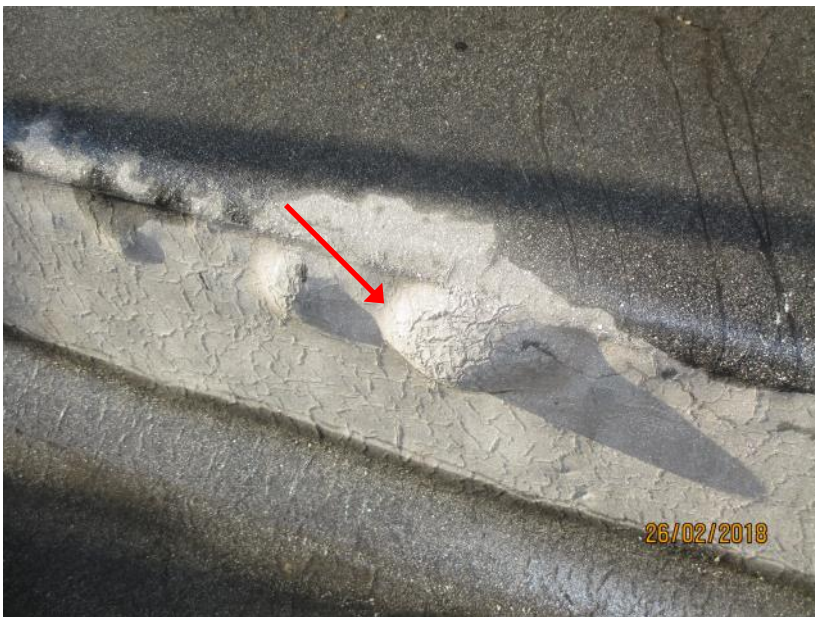
Fig 2:

East elevation, access stairs to upper ground floor; showing blistering to asphalt finishes indicating trapped moisture and a shortened service life

*Blisters or splits in the bituminous coatings should be repaired on planned refurbishment. Cracks in render at the sides of the steps should be repaired as described at 3.1.1(2) above*

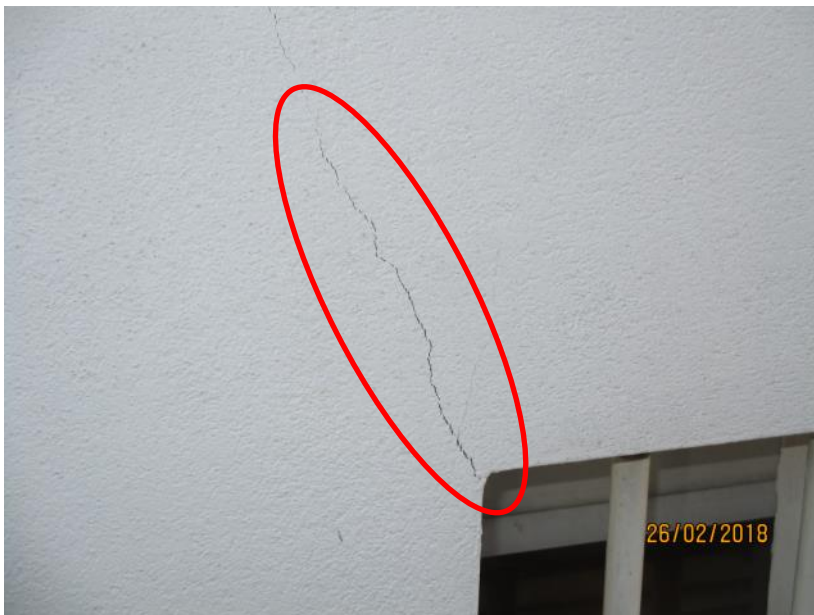
Fig 4:

East elevation, upper south side of lower ground floor window; showing diagonal crack in render and decorative finishes, increasing the risk of water penetration

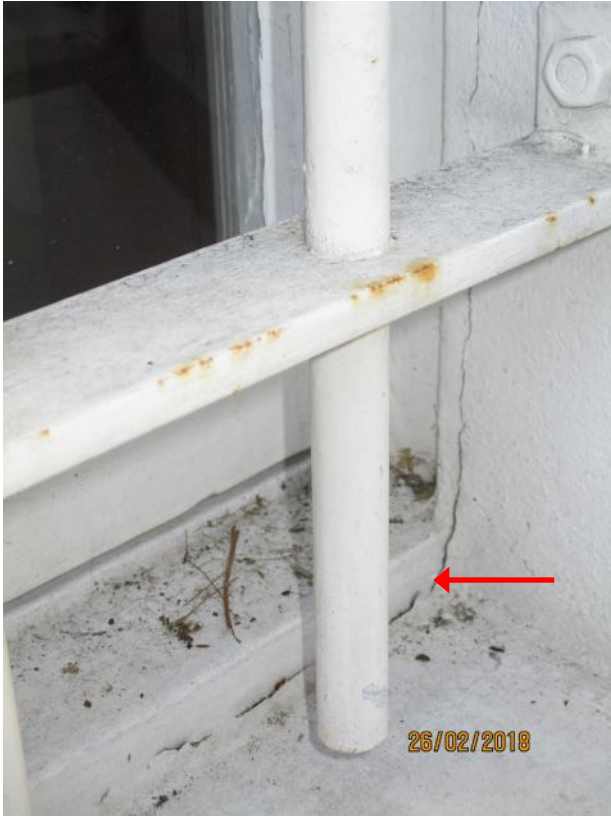
Fig 5:

East elevation, lower ground floor window; showing minor failure of sealants and decorative finishes around the window frame on the north side

*Defective sealants should be replaced around window frames and all external joinery should be subject to a programme of effective routine maintenance and redecoration, to maintain a vapour permeable but waterproof 'skin' over all external timber surfaces. Consideration should be given to stripping non-permeable or 'alkyd' paints from external joinery and replacing in a breathable micro-porous paint system on planned future refurbishment. H+R can provide further advice if required*

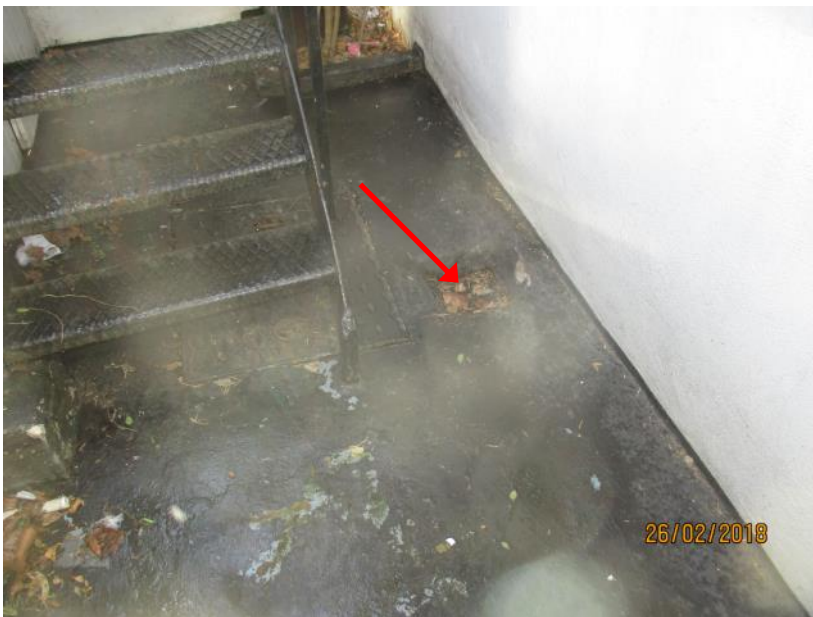
Fig 6:

- 6 External ground levels and drainage: The base of the lightwell had been detailed with a concrete screed and waterproof paint coatings. The upper coat of black paint was subject to progressive wear and failure, exposing further layers beneath and evidence of cracking to the screed, notably around the drainage outlet towards the centre on the west side. This gully was free of significant obstructions at the time of survey. The junction between the external hard standing and the façade was detailed with a cementitious fillet and falls to the drain appeared adequate to prevent ponding or surface water standing in contact with the structure

East elevation, lightwell to lower ground floor; showing bituminous paint finishes to concrete hardstanding, laid to fall to a surface drainage gulley on the west side

*No urgent remedial works are required. Effective surface drainage should be maintained at all times and below ground pipework should be routinely inspected and cleaned or repaired as required, so as to direct surface water clear of the structure*

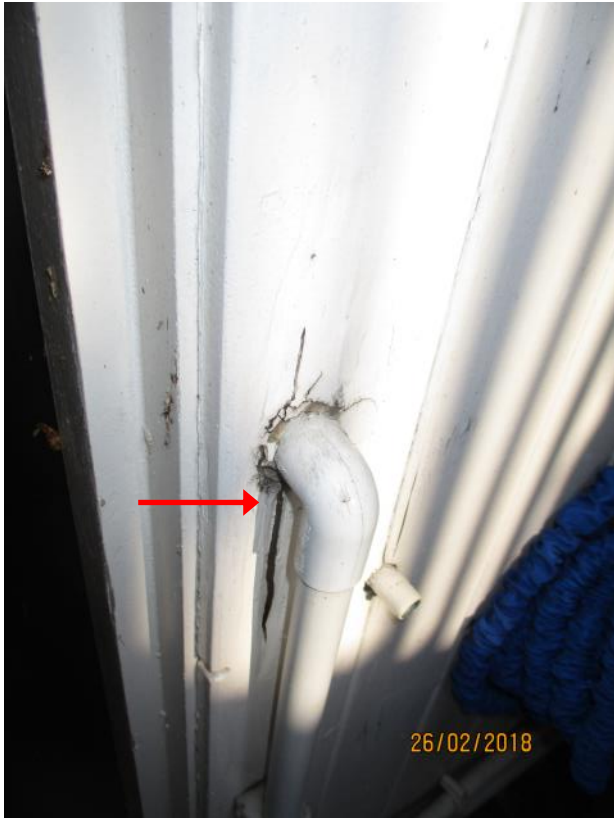
Fig 7:

- 3 Access stairs: The south side of the stair structure had been clad in timber boarding, which showed signs of decay around building services penetrations. This was likely to allow intermittent water penetration to structures behind, providing the conditions for decay in concealed timbers

East elevation, lower ground floor;  
showing minor decay to timber  
cladding on the south side of the  
access stair structure

*Allow for piece-in repair or wholesale replacement of decayed timbers and for improvements to waterproof detailing, to prevent surface water from draining into the structure and interior around pipe penetrations and at the upper and lower edges of the timber cladding. Consideration should be given in future refurbishment to replacing the timber cladding in a suitable moisture and decay resistant material*

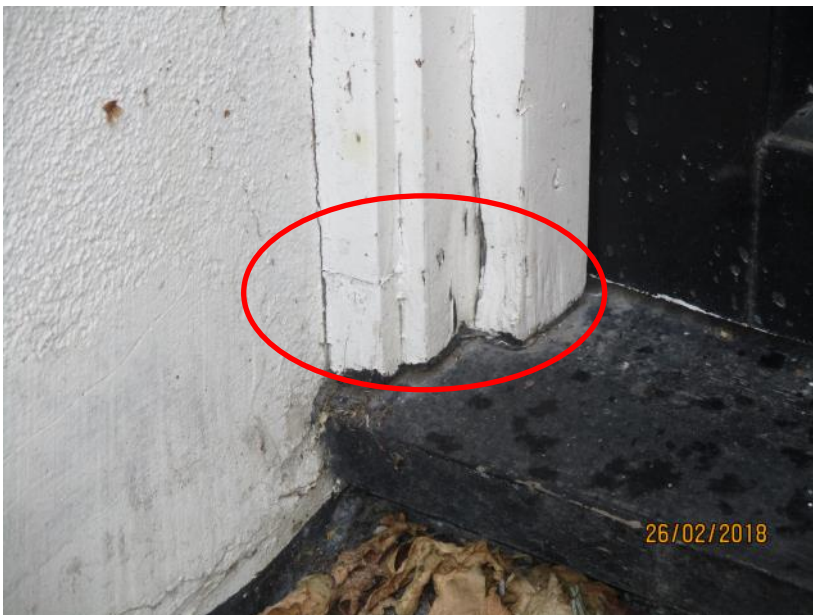
Fig 8:

East elevation, lower ground floor;  
showing evidence of decay and  
previous patch repair to the entry door  
frame on the west side

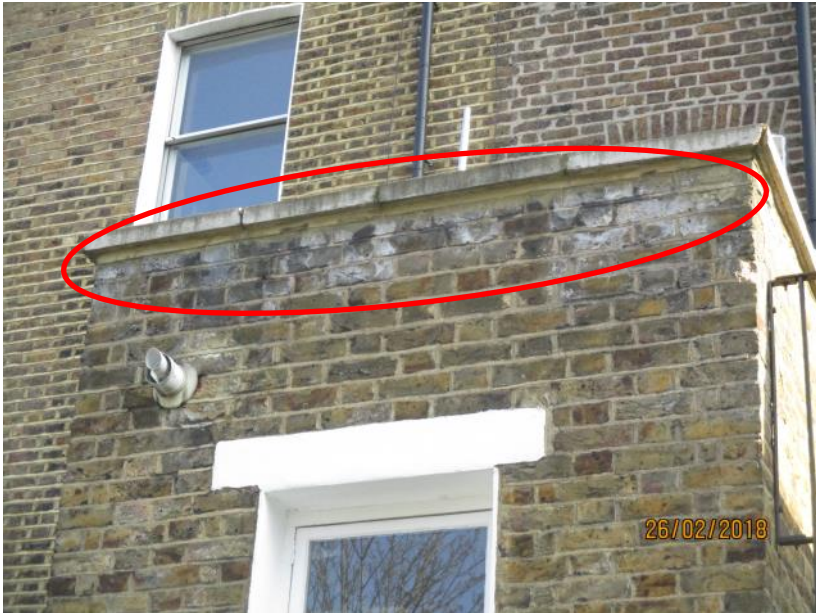
Fig 9:

West elevation, extension brickwork at upper ground floor level; showing salt efflorescence below coping stones, where pointing failure was allowing surface water to drain into the structures beneath. Flashings on the reverse may also require attention

*Allowance should be made for patch repair to pointing mortars around the parapet brickwork and copings of the extension roofs. Consideration should be given to lifting the existing copings and for replacement in new masonry slabs, with drip rebates on the undersides of the projecting edges. Copings should be laid over a suitable horizontal damp-proof course*

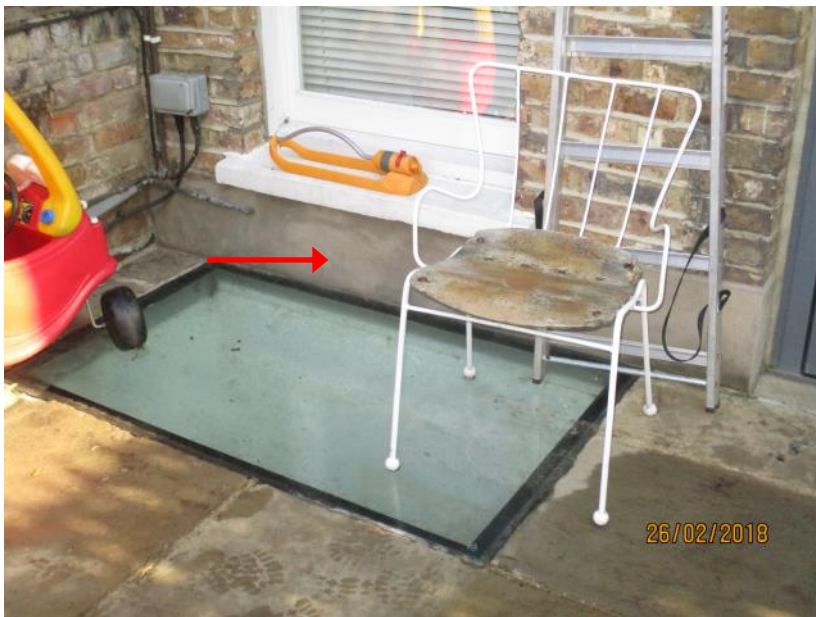
Fig 10:

West elevation, base of extension façade on north side; showing cementitious render skirting that was likely to have been encapsulating residual moisture within the structure and allowing surface water to drain behind

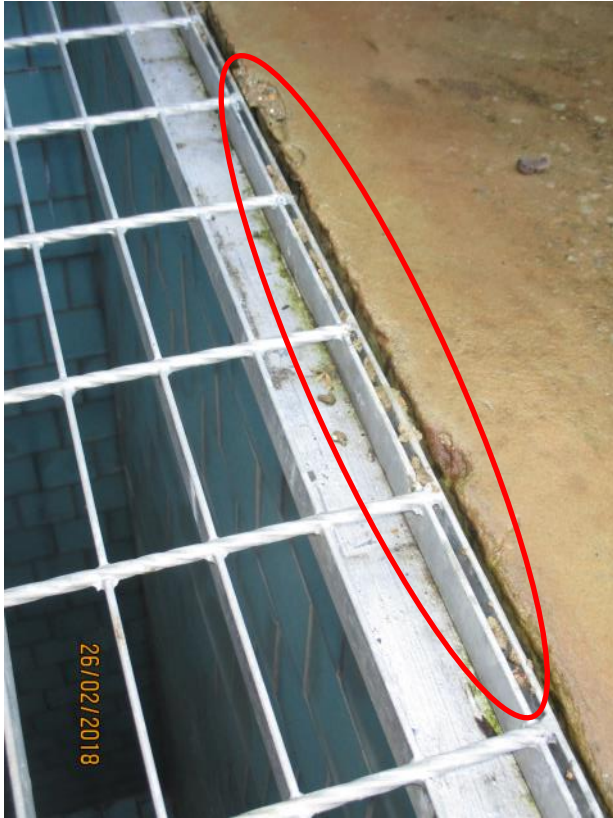
Fig 11:

West elevation, south side; showing failure of pointing between the lightwell cover and surrounding paving, allowing surface water to drain behind render and tiles applied to the lightwell wall beneath

*Open joints and other masonry defects allowing surface water penetration below the terrace paving and into the base of the west wall should be inspected in detail and repaired or replaced in new materials as required. Consideration should be given to reducing the level of the terrace generally and to improving the provision for horizontal damp proofing at the base of the west elevation and around the covered and open light wells serving the lower ground floor*

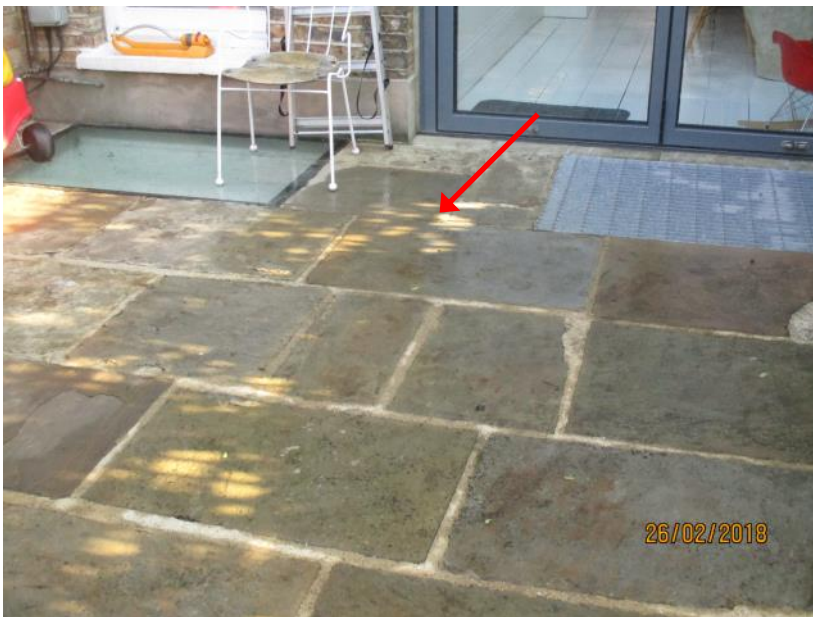
Fig 12:

- 4 External ground levels and drainage: Stone paving abutting the façade did not appear to be laid to significant falls. Approximately 100mm width of paving had been laid to drain away from the threshold of the conservatory glazing where ground levels were approximately 20mm below finished floor level on the interior. The base of the brickwork elevation on the north side had been finished with a cementitious render skirting extending to 250mm above external ground level. Some salt efflorescence was noted on brickwork immediately above the skirting indicating the presence of excess residual moisture in loadbearing brickwork, increasing the risk of damage to decorative finishes on the interior. Pointing around the light well cover, from galvanised metal framing and a loadbearing grating, was damaged, allowing surface water to drain behind the render and tile finishes of the light well below. This will have increased the risk of detachment and progressive failure of the tiles. The north light well was covered by a structural glazed panel set in a steel frame. The base of the 'open' lightwell was also tiled with a central drainage gulley on the south side which was free of significant obstructions at the time of survey

West elevation; showing stone paving not laid to significant falls or detailed with surface drains which may allow ponding against the base of the façade by rain driven by prevailing winds from the west. Water would then be able to drain into the walls at the base of the west elevation through defects in the external masonry, affecting decorative finishes on the interior

*The junction between the external paving and the west elevation should be inspected in detail and modified as required, to effectively exclude surface water and wind driven rain. Damaged joints in paving should also be repaired in a suitable water resistant and flexible mortar mix. If extensive refurbishment works are anticipated consideration should be given to reducing the level of the external paving to between 150mm and 200mm below internal finished floor level and to installing a continuous horizontal damp-proof membrane, laid over a suitable screed or tapered insulation to a minimum fall of 1:60 away from the west elevation. The abutment with the façade should be detailed with a 150mm membrane upstand, with a cover flashing, from sheet lead or other suitable material, chased and sealed into the elevation brickwork. The horizontal membrane should be detailed around the light well openings to drain water passing through the terrace coverings outside the provision for vertical damp-proofing around the light-wells. It may be possible to improve the provision for damp-proofing whilst maintaining the terrace surface at the existing level. This will require careful detailing and improvements to surface drainage, including a liner drain across the base of the west elevation to interrupt surface water that would otherwise drain into the base of the wall. H+R can provide further advice on remedial detailing of required*

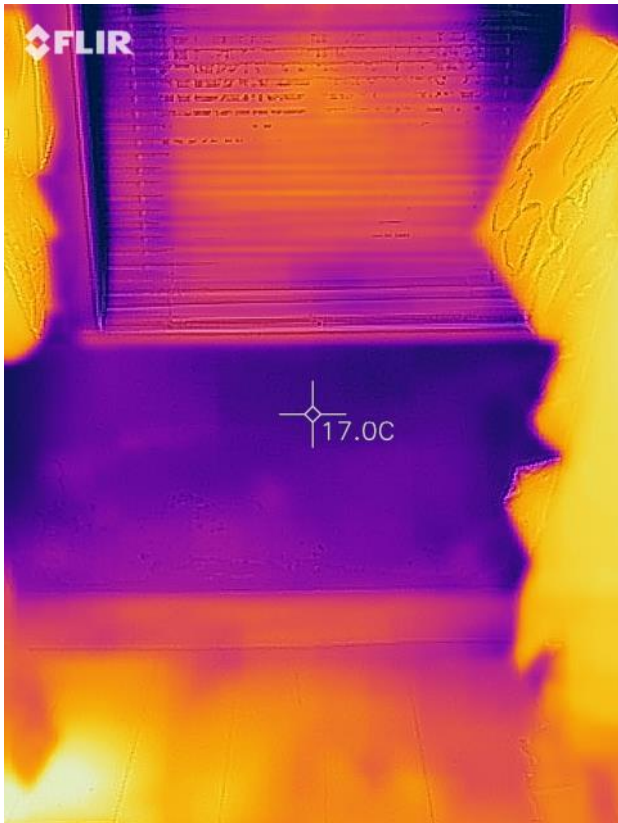
Thermal image 1, upper ground floor cloakroom, base of wall on west side; showing surface temperatures significantly above dew point at time of inspection

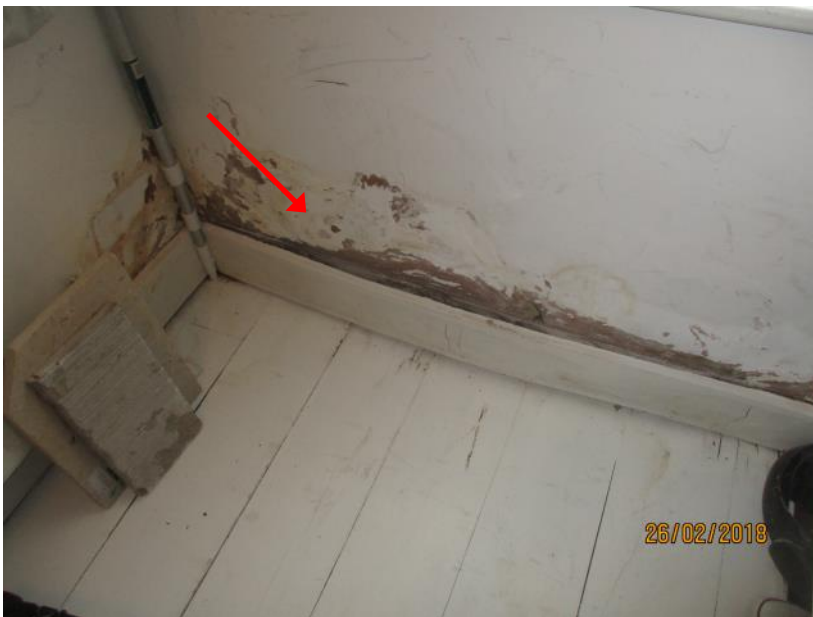
Fig 14:

- 1 Defects: Gypsum skim plaster was subject to failure across the full width of the west wall, typically extending to around 0.4m above floor level. Further detachment of skim coat plaster was noted in isolated locations up to 0.6m above floor level. External ground level was approximately 500mm above finished floor level increasing the risk of surface and ground water draining into the structure. Failure of decorative finishes and light brown 'tobacco' staining was consistent with the mobilisation of hygroscopic salts following water penetration from the exterior and intermittent efflorescence and deliquescence of salts driven by natural variations in internal humidity

Upper ground floor cloakroom ('boot room'), west side; showing damage to surface plaster and decorative finishes at low level, consistent with chronic damp penetration from the exterior and intermittent efflorescence and deliquescence of hygroscopic salts

*Floor boards should be lifted to allow inspection of the timber floor structure. All decayed timber should be replaced in new materials, isolated for the wall masonry by an air gap or damp-proof material. The base of the west wall should be detailed with a ventilated dry lining system, following removal of plaster to expose brickwork as described above*

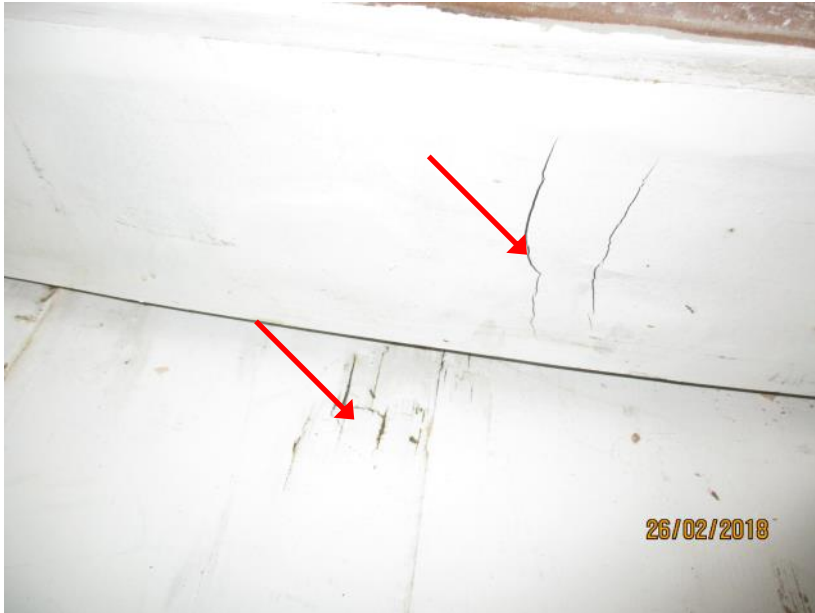
Fig 15:

- 2 Timber: The skirting board on the west side had bowed away from the wall and showed signs of decay at the centre and north ends. Decay was also noted in the west ends of the floorboards where these were assumed to be in contact with the damp affected structure of the west external wall. The shelf on the north side and the skirting on the south side were also likely to have been affected by damp and were at risk of decay. The indicative moisture contents of areas affected by historic decay were significantly above the decay threshold, indicating that further timber decay was probable. The skirting on the south side was saturated with moisture contents above 40 per cent up to 300mm from the south-west corner of the room. A corresponding section of skirting at the west end of the north dining room wall, on the reverse of the structure, had been replaced on previous refurbishment but the moisture content of this timber at time of survey was below the decay threshold

Upper ground floor cloakroom ('boot room'), west side; showing decay to the skirting board which had bowed away from the base of the wall and decay to the ends of the floorboards, which were assumed to be in direct contact with the damp affected external wall

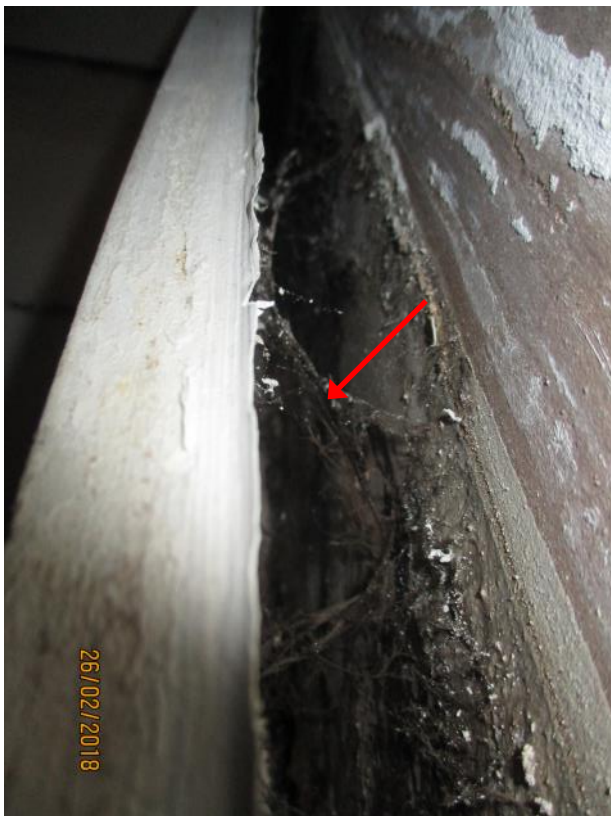
Fig 16:

Upper ground floor cloakroom ('boot room'), west side; showing the mycelium of a timber decay organism behind the skirting board which was vulnerable to damp penetration from the exterior and showed signs of historic decay

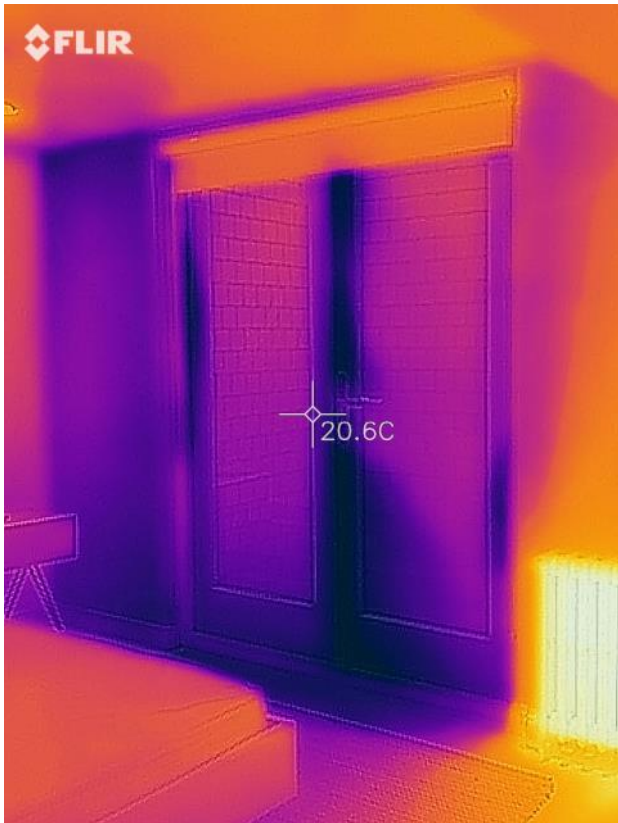
Fig 17:

Thermal image, lower ground floor, west bedroom; showing surface temperatures on south side of west wall with minimum 12°C above dew point at the time of inspection

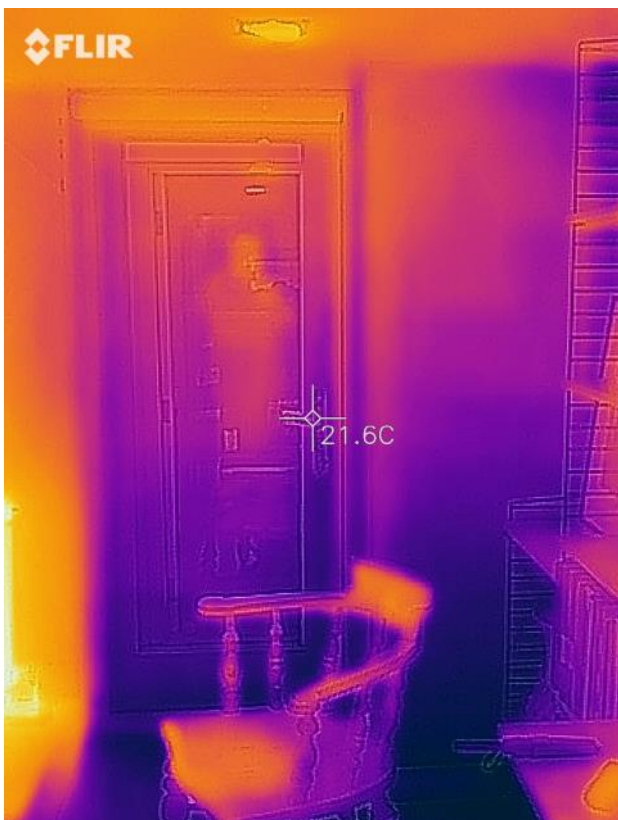
Fig 18:

Thermal image, lower ground floor, west bedroom; showing surfaces on north side of west wall minimum 12°C above dew point at time of inspection

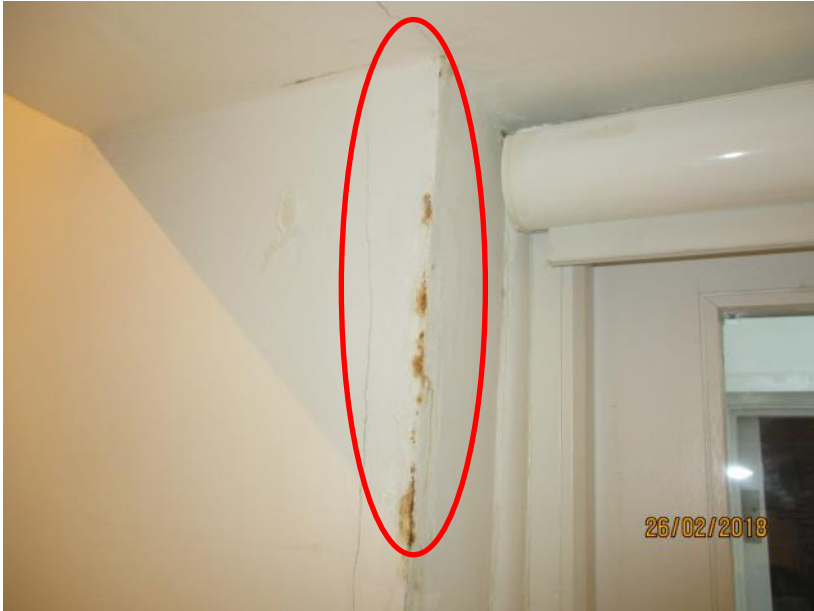
**Fig 19:**

Lower ground floor, west bedroom, west side; showing iron oxide staining to plaster beads, consistent with damp conditions in masonry behind and intermittent surface condensation

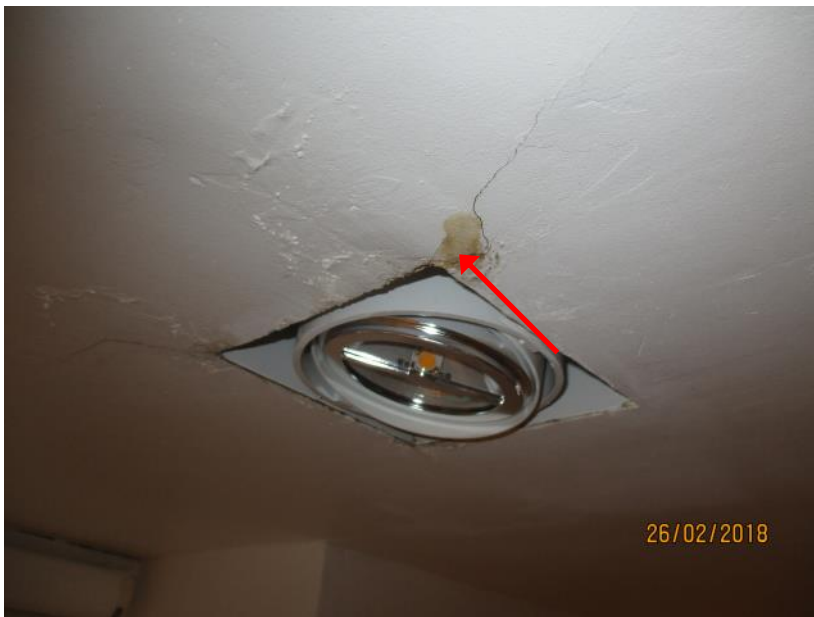
**Fig 20:**

Lower ground floor, west bedroom, ceiling towards north-west corner; showing moisture damage around recess light fittings, consistent with water draining over top surface of the ceiling boards, from the west wall

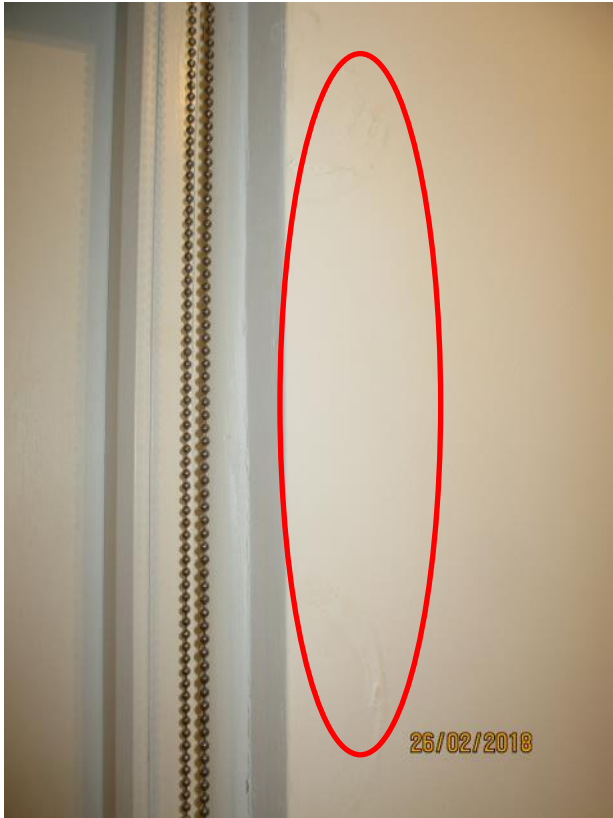
Fig 21:

Lower ground floor, west bedroom, upper north side of doorway to external lightwell; showing deformation of the wall surface, consistent with cyclical efflorescence and deliquescence of hygroscopic salts between the plaster skim and the paint coating. A cold-bridge was likely to exist around the door frame and the structure was vulnerable to damp penetration, where it was earth retaining and where surface water could drain into the structure from above

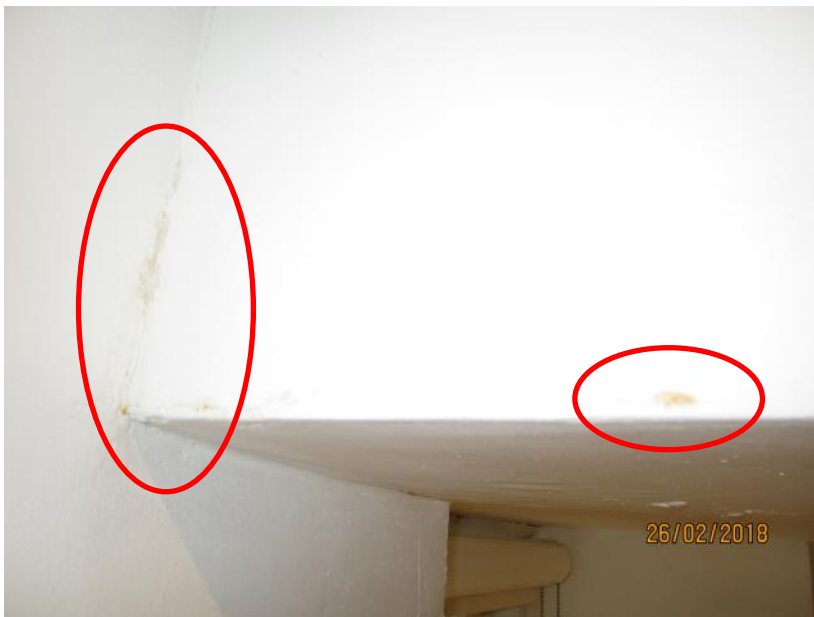
Fig 22:

Lower ground floor, west bedroom, west side; showing salt efflorescence and corrosion of plaster beads affecting decorative finishes at high level. H+R were informed that more severe damage has been apparent in the past but has been disguised by redecoration

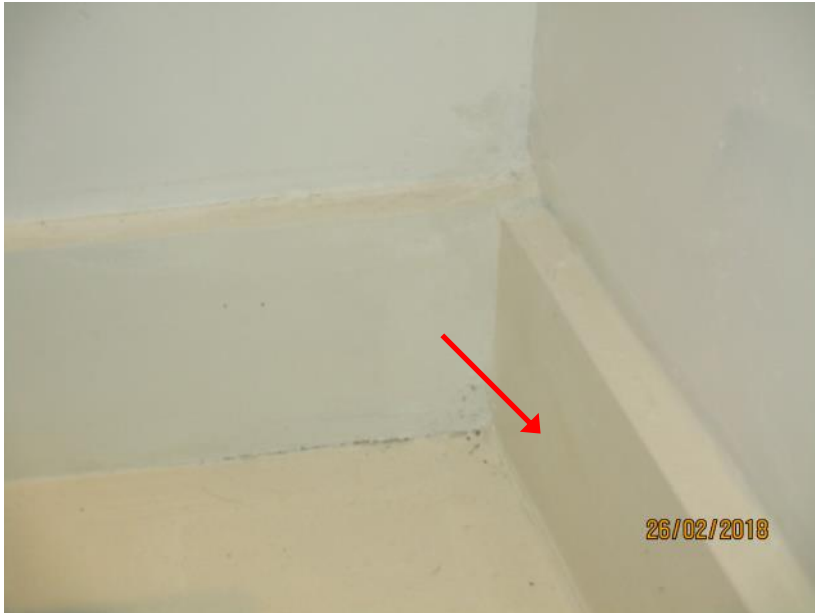
Fig 23:

Lower ground floor, west bedroom;  
showing section of skirting at south-  
west corner with moisture content  
significantly above the decay threshold

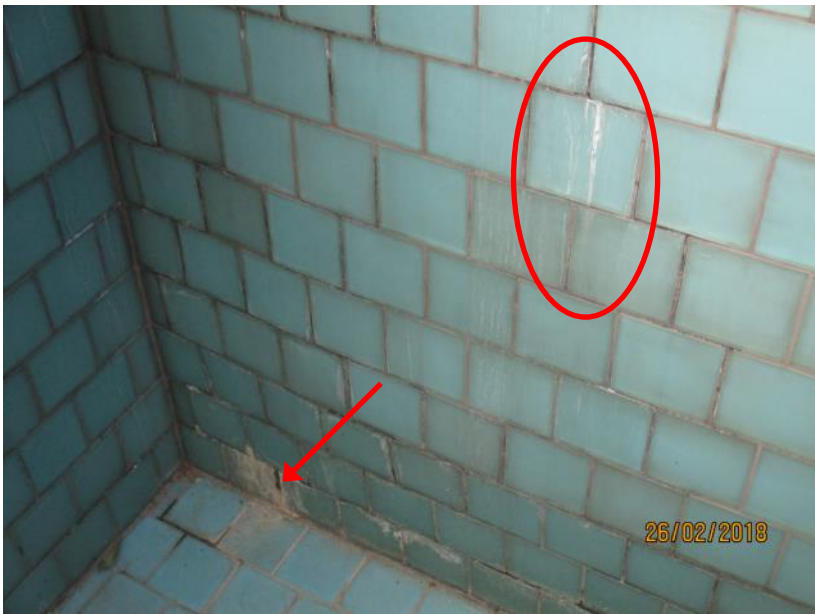
Fig 24:

Lower ground floor, lightwell on west  
side; showing soluble minerals draining  
through open joints in the structure,  
where the glass tiles had become  
detached

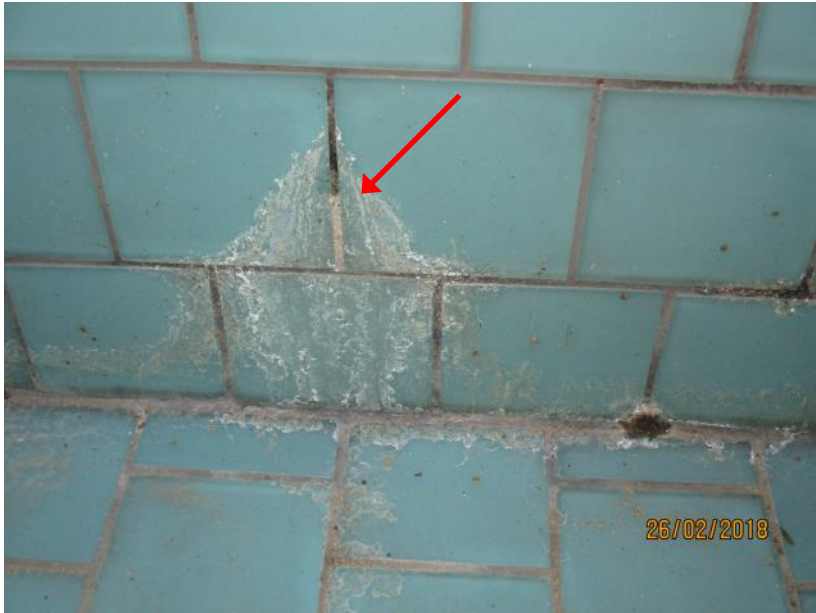
**Fig 25:**

Lower ground floor, lightwell, south side; showing soluble minerals on glass tile surface where water drained below ground level through structures behind

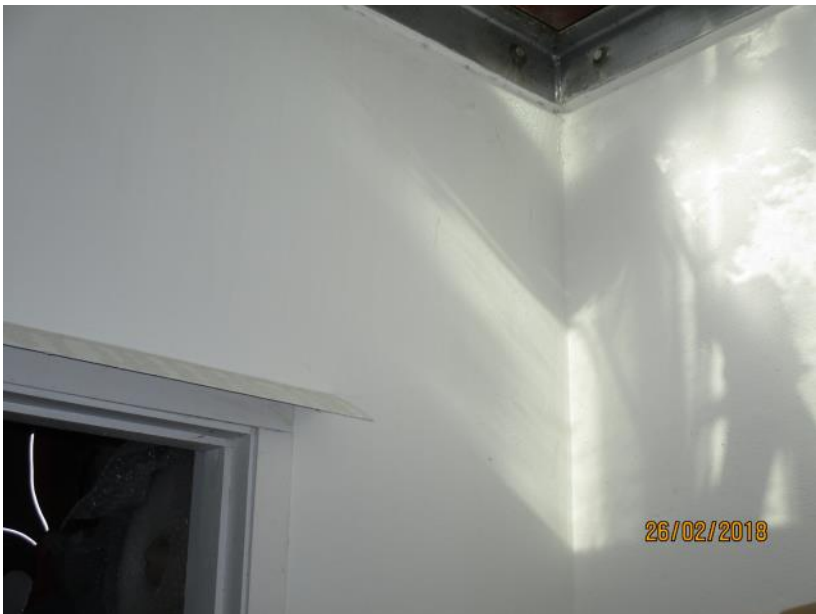
**Fig 26:**

Lower ground floor, west side, lobby to north-west storeroom; showing generally good condition of wall render and decorative finishes

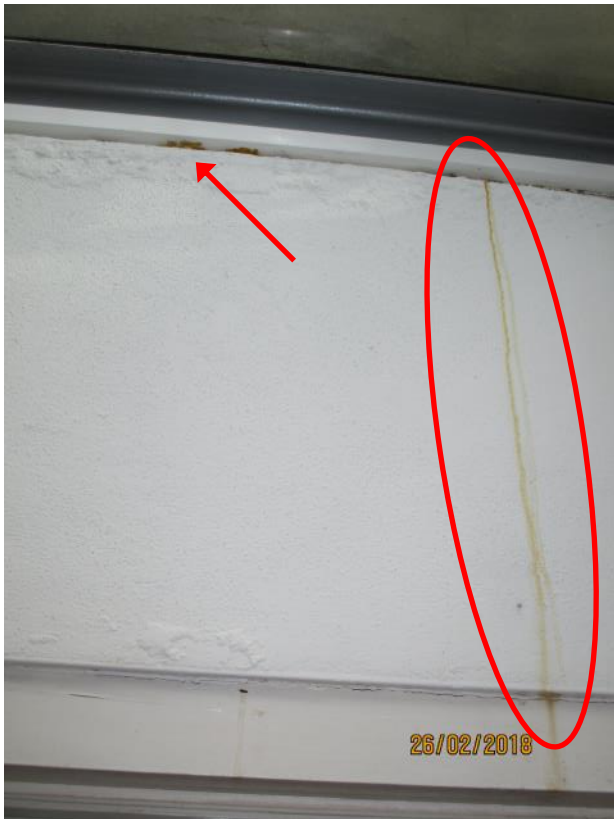
Fig 27:

Lower ground floor, lobby to north-west storeroom; showing isolated surface streaking of water contaminated iron oxide, indicating intermittent water penetration where seals around the skylight above had failed. Note blistered paint finishes at high level, indicating that water from outside was draining into the head of the wall around the skylight glazing

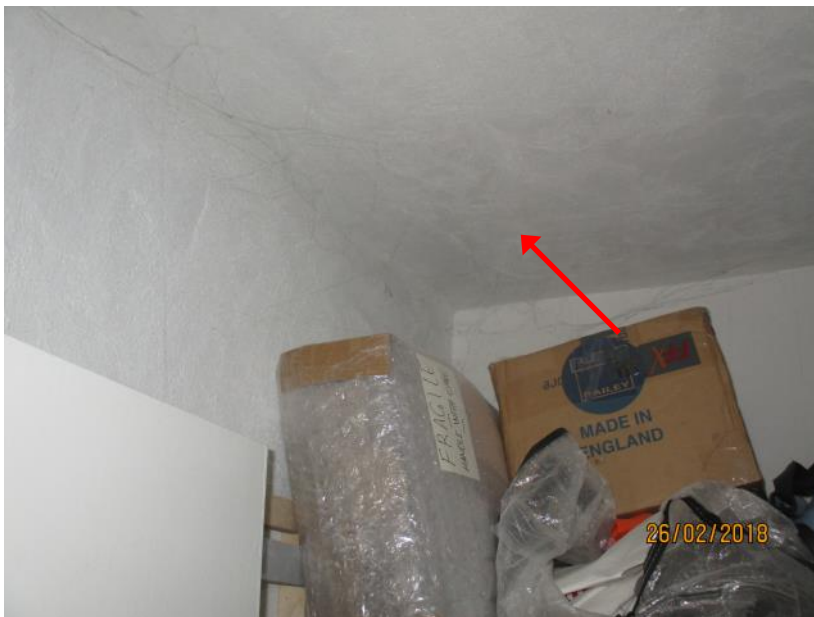
Fig 28:

Lower ground floor, north-west storeroom; showing generally good condition of wall and ceiling render and decorative finishes. The structure may be vulnerable to intermittent condensation but no defects associated with moisture or mould growth were reported to H+R by occupants

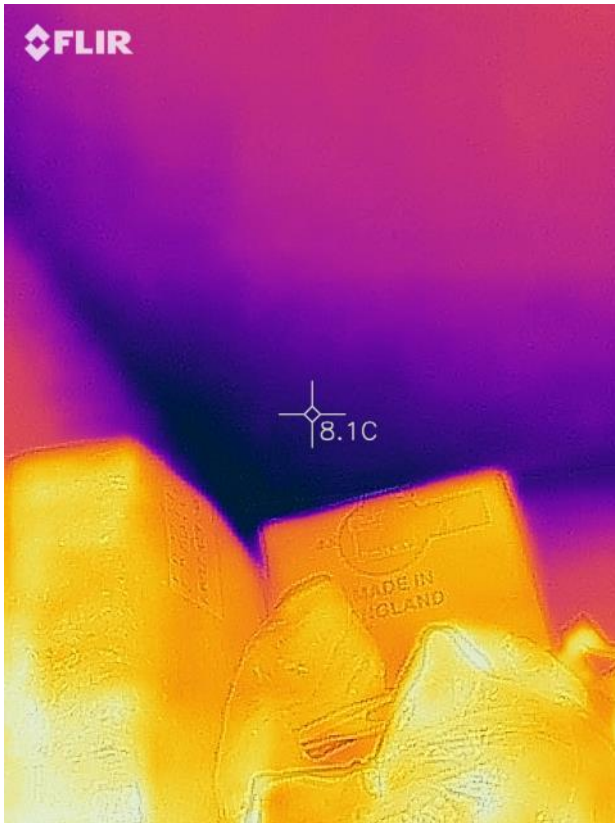
Fig 29:

Thermal image, lower ground floor, west side, south-west corner of north-west storeroom; showing surface temperatures within 4°C of dew point at time of inspection. The conditions for intermittent condensation may arise under specific circumstances including those associated with intermittent occupancy

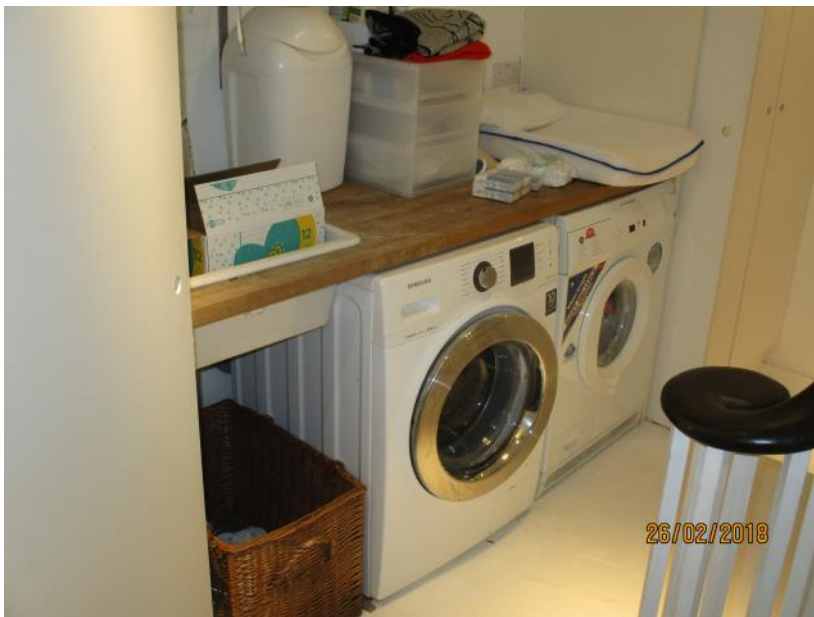
Fig 30:

Lower ground floor, central area; showing utility room installation at base of stairwell with no provision for mechanical extract ventilation

*The provision for passive and mechanical ventilation should be reviewed during proposed refurbishment and remedial works, summarised above and described at Sections 3.1 and 3.2 below, to ensure effective control of airborne moisture and condensation on future occupancy*

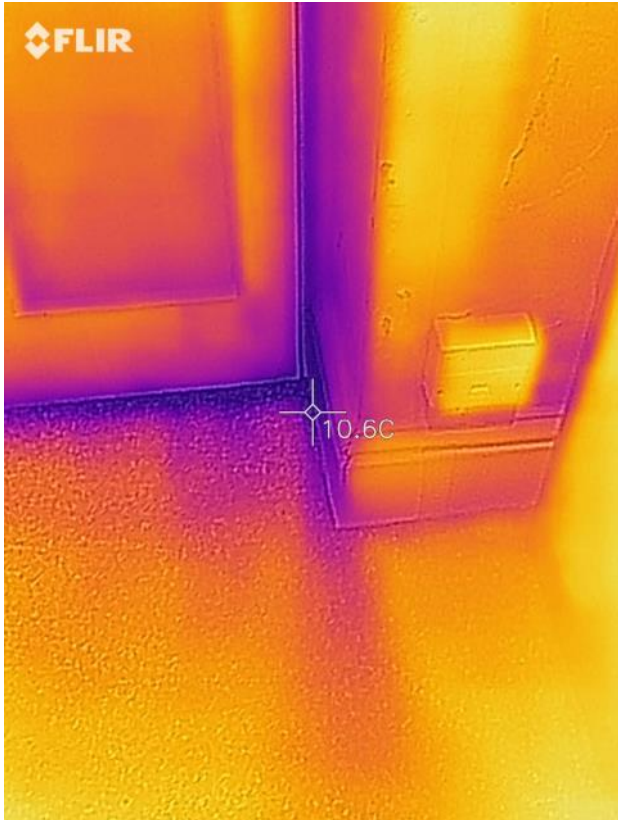
Fig 31:

Thermal image, lower ground floor, east room; showing surface temperatures a minimum 6°C above dew point around the doorway to the exterior via an entrance lobby, indicating that the conditions for condensation were not present at time of survey

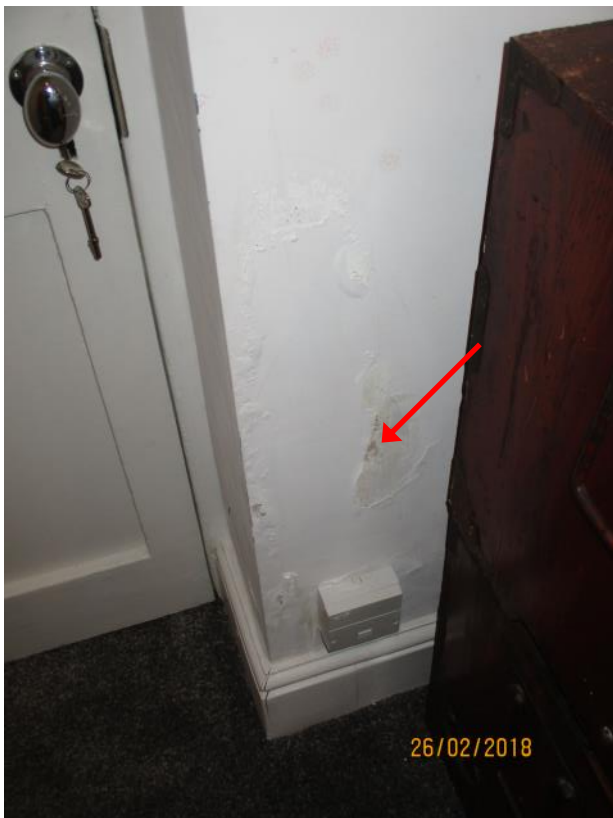
Fig 32:

Ground floor, east room, east side; showing damage to decorative finishes consistent with intermittent salt efflorescence adjacent to the external door in the north-east corner

*The base of the east wall should be detailed with a ventilated dry lining system, following removal of plaster to expose brickwork. All timber and hygroscopic materials should be isolated from the wall masonry. Pipework in the external lobby/ boiler area should be tested for escape of water and repairs carried out as required*

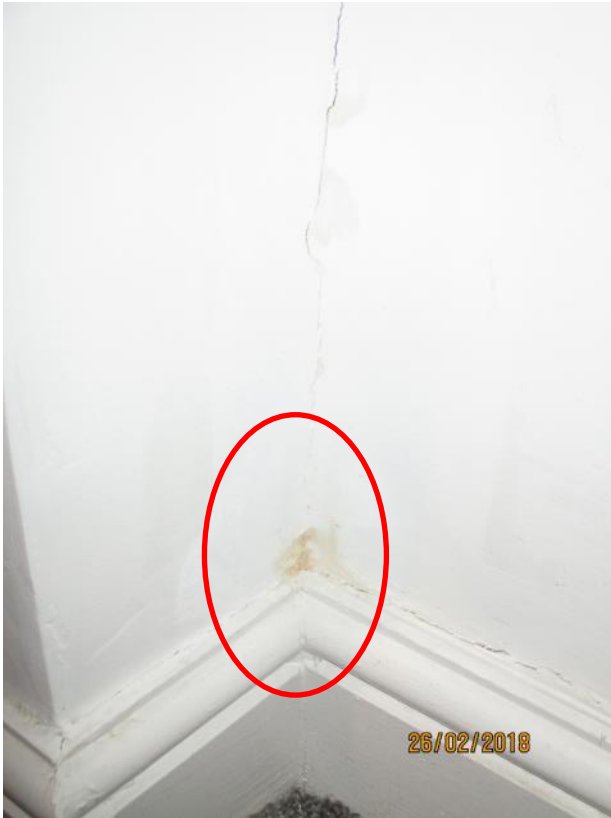
**Fig 33:**

Lower ground floor, east room, east side; showing 'tobacco' staining and failure of decorative finishes at the junction between the skirting and the wall, consistent with intermittent condensation at the wall/floor junction. The indicative moisture content of the skirting boards was above the decay threshold, indicating that water was draining into the base of the wall from outside or that cumulative condensation was taking place on the reverse of the skirting board

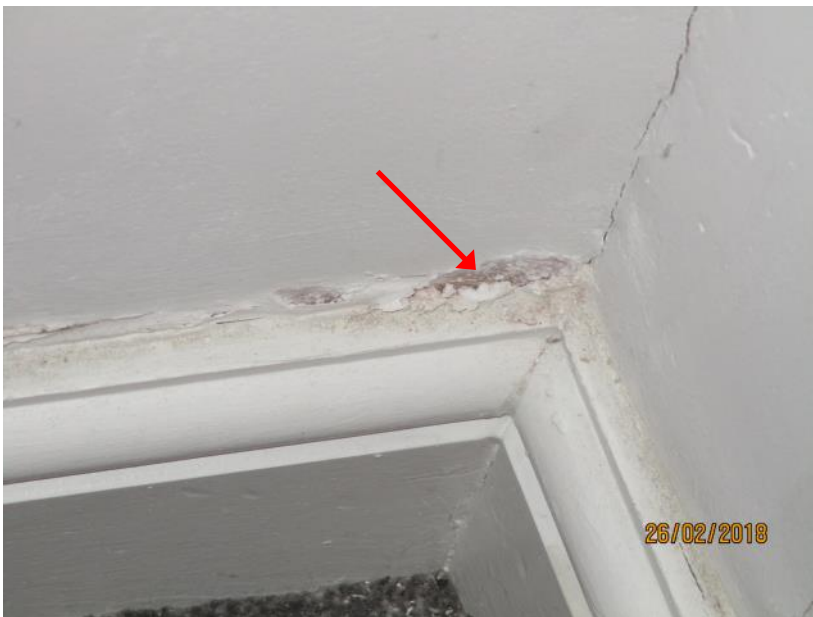
**Fig 34:**

Lower ground floor, east room, east side; showing failure of plaster skim and decorative finishes at low level, consistent with active or historic moisture penetration and intermittent surface condensation

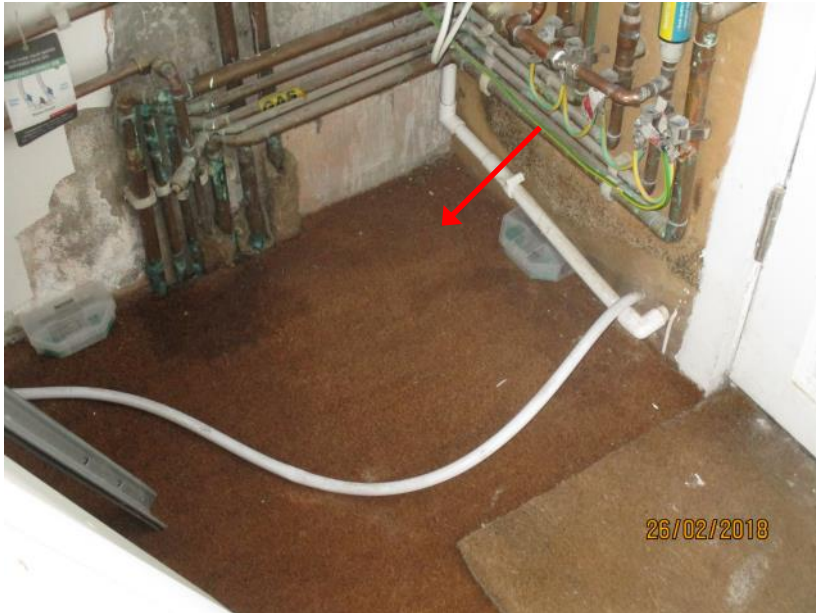
Fig 35:

Lower ground floor, entrance lobby and boiler space; showing evidence of damp affecting wall and floor finishes at low level in the south-east corner

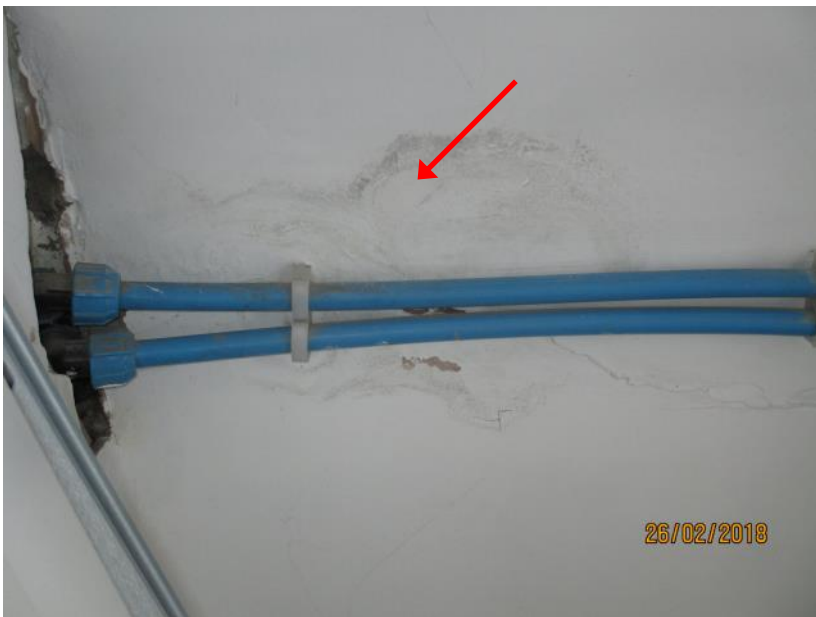
Fig 36:

Lower ground floor, entrance lobby and boiler space to north-east; showing condensation affecting decorative finishes behind cold water supply pipes, where surface temperatures would have been reduced locally by proximity to the pipes
