TITLE: **Level 3 Arboricultural Assessment:**
*1no. False Acacia at 98 Priory Road,
London, NW6 3NT.*

DATE: 10th October 2018

ARBORICULTURAL ASSESSMENT (Level 3)

**1No. False Acacia at 98 Priory
Road, London, NW6 3NT**

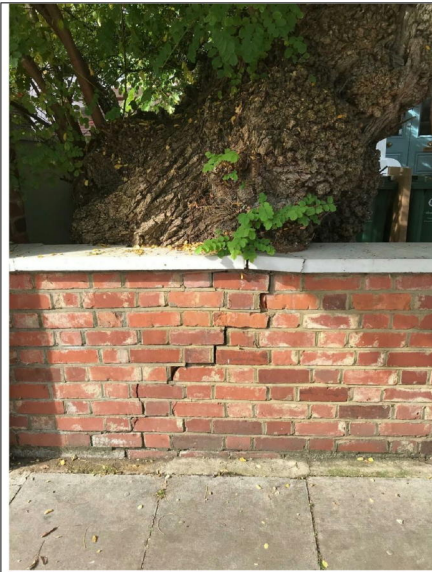
- The western boundary wall has been re-built previously with modifications made to accommodate the lower stem.
- Cracking and displacement to the wall is evident when viewed from the public highway and reactive growth from the tree is also evident and indicates that the wall is being utilised for support with corresponding loads being transferred.

Image 1: taken from west and showing wall cracking and displacement.

- 8.7 The relationship with the western boundary wall is a long-term concern; with a foreseeable need for replacement/repairs in the near future.

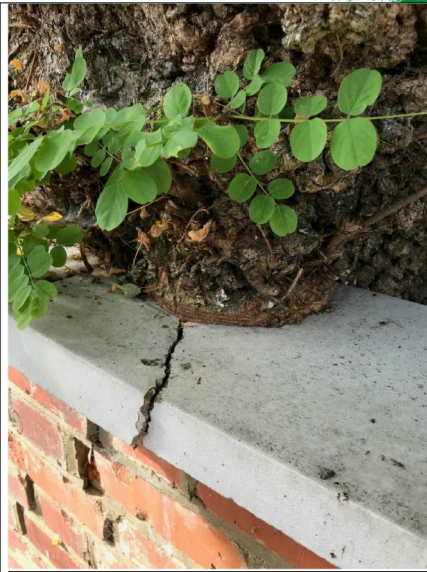
Image 2: taken from west and showing adaptive growth atop wall.

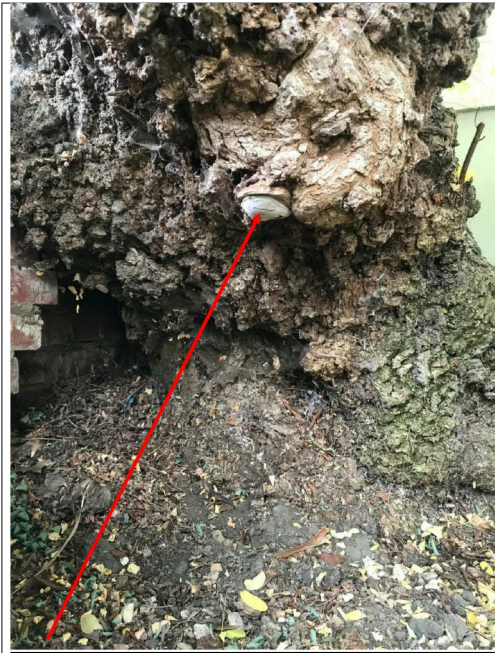
- Located on the northern side, at approximately 400mm is a small fungal fruiting body from the Ganoderma species.
- Epicormic growth is evident on the upper side (southern side) of the leaning stem.

- 8.3 The presence of the fruiting body of a ganoderma species fungus indicates internal decay and outwardly visible signs of bark and sapwood decay were also evident on the stem.

Image 3: taken from north and showing fruiting body of ganoderma species fungus

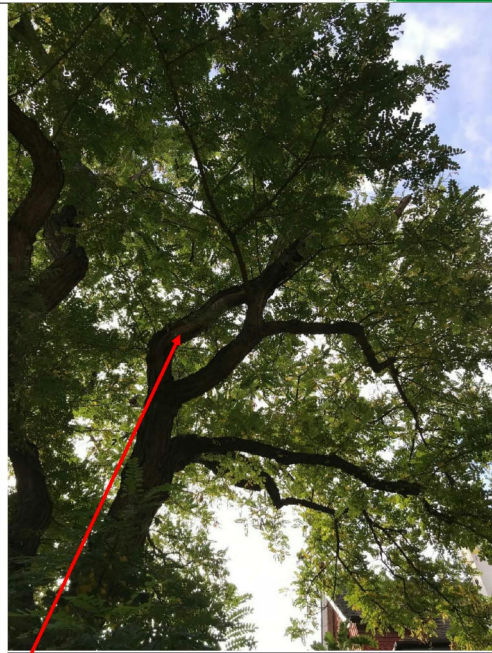
- There are small amounts of minor dead wood throughout the crown and two faulted branches identified at approximately 6m in the upper north eastern crown quadrant. The fault appears to indicate a longitudinal split, with exposed heartwood.

Image 4: Taken from north and showing faulted branches

- 9.1 A maximum 1.5m linear crown reduction be undertaken within the next 6 months (between November and February) to remove minor deadwood, reduce loading and promote the retrenchment process.
- 9.2 The lower epicormic growth should be retained; whilst ensuring that encroachment of the public highway and the neighbouring driveway is cleared.
- 9.3 Whilst the crown reduction is undertaken, the tree surgeon should assess the two faulted branches in the upper north-eastern crown quartile with a view to whole branch removal or further reduction.
- 9.4 It is recommended that a replacement tree is planted somewhere in the front courtyard as a long-term replacement for the surveyed tree.

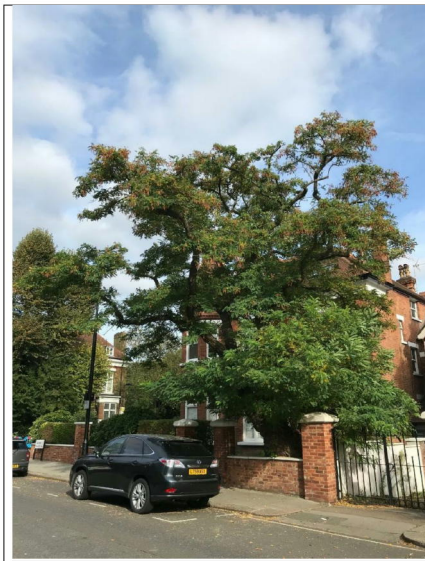
Image 5: taken from south west and showing entire tree

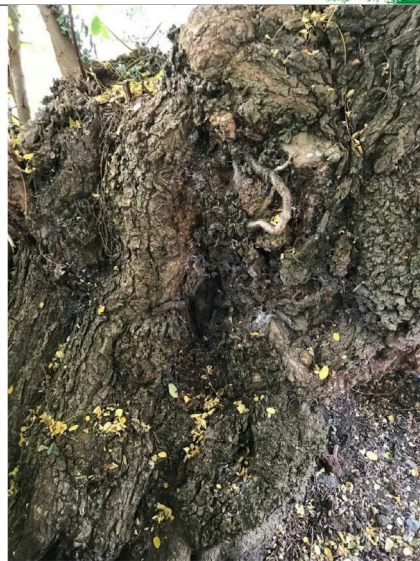
- Large burrs are evident along the lower and upper stem.
- Large area of bark necrosis and sapwood decay was evident on the eastern aspect of the stem from just above ground level to crown break. This was probed in areas to 200mm.

- 8.6 Given this trees anticipated age, location and condition, it is assessed to have a limited safe useful life expectancy. Problems associated with old age are beginning to manifest themselves in the form of cavities and heartwood decay.

Image 6: Taken from east and showing bark necrosis and decay on lower stem.
