11<sup>th</sup> March 2019

Ref:ha/letrpt1/millfieldcot

**Horse Chestnut trees at Millfield Cottage, Millfield Lane London N6 6JH**

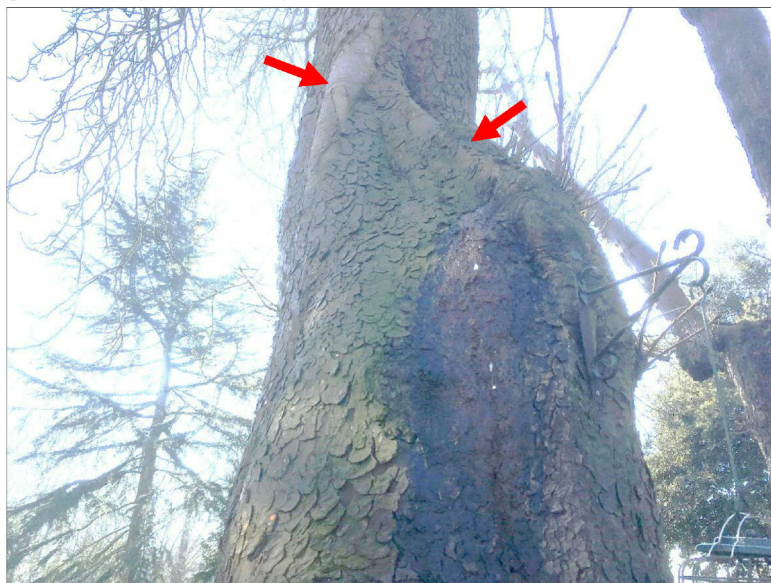
- 5) Upon the trunk below the previous pollarding is an area of reaction wood development and some slime fluxing, which is liquid from cells within the wood of the stem normally caused by bacteria. This is probably an area of some internal decay but I note the compensatory wood production, by the tree, around this wound is robust and strong. On the basis that there is no large area of open, decaying cavity for example and the tree is growing vigorous reaction wood around this area, I am confident that the slime fluxing is only aesthetically rather unpleasant rather than the symptom of significant internal decay and trunk weakness. Specialist, diagnostic equipment might be able to further assess any internal decay but I do not believe that this additional expense is warranted at this stage.

Fig.1 Slime flux (blackened area) and areas of robust reaction wood arrowed

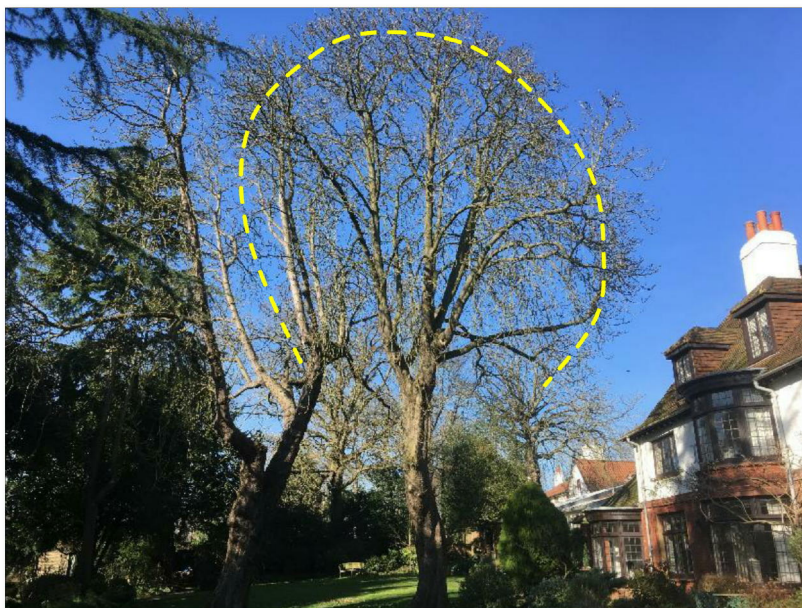
Fig. 3

- 7) In conclusion the tree appears in good order with no significant structural defects. There may be a degree of internal decay in the main trunk behind an area of slime fluxing. There is evidence of effective wood growth having developed to compensate for some additional flexing in the trunk, which is a sign of normal tree vitality and response. The canopy spreads out laterally and it will be sensible tree management to lightly reduce the canopy spread evenly throughout, which will reduce wind loading upon the canopy in stormy conditions and thus reduce the risk of branch breakage. It is always sensible to remove weak, dead and broken branches as a matter of general tree husbandry.

Tree ID/Name*	Dimensions**	Tree Works Specification (Sp#)	Summary Reasons	Risk
T1 Horse Chestnut	22 x 7 x 850	Crown reduce by 2m (Sp1) Crown clean (Sp3)	Lighten loading upon spreading lateral branches; reduce risk of failure; improve tree structure	<b>Low</b> ; pruning prudent

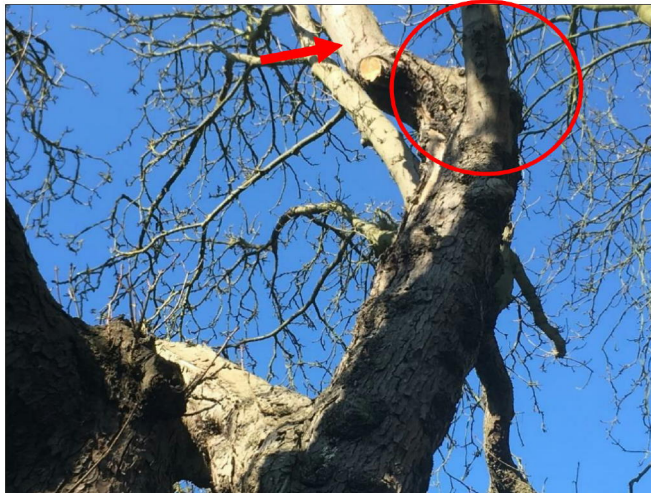
- 9) This tree too has been pollarded to around the same height as t1 and I estimate around the same period of time ago. Again, primary regrown spars grow up and outward from the points of pollarding. However, instead of the unions between the base of the spar/re-grown stem and the parent trunk wood being sound, quite extensive decay has developed, which is not surrounded by robust wound wood. Such unions are weak and the associated stem/spars or branches are at quite high risk of breaking off in stormy conditions.

Fig. 4 Circled – a weak and decayed union between the relatively new stem/spar (arrowed) and the parent stem/trunk

- 10) Owing to the depleted physiological condition of the tree, pruning the branches to reduce the risk of failure in stormy weather, is likely to significantly affect the tree's ability to respond and bring about the tree's demise. Access to the tree is limited and operatives would be required to rely upon the tree's branching structure for anchorage during a pruning treatment and I am not confident that this is a safe working environment. Under such circumstances, I cannot recommend the tree for retention with pruning and I recommend that the tree should be removed entirely, removing the stump by grinding out the roots.

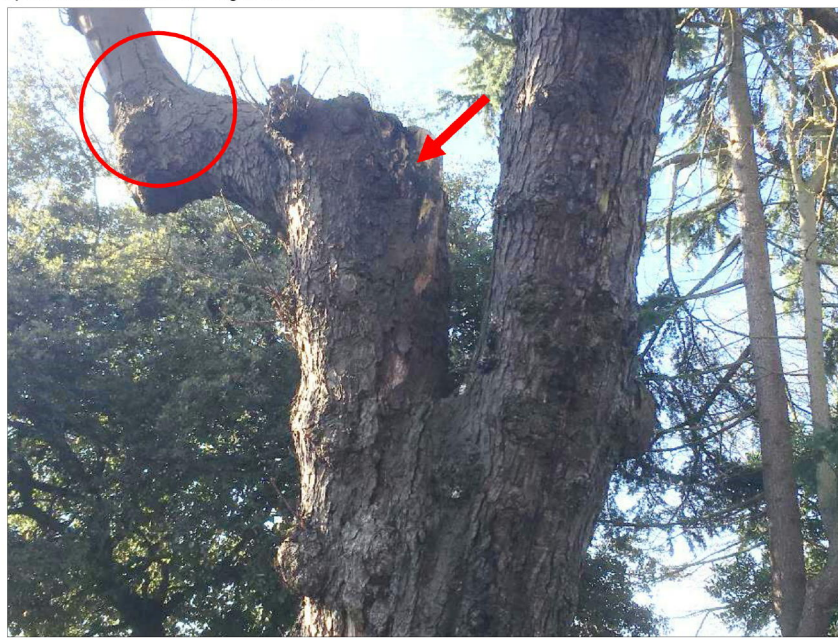
- 8) This mature Horse Chestnut is not in sound structural or physiological condition. Taking the tree's vitality first, I note that the tree has been pruned to remove a large limb in the recent past and that large diameter dead branches have developed since the pruning was conducted. This is an indication of progressive decline in condition. I also note tarry spots on the trunk and quite significant bark death and loss. Fungi that grow on dead wood emanate from cracks in the bark throughout the main trunk. The tree has contracted Bleeding Canker, which causes dark exude to emanate from lesions and leads to tree death and breakage.

Fig. 5 Extensive decay has developed at an historic pollarding location (arrowed); circled weak spar/stem union under high stress.

- 13) In conclusion and having given all considerations to tree management options and practicalities, I recommend the tree is removed entirely and that resources are better
