Project Name Drummand ST CCTV	Project Number:	Date: 26/04/2017
---	-----------------	----------------------------

Section Inspection - 20/04/2017 - MH1X

Section: 1	Inspection: 1	Date: 20/04/17	Time: 10:05	Client's Ref : 01	Weather:	Pre Cleaned: No	PLR: MH1X
Operator: Adam Page		Vehicle:		Camera:	Preset Length [m]:	Criticality Grade:	Type of Pipe: Gravity drain/sewer

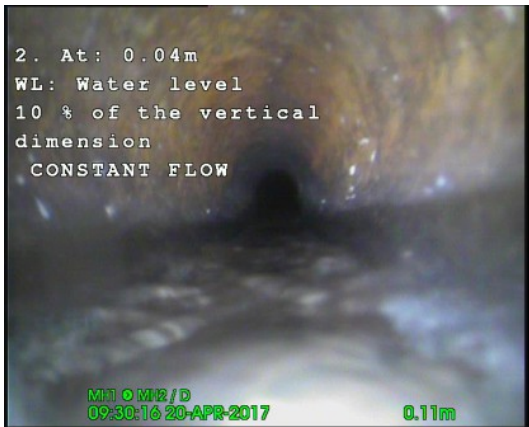
, 00:00:15, 0.14m
 Water level 10 % of the vertical dimension CONSTANT FLOW

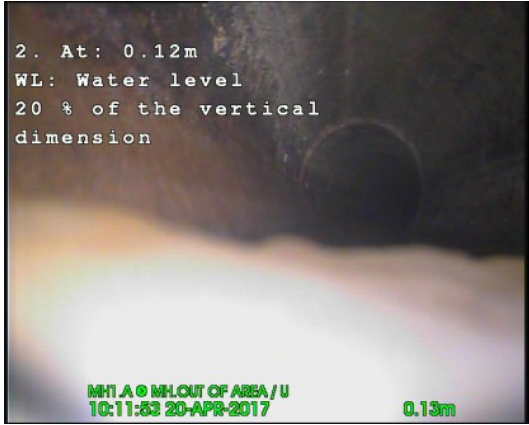
, 00:00:10, 0.28m
 Water level 20 % of the vertical dimension

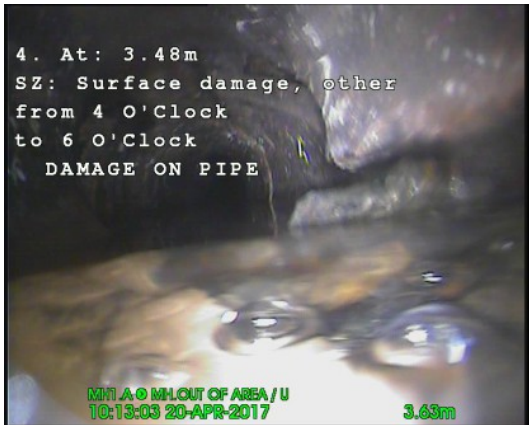
<table><tr> <td style="width: 10%; text-align: center;">0.08</td> <td style="width: 5%; text-align: center;">MH</td> <td style="width: 45%;">Start node type, manhole reference number: MH1.A A: A</td> <td style="width: 10%; text-align: center;">00:00:01</td> <td colspan="2"></td> </tr><tr> <td style="text-align: center;">3.75</td> <td style="text-align: center;">SZ</td> <td style="color: red;">Surface damage, other from 4 O'Clock to 6 O'Clock DAMAGE ON PIPE: DAMAGE ON PIPE</td> <td style="text-align: center;">00:00:30</td> <td colspan="2"></td> </tr></table>

, 00:00:30, 3.75m
 Surface damage, other from 4 O'Clock to 6 O'Clock DAMAGE ON PIPE

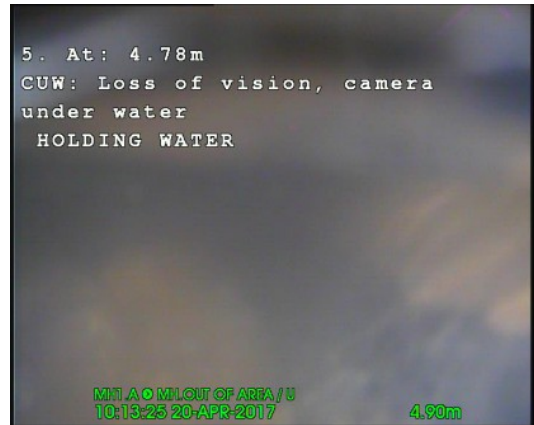
<table><tr> <td style="width: 10%; text-align: center;">0.08</td> <td style="width: 5%; text-align: center;">MH</td> <td style="width: 45%;">Start node type, manhole reference number: MH1.A A: A</td> <td style="width: 10%; text-align: center;">00:00:01</td> <td colspan="2"></td> </tr><tr> <td style="text-align: center;">5.00</td> <td style="text-align: center;">CUW</td> <td>Loss of vision, camera under water HOLDING WATER: HOLDING WATER</td> <td style="text-align: center;">00:00:38</td> <td colspan="2"></td> </tr></table>

, 00:00:38, 5.00m
 Loss of vision, camera under water HOLDING WATER

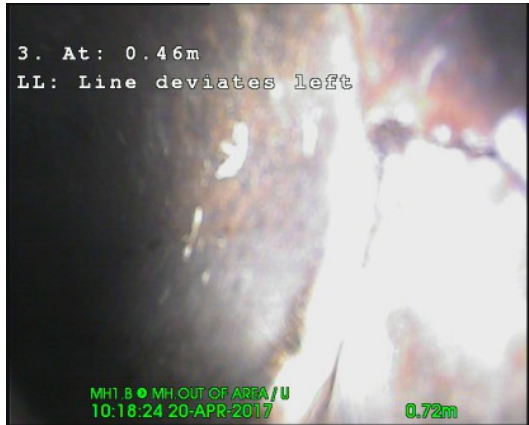
, 00:00:08, 0.72m
Line deviates left

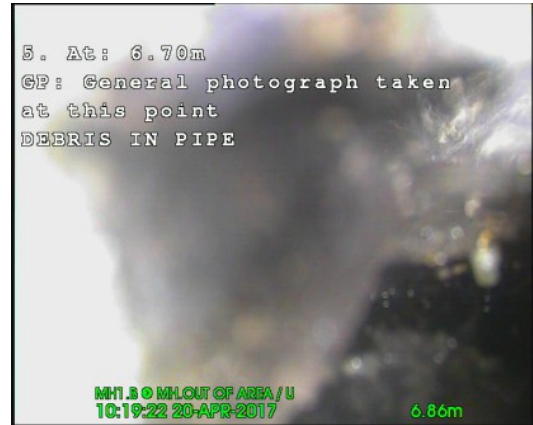
, 00:00:37, 6.88m
General photograph taken at this point DEBRIS IN PIPE

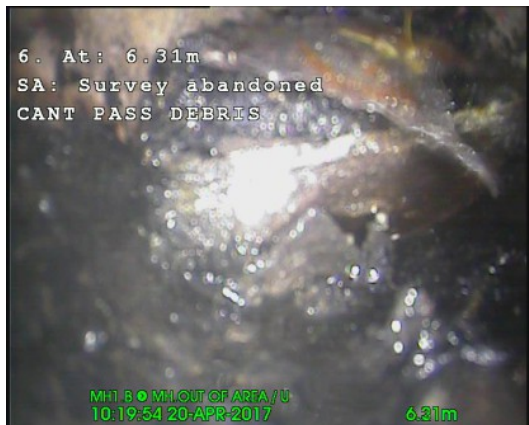
Section	Pipe Ref	Description
3	MH.OUT OF AREAX	Survey abandoned CANT PASS DEBRIS
6	SVP1X	Survey abandoned LOSS OF VISION BLOCKED

, 00:00:52, 6.19m
Survey abandoned CANT PASS DEBRIS

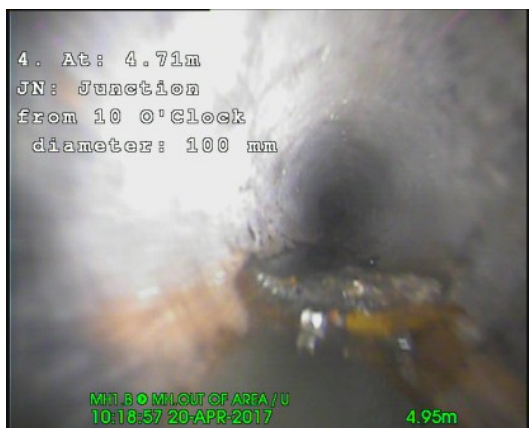
, 00:00:30, 4.98m
Junction from 10 O'Clock diameter: 100 mm

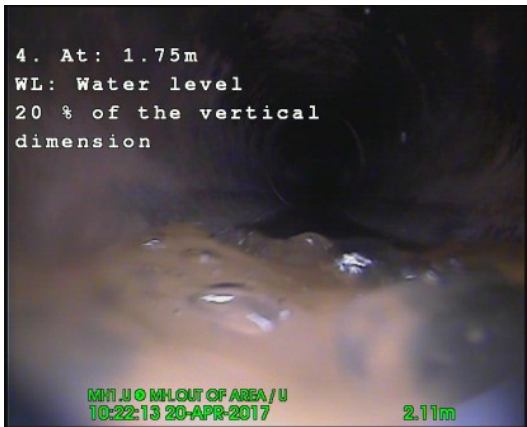
, 00:00:20, 2.17m
 Water level 20 % of the vertical dimension

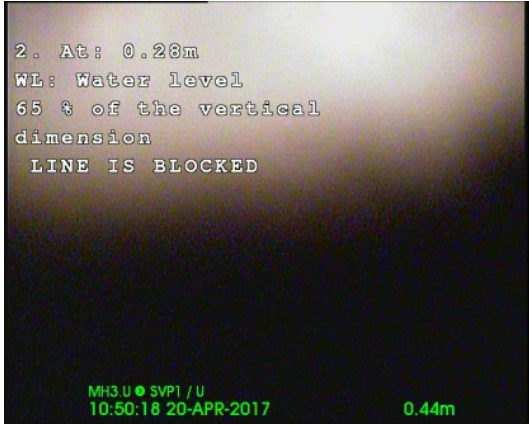
<table><tr> <td style="width: 10%;"></td> <td style="width: 15%; text-align: center;">0.26</td> <td style="width: 10%;">MH</td> <td style="width: 45%;">Start node type, manhole reference number: MH3.U UPSTREAM: UPSTREAM</td> <td style="width: 10%; text-align: center;">00:00:01</td> <td></td> <td></td> </tr><tr> <td></td> <td style="text-align: center;">0.44</td> <td>WL</td> <td>Water level 65 % of the vertical dimension LINE IS BLOCKED: LINE IS BLOCKED</td> <td style="text-align: center;">00:00:03</td> <td></td> <td></td> </tr></table>

, 00:00:03, 0.44m
 Water level 65 % of the vertical dimension LINE IS BLOCKED

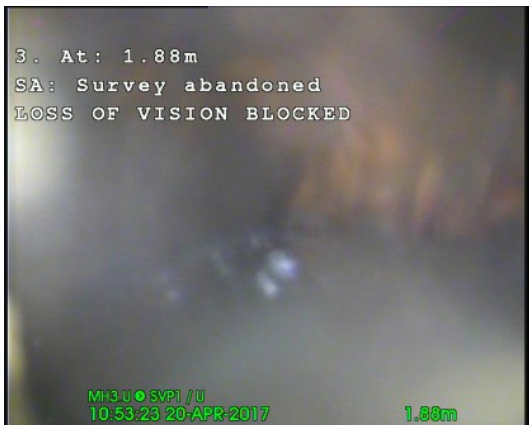
<table><tr> <td style="width: 10%;"></td> <td style="width: 15%; text-align: center;">0.26</td> <td style="width: 10%;">MH</td> <td style="width: 45%;">Start node type, manhole reference number: MH3.U UPSTREAM: UPSTREAM</td> <td style="width: 10%; text-align: center;">00:00:01</td> <td></td> <td></td> </tr><tr> <td></td> <td style="text-align: center;">1.88</td> <td>SA</td> <td>Survey abandoned LOSS OF VISION BLOCKED: LOSS OF VISION BLOCKED</td> <td style="text-align: center;">00:02:48</td> <td></td> <td></td> </tr></table>

, 00:02:48, 1.88m
 Survey abandoned LOSS OF VISION BLOCKED

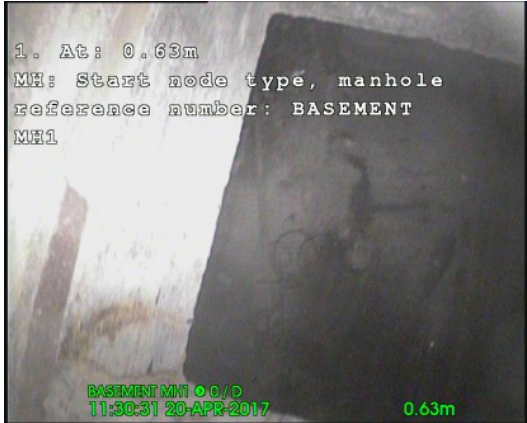
Comment: **2.750 TO FLOOR SLAB .90 FURTHER CONFIND SPACE ACCESS MAY BE NEEDED**
 Recommendation:

, 00:00:07, 0.63m
Start node type, manhole reference number: BASEMENT MH1

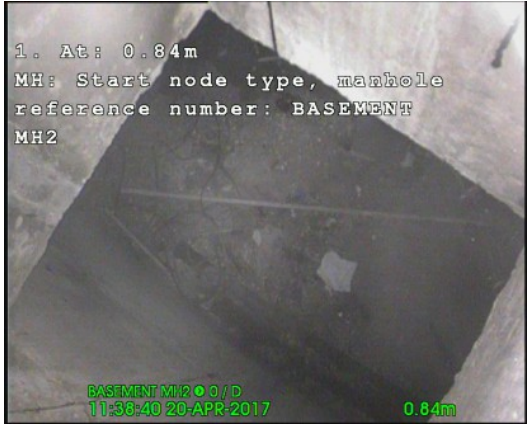
Comment: **2.6 TO FLOOR SLAB .74 FURTHER CONFIND SPACE ACCESS MAY BE NEEDED**
 Recommendation:

, 00:00:07, 0.84m
Start node type, manhole reference number: BASEMENT MH2
