CCTV Survey Report Prepared For:

11 briardale gardens - CCTV Survey Report : 09/01/19

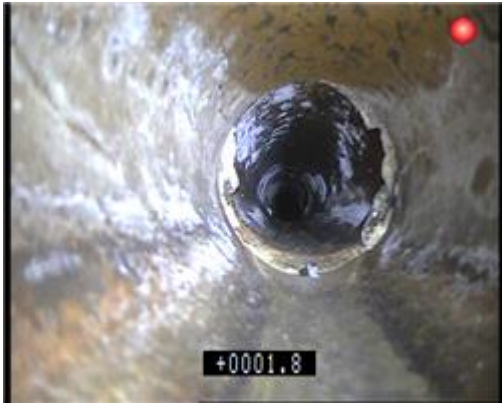
| Pos | Code | Description | Image |
|---|---|---|---|
| 01.80m | JDL | Joint displaced large - Grade 3 | <p>Image Provided - Ref: 0_2</p> |

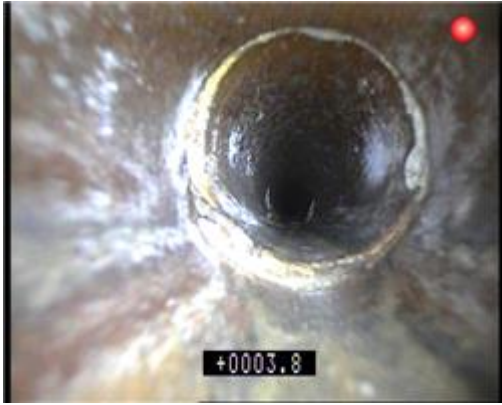
| Pos | Code | Description | Image |
|---|---|---|---|
| 03.80m | JDL | Joint displaced large - Grade 3 | <p>Image Provided - Ref: 0_3</p> |

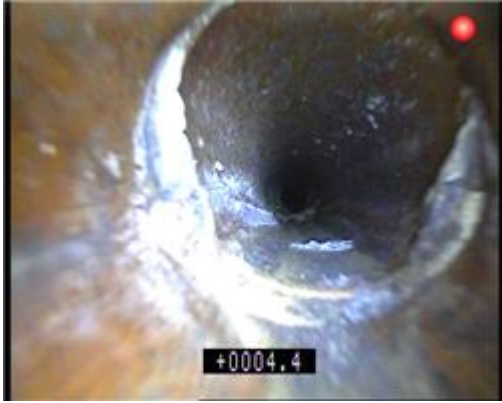
| Pos | Code | Description | Image |
|---|---|---|---|
| 04.40m | JDL | Joint displaced large - Grade 3 | <p>Image Provided - Ref: 0_4</p> |

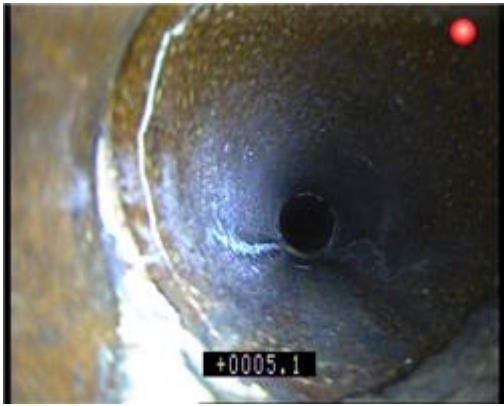
| Pos | Code | Description | Image |
|---|---|--|---|
| 05.10m | CM | Cracks, multiple from 06 o'clock to 12 o'clock - Grade 3 | Image Provided - Ref: 0_5 |

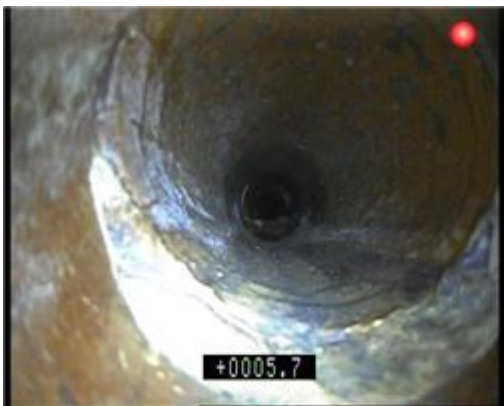
| Pos | Code | Description | Image |
|---|---|--|---|
| 05.70m | JDL | Joint displaced large - Grade 3 | Image Provided - Ref: 0_6 |

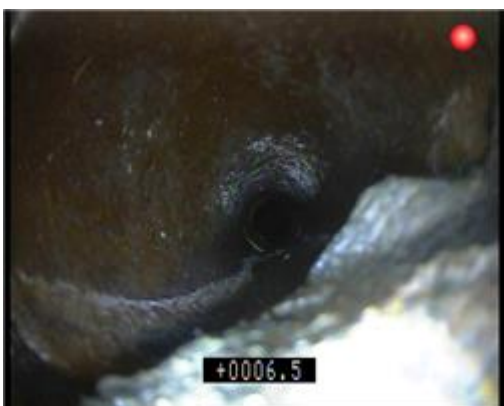
| Pos | Code | Description | Image |
|---|---|--|---|
| 06.50m | DER | Settled deposits coarse: 40% Cross sectional area loss - Grade 3 concrete in run | Image Provided - Ref: 0_7 |

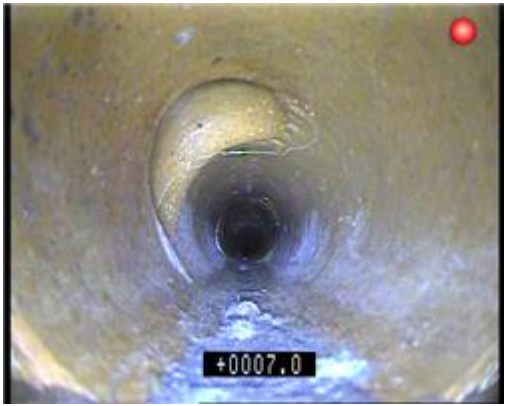
| Pos | Code | Description | Image |
|---|---|--|--|
| 07.00m | JX | Defective junction at 12 o'clock: 100mm Diameter - Grade 4 | Image Provided - Ref: 0_8 |

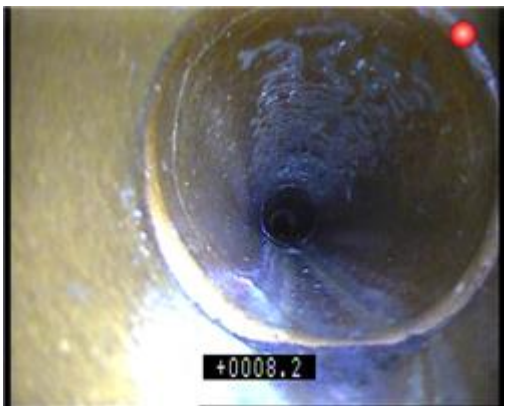
| Pos | Code | Description | Image |
|---|---|--|--|
| 08.20m | CC | Crack, circumferential from 06 o'clock to 12 o'clock - Grade 2 | Image Provided - Ref: 0_9 |

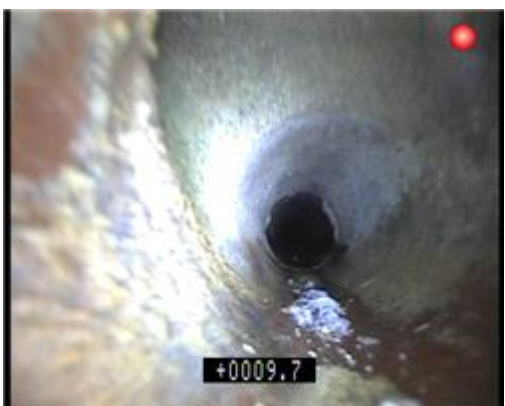
| Pos | Code | Description | Image |
|---|---|--|--|
| 09.70m | JN | Junction at 10 o'clock: 100mm Diameter | Image Provided - Ref: 0_10 |

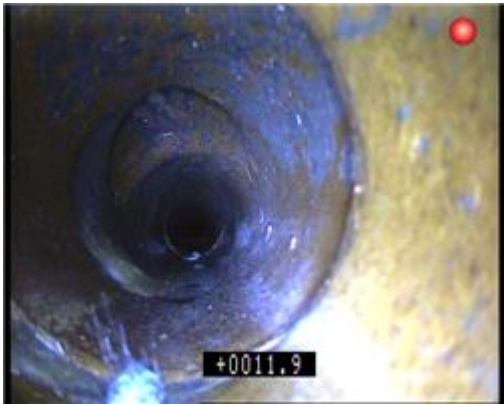
| Pos | Code | Description | Image |
|---|---|--|---|
| 11.90m | JN | Junction at 10 o'clock: 100mm Diameter | Image Provided - Ref: 0_11 |

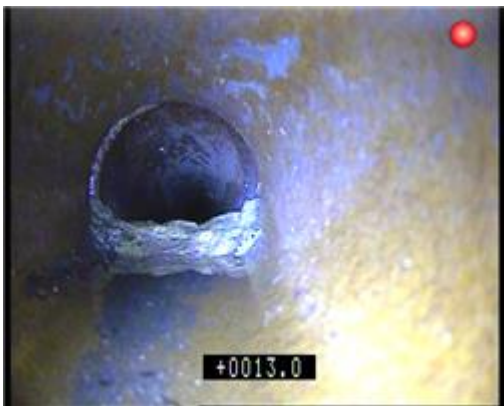
| Pos | Code | Description | Image |
|---|---|--|---|
| 13.00m | DER | Settled deposits coarse: 40% Cross sectional area loss - Grade 3 concrete in run | Image Provided - Ref: 0_12 |

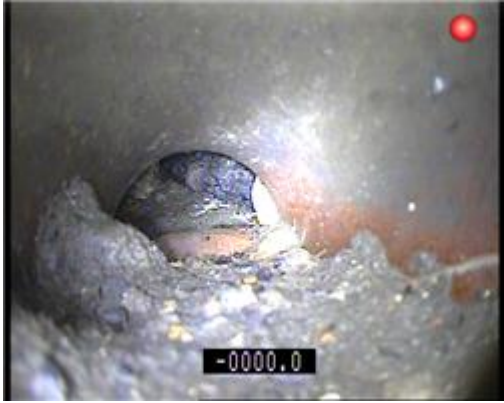
| Position | Code | Description | CD | Pic | Grade |
|---|---|---|---|---|---|
| 00.00m | XP | Collapsed drain/sewer 80% | | 1_2 | 5 — |

| Pos | Code | Description | Image |
|---|---|---|---|
| 00.00m | XP | Collapsed drain/sewer: 80% Cross sectional area loss - Grade 5 | <p>Image Provided - Ref: 1_2</p> |

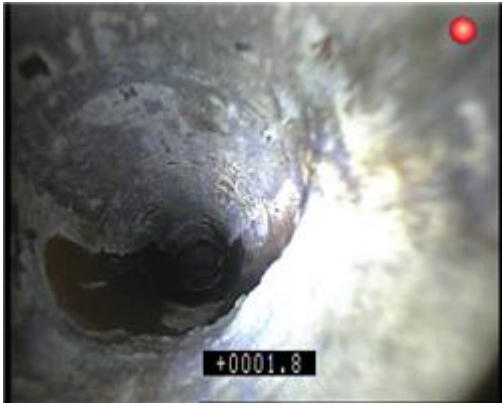
| Position | Code | Description | CD | Pic | Grade |
|---|---|--|---|---|---|
| 01.80m | DER | Settled deposits coarse 40% | | 2_2 | 3 |

| Pos | Code | Description | Image |
|---|---|---|---|
| 01.80m | DER | Settled deposits coarse: 40% Cross sectional area loss - Grade 3 | Image Provided - Ref: 2_2 |

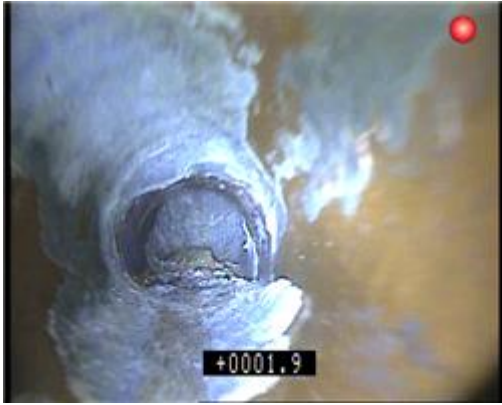
| Position | Code | Description | CD | Pic | Grade |
|---|---|--|---|---|---|
| 01.90m | DER | Settled deposits coarse 20% | | 2_3 | 3 |

| Pos | Code | Description | Image |
|---|---|---|---|
| 01.90m | DER | Settled deposits coarse: 20% Cross sectional area loss - Grade 3 | Image Provided - Ref: 2_3 |

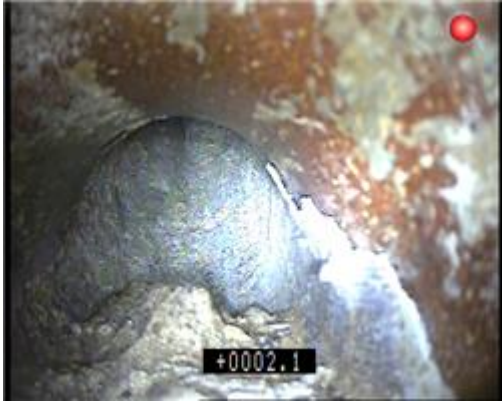
| Position | Code | Description | CD | Pic | Grade |
|---|---|--|---|---|---|
| 02.10m | DER | Settled deposits coarse 40% | | 2_4 | 3 |

| Pos | Code | Description | Image |
|---|---|---|---|
| 02.10m | DER | Settled deposits coarse: 40% Cross sectional area loss - Grade 3 | Image Provided - Ref: 2_4 |

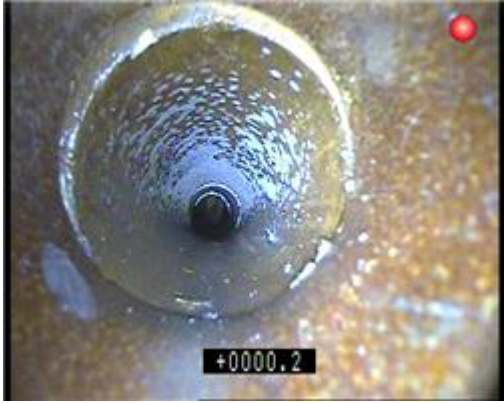
| Position | Code | Description | CD | Pic | Grade |
|---|---|--|---|---|---|
| 00.20m | JDM | Joint displaced medium | | 3_2 | 2 |

| Pos | Code | Description | Image |
|---|---|---|---|
| 00.20m | JDM | Joint displaced medium - Grade 2 | <p>Image Provided - Ref: 3_2</p> |

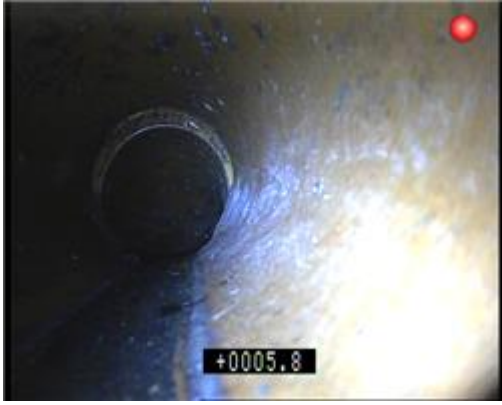
| Position | Code | Description | CD | Pic | Grade |
|---|---|--|---|---|---|
| 05.80m | JDL | Joint displaced large | | 4_4 | 3 |

| Pos | Code | Description | Image |
|---|---|--|---|
| 05.80m | JDL | Joint displaced large - Grade 3 | <p>Image Provided - Ref: 4_4</p> |

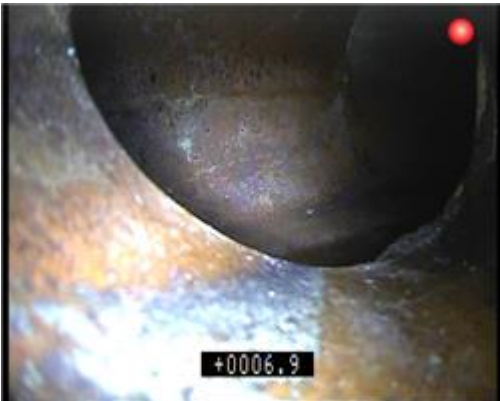
| Pos | Code | Description | Image |
|---|---|---|--|
| 06.90m | BRF | Finish node type, major connection without manhole Main | Image Provided - Ref: 4_9999 |

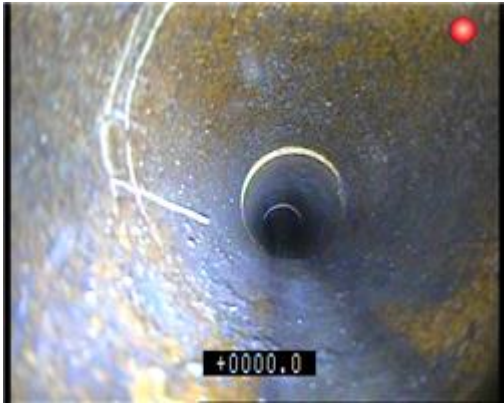
| Position | Code | Description | CD | Pic | Grade |
|---|---|---|---|---|---|
| 00.00m | CM | Cracks, multiple 06-12 | | 5_2 | 3 |

| Pos | Code | Description | Image |
|---|---|---|---|
| 00.00m | CM | Cracks, multiple from 06 o'clock to 12 o'clock - Grade 3 | Image Provided - Ref: 5_2 |

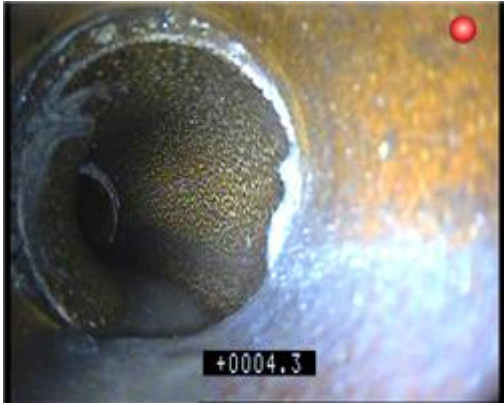
| Position | Code | Description | CD | Pic | Grade |
|---|---|---|---|---|---|
| 04.30m | JDL | Joint displaced large | | 5_3 | 3 |

| Pos | Code | Description | Image |
|---|---|---|---|
| 04.30m | JDL | Joint displaced large - Grade 3 | Image Provided - Ref: 5_3 |
