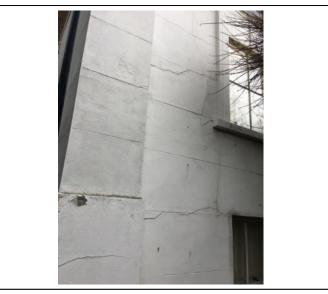
4. Cracking to stucco to front - 1 Agar Grove

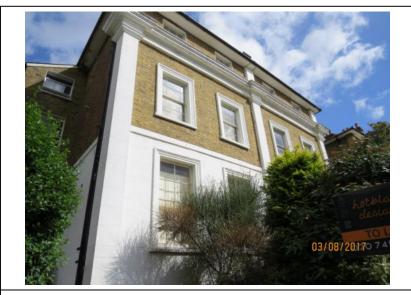
3. Front elevation – 1 Agar Grove

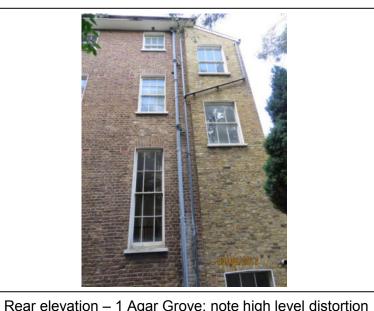
7. Rear elevation – 1 Agar Grove; note high level distortion up to side extension

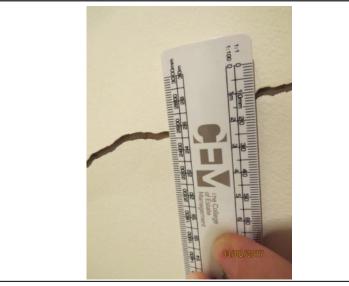
9. Close-up of crack in photo 8

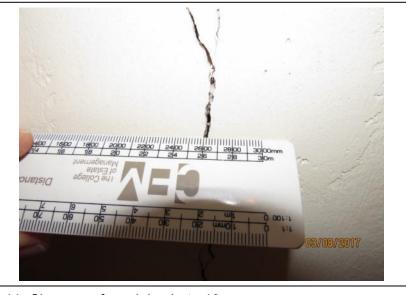
11. Close-up of crack in photo 10

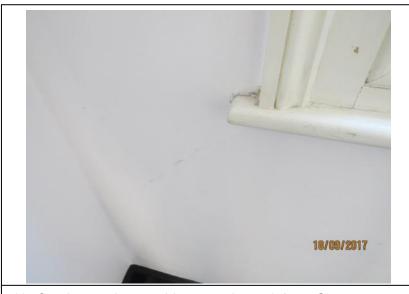
13. Crack to staircase side extension – 1 Agar Grove

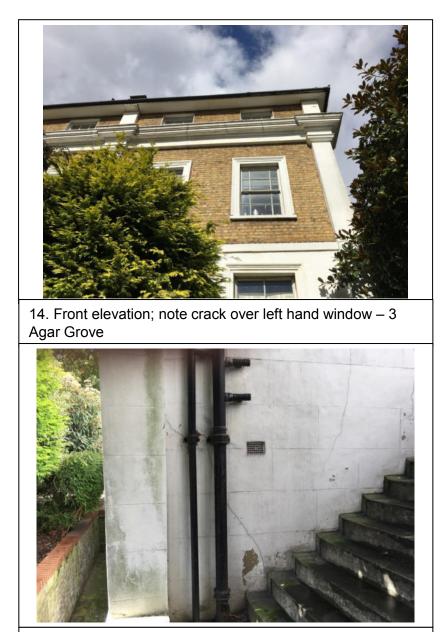
16. Cracking to front corner – 3 Agar Grove

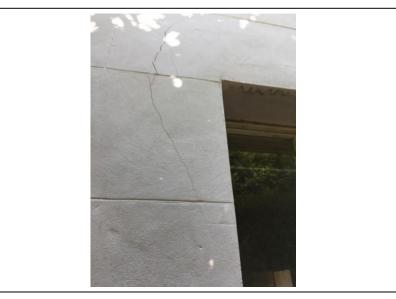
15. Crack to front stucco – 3 Agar Grove

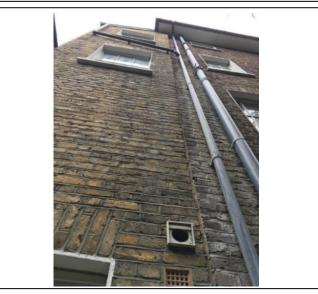
17. Rear elevation – 3 Agar Grove; note high level distortion up to side extension

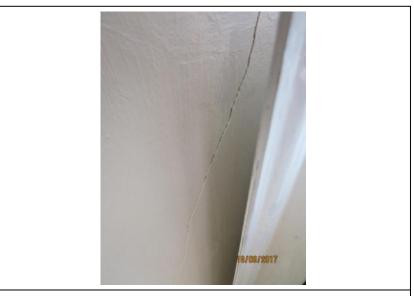
23. Internal crack to first floor front wall – 5 Agar Grove

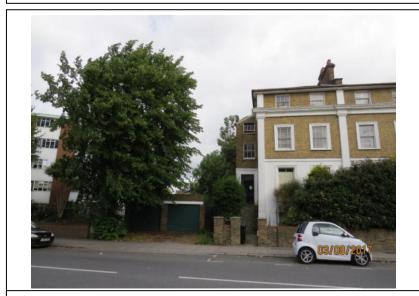
25. Lime tree to Gairloch House land to west of 1 Agar Grove

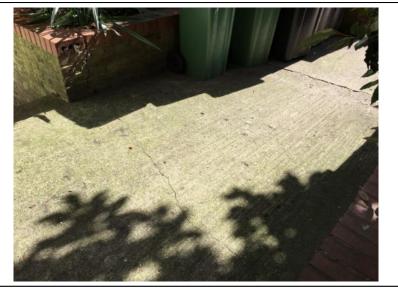
28. Cracking to concrete pathway – 1 Agar Grove

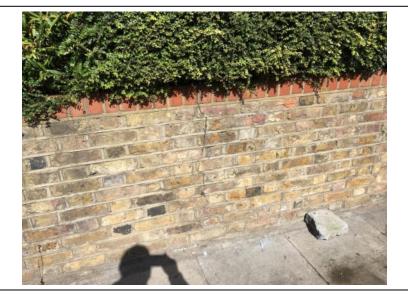
27. Crack to front boundary wall – 1 Agar Grove

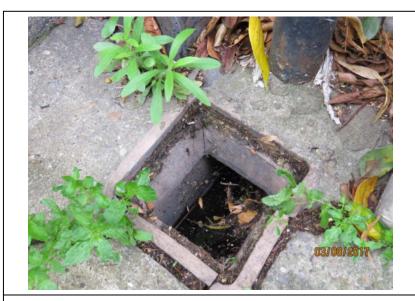
31. Blocked surface water gully – 1 Agar Grove

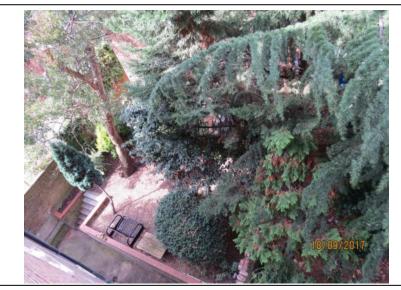
33. View of vegetation to rear of 1 Agar Grove

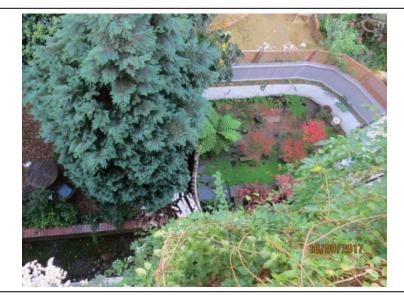
35. View of vegetation and collapsed garden wall to rear of 5 Agar Grove

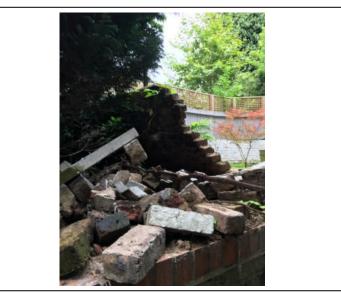
39. Collapsed garden wall to 5 Agar Grove with 7 Agar Grove
