## Arboricultural Appraisal Report

### Subsidence Damage Investigation at:

3 Crediton Hill  
London  
NW6 1HT

CLIENT:	Crawford & Company
CLIENT REF:	██████████
MWA REF:	SUB190218-3651
MWA CONSULTANT:	George Peters BSc. (Hons)
REPORT DATE:	24/02/2019

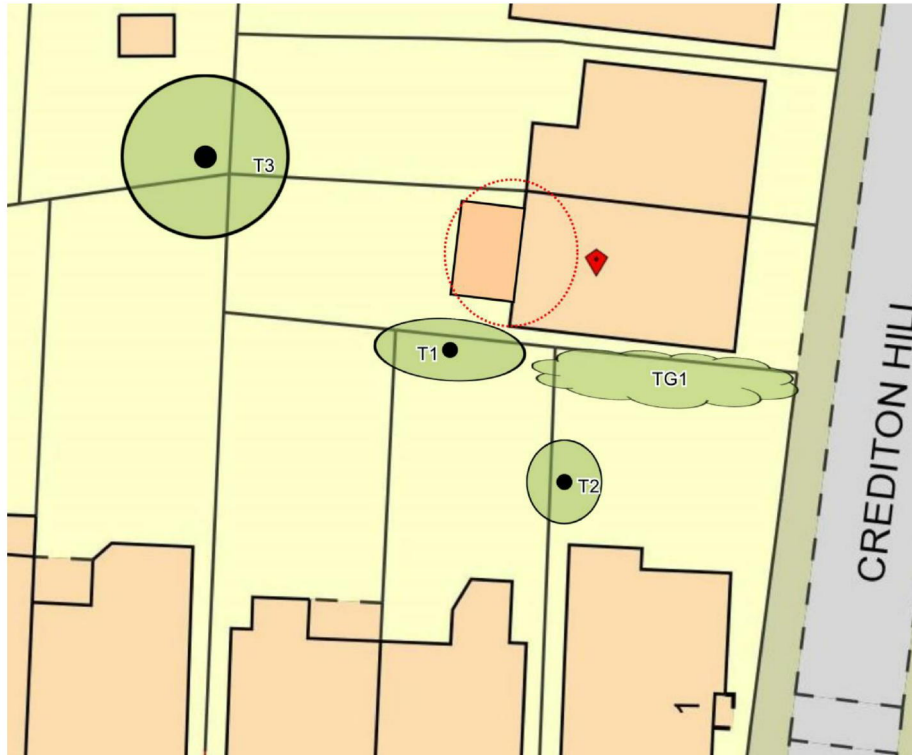
SITE PLAN

Approximate areas of damage

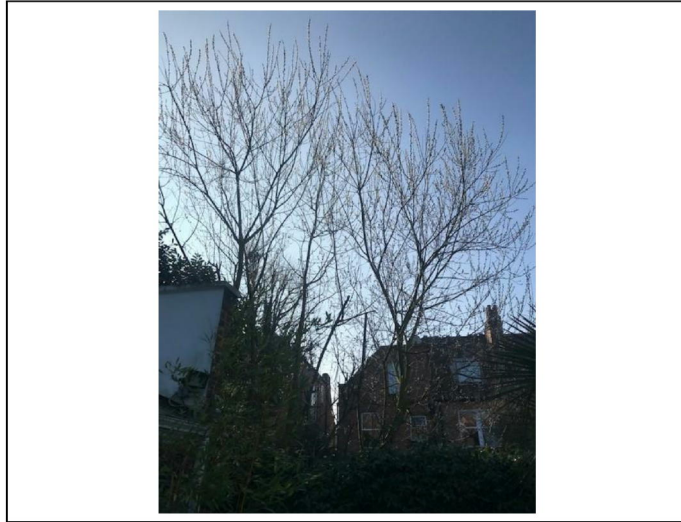
The most significant vegetative influence in relation to the current damage is T1 (Goat Willow) with a potential contribution from TG1 (Cherry Laurel). Other vegetation recorded represents a future risk.

Having considered the available information, it is our opinion that T1 and TG1 are the principal cause of any damage related to clay shrinkage subsidence.

View of T1 Goat Willow, current claim.

If an arboricultural solution is to be implemented to mitigate the influence of the trees/shrubs considered to be responsible for the damage we recommend that T1 is removed, and TG1 is reduced to 2.5m height and 1m width, and is to be maintain at broadly reduced dimensions on a biannual pruning cycle.

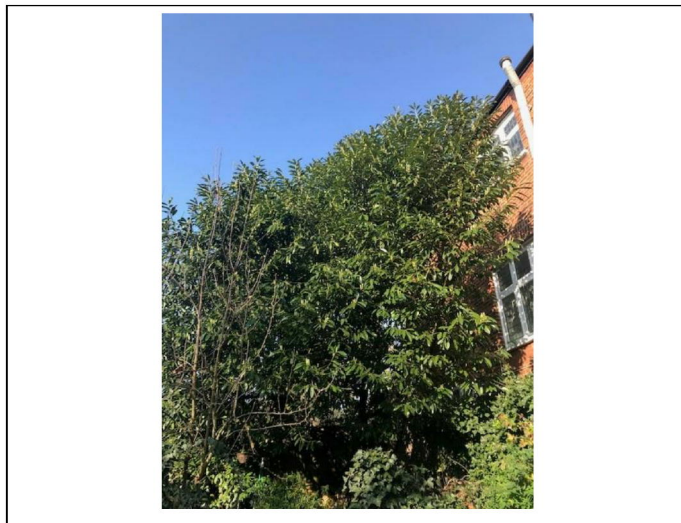
View of TG1 Cherry Laurel, current claim.

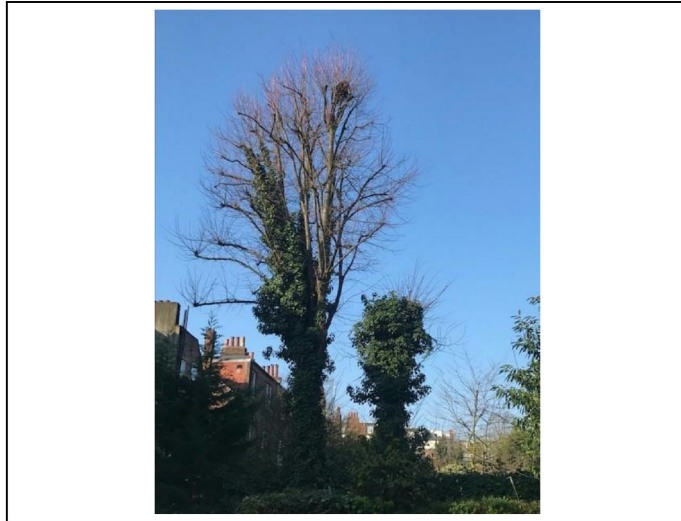
View of T2 Lime, future risk.

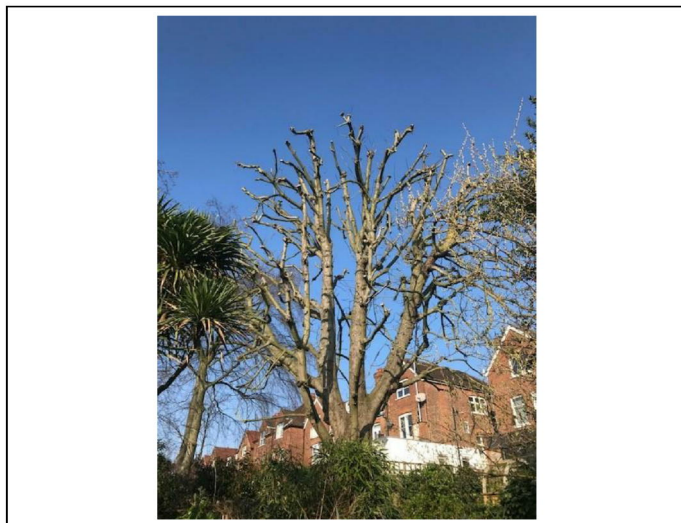
View of T3 London Plane, future risk.
