TECHNICAL REPORT ON A SUBSIDENCE CLAIM

SUBSIDENCE CLAIM

DATE 15 February 2019

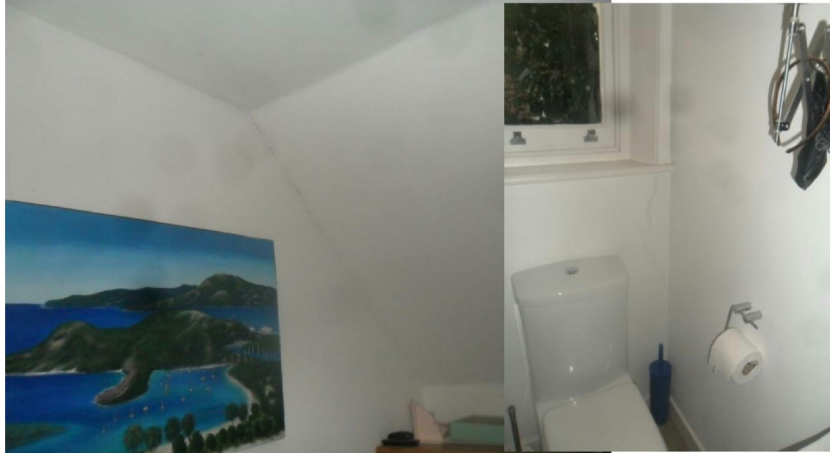
Subsidence crack

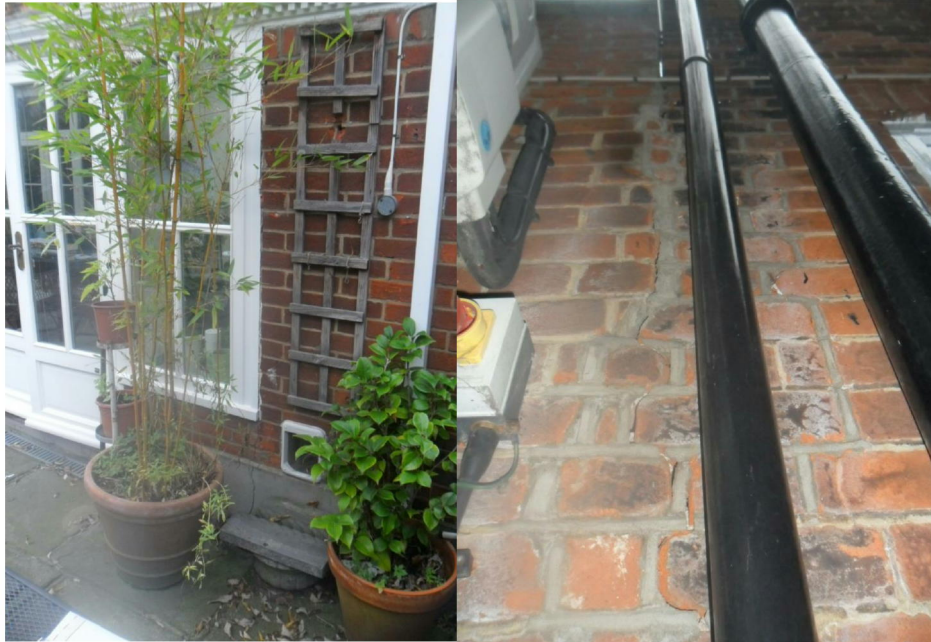
Rear

Subsidence crack

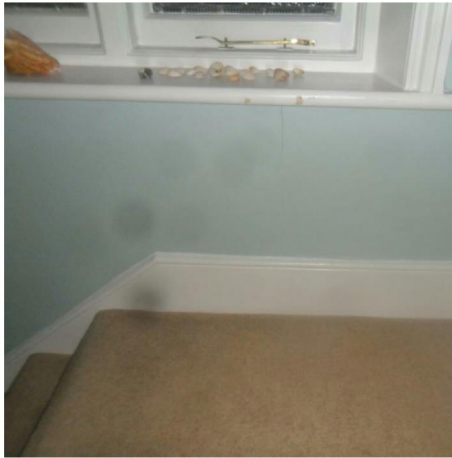
Subsidence crack

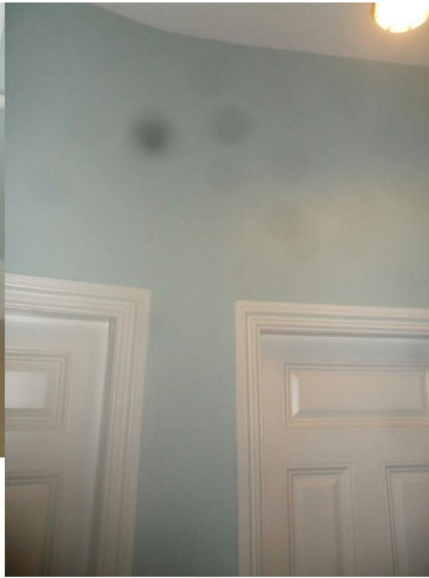
Subsidence crack

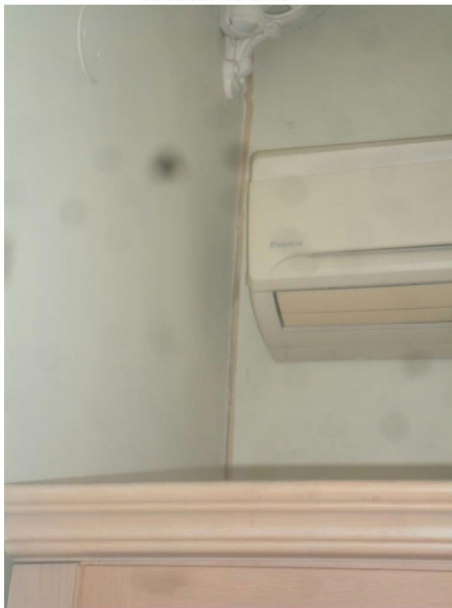
Subsidence crack

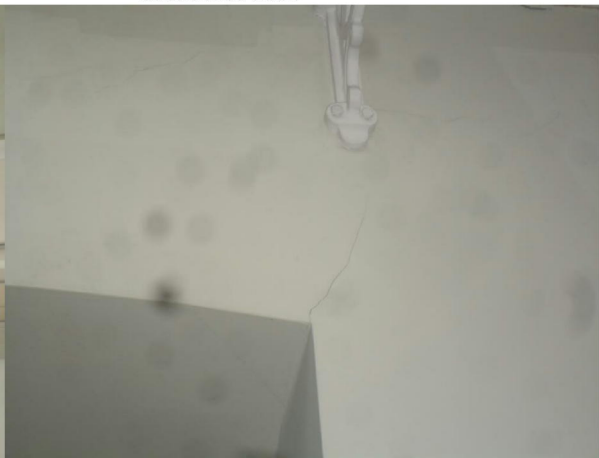
Subsidence crack

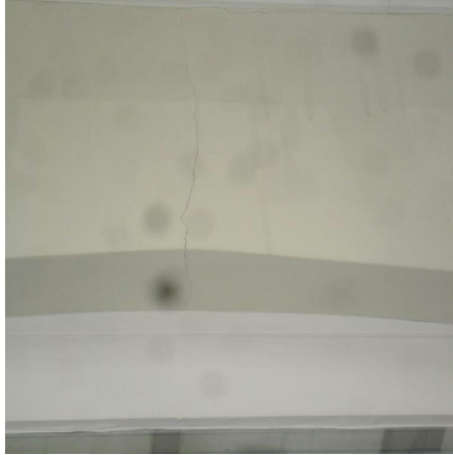
Subsidence crack

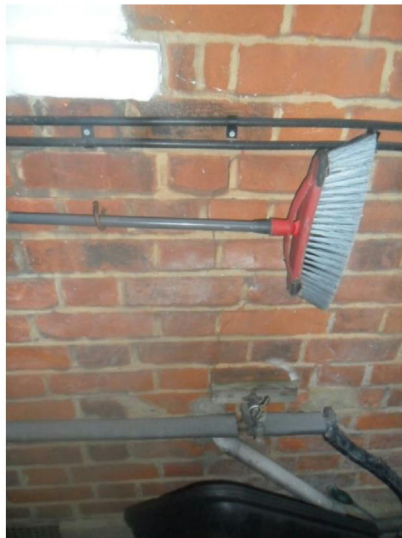
Subsidence crack

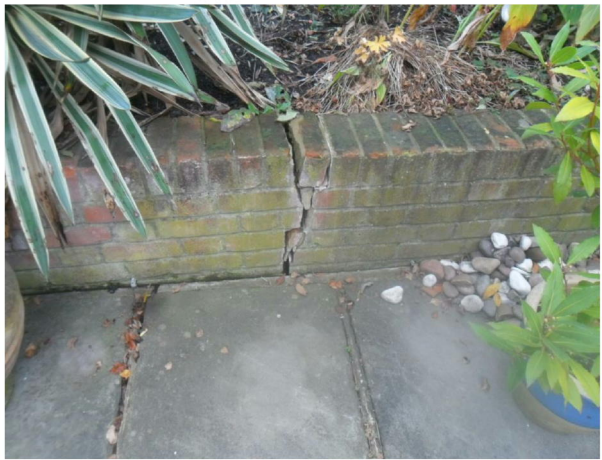
Subsidence crack
