## Damp Investigation Survey Final Report

**Areas 8 Ltd**

65, Kingsway, London. WC28 6TD

October 30, 2018

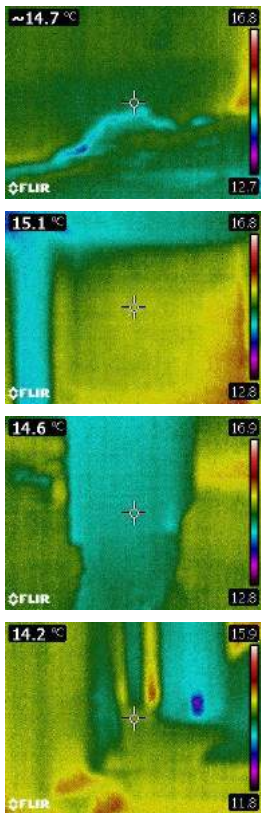
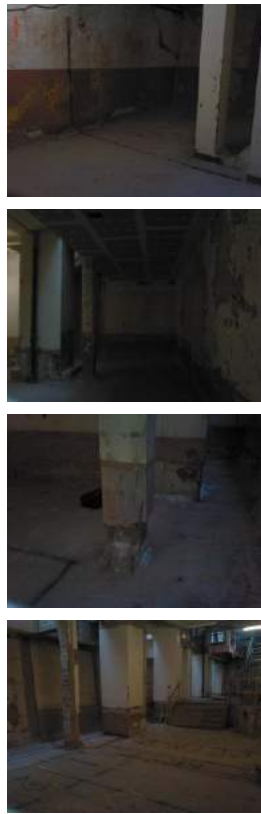
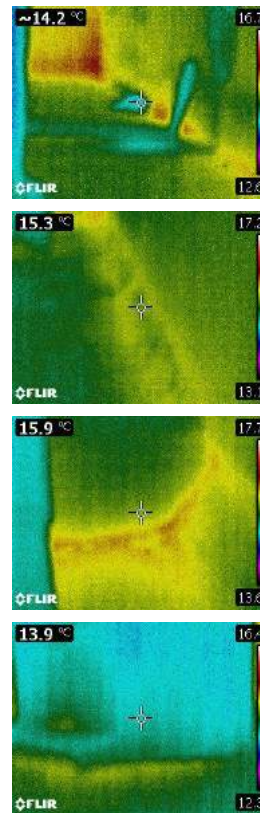
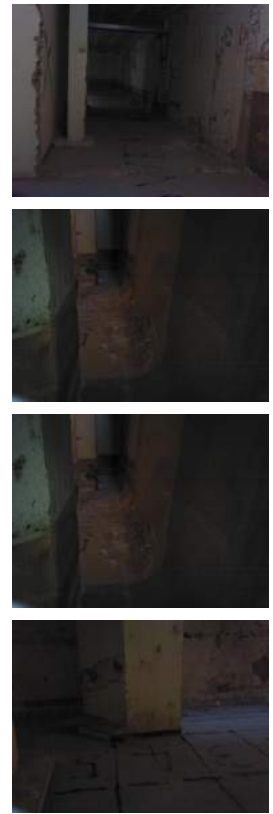
There is no evidence of any tanking system applied to the walls, but this may be a liquid system, which has then been rendered over. The cement render would act as a barrier, to prevent moisture ingress, but this often fails at the wall/ floor junction, and in corners, as these are the weakest points.

In our opinion, the current cement based render is providing an adequate moisture barrier at high level, but has failed at low level, at the wall/floor junction, and in some of the corners. This will allow moisture to track along the floor, which is evidenced by the MC levels, obtained close to the walls.

The MC levels, taken away from the walls were acceptable, suggesting there is an adequate membrane under the floor. The water noted in the pilot hole is ground water, due to the depth of the basement. In order to provide a tanking system, then a floor membrane will also be required to prevent any moisture from the walls, affecting the floor.

1. We understand a specialist tanking contractor, has already visited, and provided recommendations for a low level tanking system. We have not seen the specification for this, or the type of system to be used. Based upon our observations, and readings, this should be designed to prevent further moisture ingress, especially at the wall/ floor junction. Any tanking system, should allow the structure to breathe, allowing any trapped moisture to escape. We normally recommend, a Delta Membrane or similar system, that will capture moisture that penetrates the structure, and drain it away, but provide a dry room internally. The new tanking system, should also be provided with a manufacturers, or insurance backed guarantee, to cover any future issues.
