## ARBORICULTURAL ASSESSMENT REPORT

<b>For:</b>	<b>Client:</b>	Oriel Services Limited
	<b>Insurer:</b>	[REDACTED]
<b>Site:</b>	<b>Policyholder:</b>	[REDACTED]
	<b>Risk Address:</b>	6 Hollycroft Avenue, London, NW3 7QL
<b>Refs:</b>	<b>OCA Ref:</b>	[REDACTED]
	<b>Client Ref:</b>	[REDACTED]
	<b>Insurer Ref:</b>	[REDACTED]

<b>Report By:</b>	Sue Lawson		
<b>Title:</b>	Arborist	<b>Date:</b>	21 January 2015

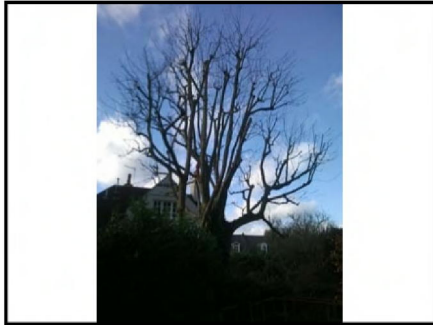
The site investigation has confirmed the presence of a shrinkable clay soil. Roots have been identified from below foundation level at the front of the property which are consistent with the position and species of Ash T7 and from below foundation level at the rear which are consistent with the position and species of Ash T1.

We consider that T1 and T7 are the main cause of the damage to the front and rear of the property.

1. Ash T1 from the rear garden

Tree No:	Species	Works Required
T1	Ash	Fell and treat stump
T7	Ash	Fell and grind stump

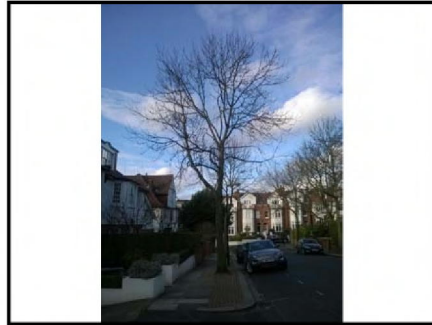
2. Ash T7 on the street to the front

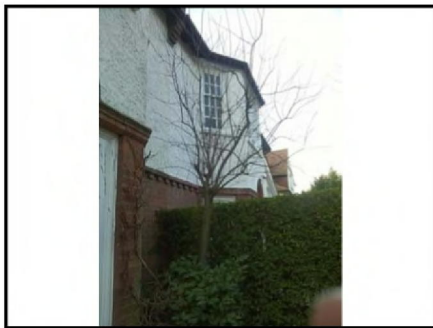
We consider that Cherry T3 and Cherry T5 are a future risk however the policyholder has indicated that both of these trees are shortly to be removed. In addition, we would recommend that the size of Climbing Hydrangea G3 be contained as a precaution against future damage.

3. Cherry T3 with G2 in background

Tree No:	Species	Works Required
T3	Cherry	Fell and treat stump.
T5	Cherry	Fell and treat stump.
G3	Climbing Hydrangea	Maintain at current dimensions with regular pruning.

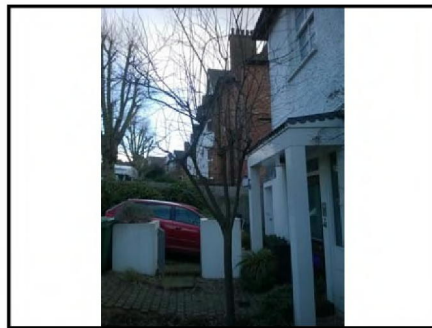
4. Cherry T5 to the front of the property

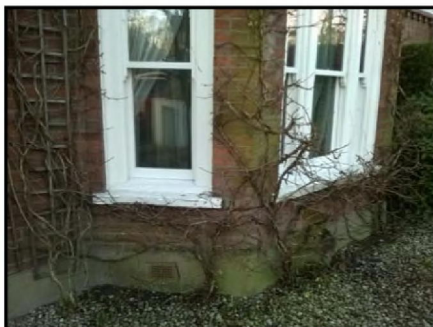
5. Climbing Hydrangea G3

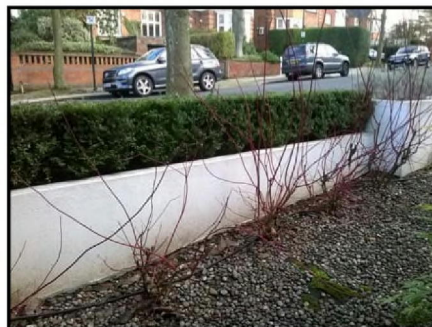
6. G4 in foreground and G5 in background
