TECHNICAL REPORT ON A SUBSIDENCE CLAIM

4 Leverton Street
Kentish Town
London
NW5 2PJ

SUBSIDENCE CLAIM

30th August 2018

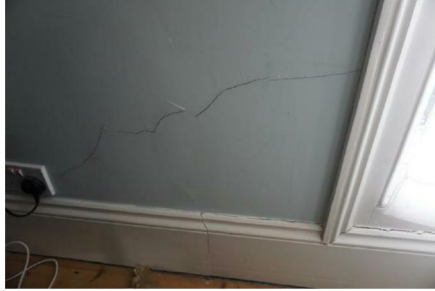
Front Bedroom - Diagonal crack.

Diagonal crack to right wall at high level - 1mm

Diagonal crack to front wall at low level - 1.5mm

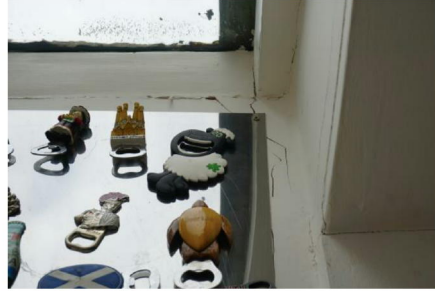
Dining Room - Tapering crack at main house junction.

Vertical crack to front left corner - 3mm

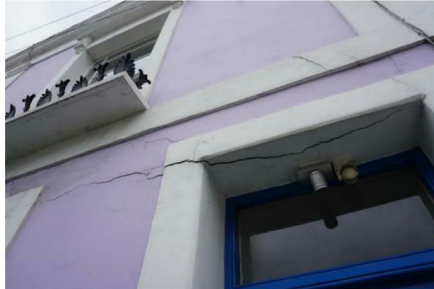
**Front Elevation - Horizontal Crack.**

Horizontal crack to right of front door - 2.5mm
 Horizontal crack above front door/underside - 5mm
 Crack below window with previous repairs - 2mm

The cause of the movement needs to be dealt with first. We have completed a Soil Risk Analysis (VISCAT Assessment) and we are satisfied that your Hedge can be removed. As the property is in a conservation area we will carry out a site investigation to provide evidence that the tree roots are the cause.

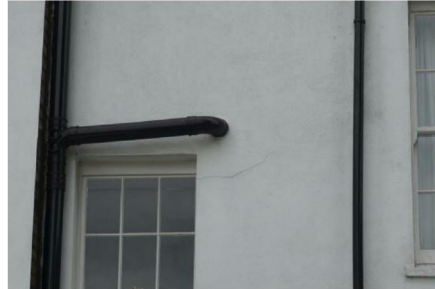
**Rear Elevation - Horizontal Crack.****Front Elevation**

Horizontal crack to left of landing window - 1mm

Although the cause of the movement needs to be dealt with, we note the involvement of a commercial third party tree. Unfortunately, they will require certain investigations to be carried out to demonstrate the influence of their vegetation. These will include a site investigation to the rear and a period of crack and level monitoring for up to one year. A specialist arborist report will also be instructed.

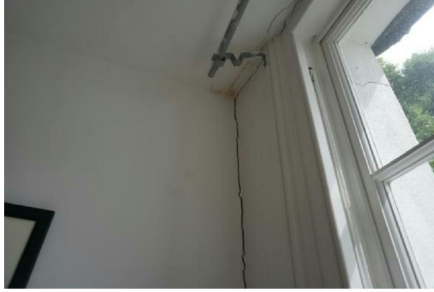
Vertical crack to rear left corner - 4mm

Stairs - Vertical crack at rear left junction.

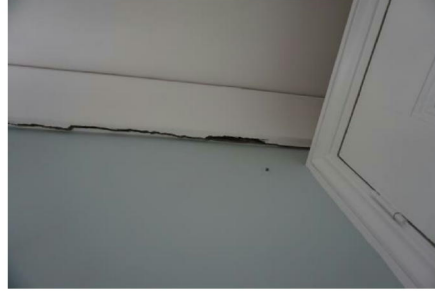
Coving separation to front - 5mm

Front Bedroom - De-bonded coving.

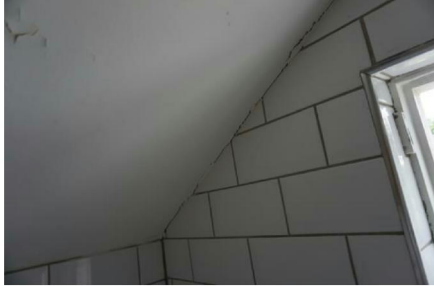
Ceiling junction separation to rear - 1mm

Bathroom - Ceiling junction separation.

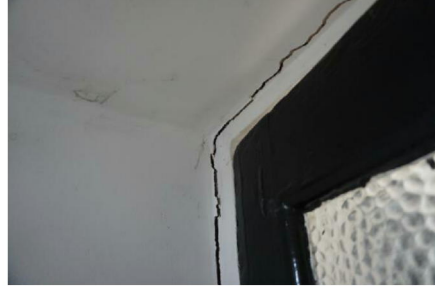
Hall - Separation around rear door to kitchen.

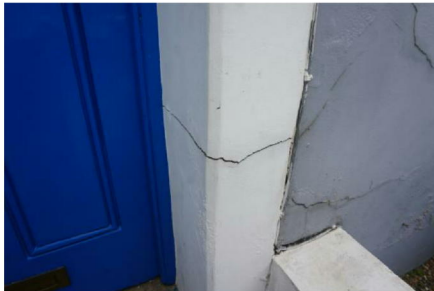
Front Elevation - Horizontal crack to right of door.

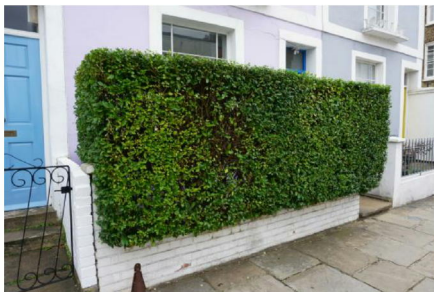
Privet (*Ligustrum*). Commonly encountered as a boundary definition hedge. Evergreen with medium root activity⁴. Can be associated with damage when situated close to a property. Tolerant of heavy pruning with quick regrowth. Along with other members of the Oleaceae (Forsythia, Jasmin, Privet and Lilac) family accounted for 354 enquiries, or 35% of the cards completed in the Kew Survey⁵ between 1979 - 86.

View of Privet to Front.

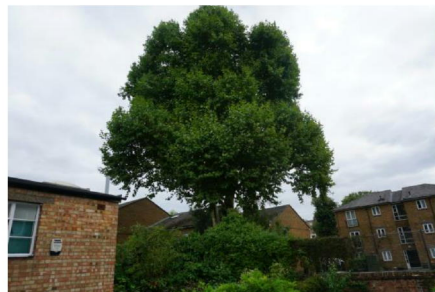
Planes (*Platanus*) are deciduous and can reach heights in excess of 30m depending on health, environment and soil conditions. They have a medium growth rate of around 300mm per year and medium root activity⁶.

View of Plane Tree to Rear.
