INTERVENTION REPORT

MONMOUTH ST

Client: Shaftesbury Covent Garden Ltd
Address: 22 Ganton Street, Carnaby, London, W1F 7FD
Date: April 2019
REF: 1923
AT: 2nd and 3rd Floor, 42 Monmouth Street, London
Written by: VT
Checked by: NH

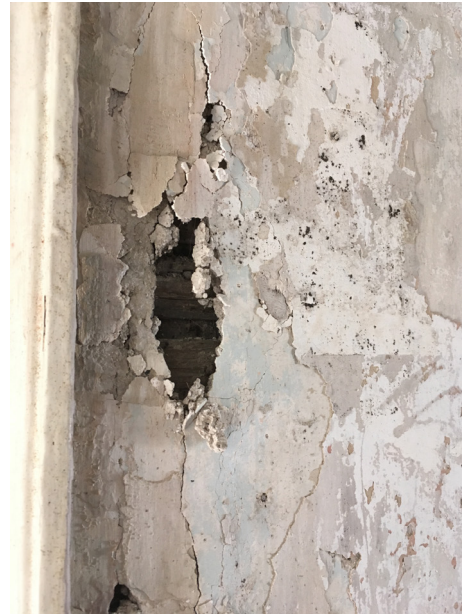
Some walls are lathe and plaster, some are modern stud.

Blown plaster existing to most walls in property to be removed and new plaster finish applied.

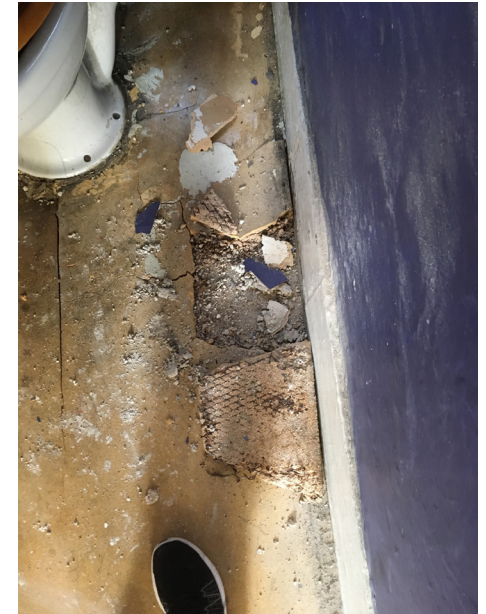
Original flooring beneath boarding.
