The Danish Church

REUSE & SALVAGE STRATEGY

85331-CFM-30-DOC-900

MARCH 2019

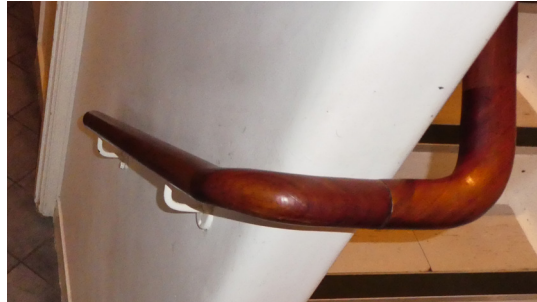
01 Existing Stair - Handrail

Dated: Post-WWII presumed, circa. 1950

Size: approx. 1.6m

Condition: Curved timber handrail maintained in a good condition.

Reuse/Salvage Strategy: For Architectural Salvage

Handrail from basement to first floor is not original but in good condition - to be retained for architectural salvage.

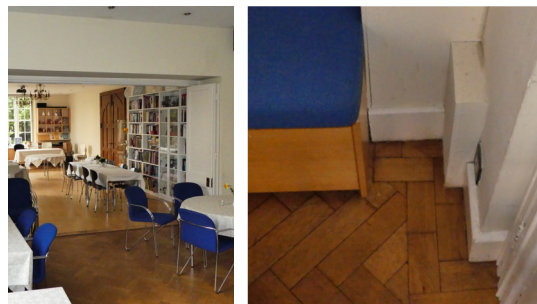
02 Ground Floor Hall - Herringbone Flooring

Size: 35m² herringbone floor to the Hall Cafe. Potential 50m² of herringbone in the Hall underneath the current laminate wood flooring - condition unknown of the flooring beneath until site opening up works.

Condition: Considerable wear and tear due to constant use of space, the wood is not incredibly well maintained. N.B. Bitumen layer beneath on existing concrete slab, potential asbestos containing material.

Reuse/Salvage Strategy: For Architectural Salvage

High-quality solid oak herringbone floor to be installed continuously across the Hall and Cafe space, and better maintained with regular oiling and sanding as required.

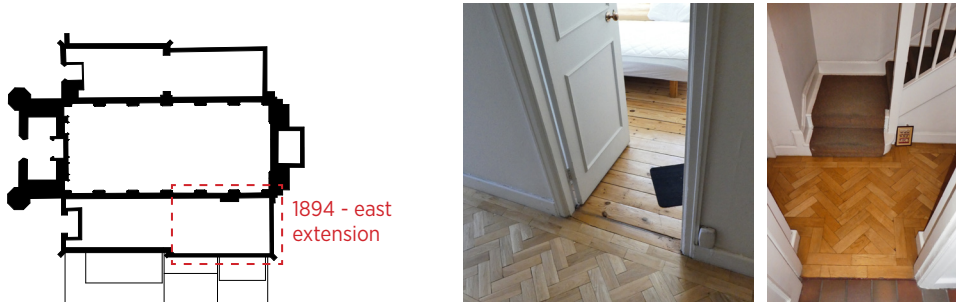
04 Herringbone & Pine Flooring - Ground Floor

Dated: Not original - it is presumed the current mix of flooring was part of a later refurbishment when the Vicarage hall space was partitioned to form accommodation rooms. Exact date unknown - potential mid-century refurbishment.

Size: approx. 50m²

Condition: The mix of herringbone and pine floors to the east extension of the Vicarage, as above photos show, have been cleaned too regularly with hot soapy water. Therefore the wood has generally begun to bow upwards. Isolated areas of damage from use, to be expected. Otherwise in fine condition.

Reuse/Salvage Strategy: For Architectural Salvage

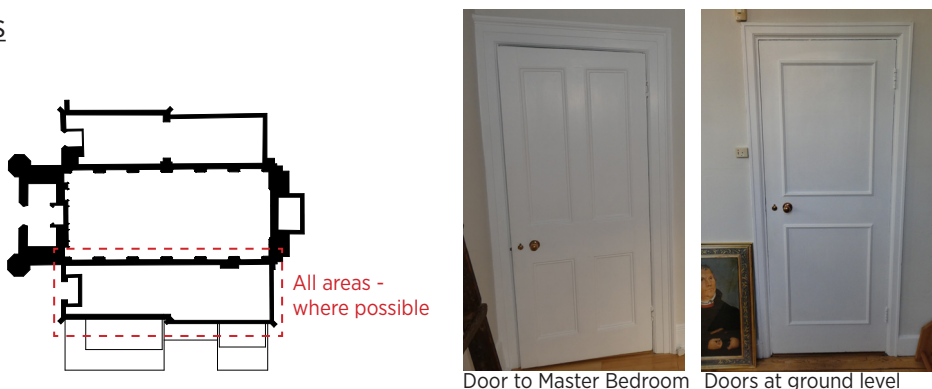
05 Doors

Dated: Master bedroom: late 19C presumed; Ground floor: 1980s presumed
Quantity: 1no. 4 panel door to master bedroom at first floor level - potentially original; 3no. 2 panel doors at ground level in eastern extension of Vicarage - presumed part of later refurbishment

Condition: Master bedroom door to be retained and reused if possible, however, due to building settlement over the years the door frame and architrave have become skewed.

Reuse/Salvage Strategy: For Reuse

Master bedroom door to be reused and hung on a new door frame and architrave, as replicas of original. Other 3no. doors reused if possible, otherwise retained for salvage.

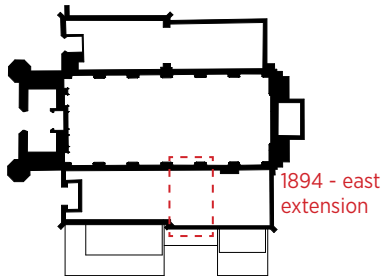
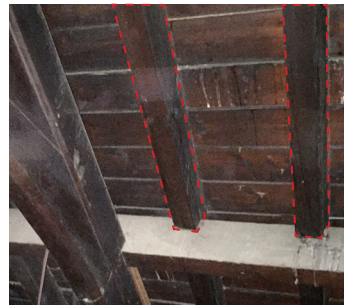
06 Dormer - Rafters

Dated: Presumed circa. 1894
Size: approx. 30m²

Condition: Timber rafters appear in good condition - to be confirmed on site.

Reuse/Salvage Strategy: For Reuse

Reclaim existing timber rafters if deemed in good condition for reuse if any rafters are damaged elsewhere

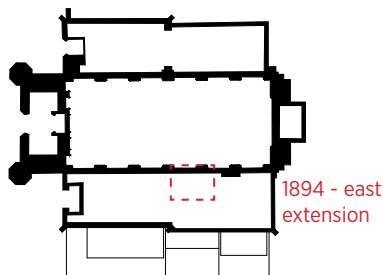
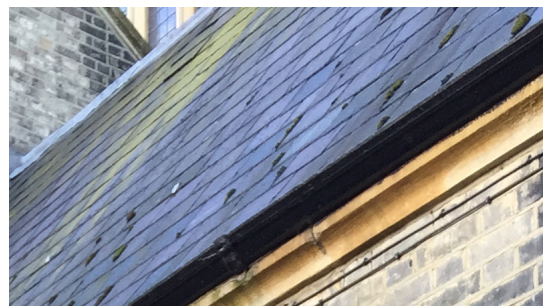
07 Dormer - Slate Tiles

Dated: Some presumed circa. 1894 with likely mid 20C replacements
Size: approx. 15m² - at location of new dormer to northern side of roof ridge.

Condition: Appear in good condition with a natural patina and weathering.

Reuse/Salvage Strategy: For Reuse

Retain all existing slate tiles for re-use on site, to be hung on the new dormer cheek wall and used if any tiles are damaged elsewhere.

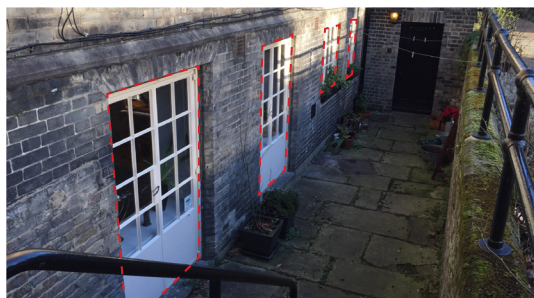
08 Crittall Windows and Doors - Basement Level

Dated: Mid 20C presumed

Quantity: 3no. crittall terrace doors & 3no. crittall windows, as identified on C.F. Møller's south and east demolition elevations.

Condition: Appear in good condition, painted over many years with usual wear and tear - to be investigated further on site.

Reuse/Salvage Strategy: For Architectural Salvage

Single glazed crittall windows and doors to be retained for architectural salvage, and new double glazed crittall terrace doors and windows to be installed.

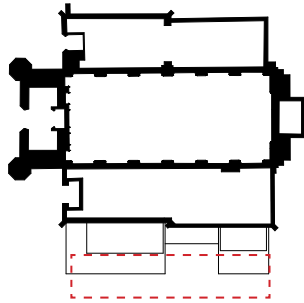
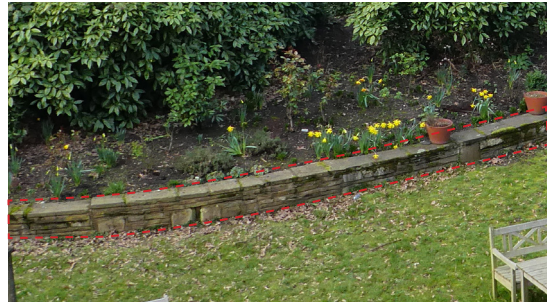
09 South Garden - Low garden stone retaining wall

Dated: Exact date unknown
Size: approx. 45m in length

Condition: Appears in relatively good condition with a natural patina and weathering.

Reuse/Salvage Strategy: For Reuse

External low brick wall to be carefully disassembled where required and reconstructed to new configuration, as per C.F. Møller's landscape plans.

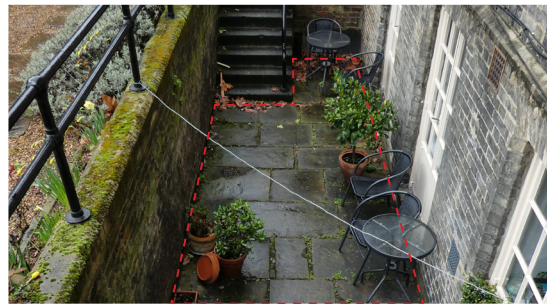
10 Vicarage Lightwells - Flagstone paving

Dated: Exact date unknown
Size: approx. 20m²

Condition: In relatively good condition with natural weathering.

Reuse/Salvage Strategy: For Reuse

Existing paving stones recalimed for reuse in North Garden lightwell.

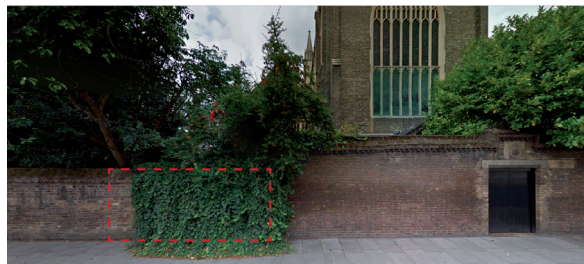
11 Temporary removal of 4m brickwork garden wall

Dated: 1826 presumed

Quantity: 4m section as indicated

Condition: In good condition with natural patina. Some chipping and damage over the years, largely due to leaning cherry tree and exposure to pavement/street.

- a. Remove the vegetation within the area indicated on the drawing.
- b. Photograph the relevant section of the wall, from both sides, both in one section (from approx. 2m) and in several sections (from approx. 1m) to ensure that any detail is captured for later reference.

- c. Carefully mark with chalk the extent of brick removal proposed, extending to existing mortar lines as shown.
- d. Carefully remove by hand the bricks within the indicated area, cleaning each brick individually before storing as described below.

- e. Retain labelled samples of mortar for later analysis if required to achieve a good match.
- f. Protect the standing toothed jambs of the opening in a manner guaranteed to reasonably resist the impact of light construction vehicles and plant. It is suggested that this would be best achieved by the location of steel gate posts, bedded securely in concrete, and located within the opening width.

- g. The toothed jambs should also be protected from the weather by being carefully wrapped in heavy gauge polythene secured into the brick joints by screw fixed treated timber battens.

- a. Stack the removed bricks on pallets on site, as close as conveniently possible to the wall, within the constraints imposed by the construction project.
- b. Protect the removed bricks from rain by wrapping carefully in heavy gauge polythene sheet, secured to be wind resistant for the duration of the project.

- a. At the conclusion of the works, ensure (in discussion with the Structural Engineer) that the wall's foundations are sound and capable of supporting the rebuilt section of wall without settlement or other movement.

- b. Rebuild a section of wall (say 1m²) in mortar to match that existing (analysed if necessary) for approval by the architect before the remainder of the wall's construction proceeds. The colour and texture of the mortar, as well as the precise profile of the joints will be critical at this stage.

- c. Once the sample has been approved, complete the reconstruction of the wall in accordance with the photographs and following any and all details previously present, including the size and profile of the mortar joints, the two course overhang, the canted course and the brick on edge capping.

- d. All new brickwork is to be built with the salvaged bricks as far as possible. Any damaged bricks are to be replaced with used bricks from elsewhere, of a similar appearance and identical size, approved by the architect before being laid and placed on the inside (W face) of the wall where they will be less visible.

- e. All rebuilt bricks are to be toothed into the remaining brickwork, brushed down and left as close as possible to the appearance of the wall prior to the commencement of the works.
