EXISTING THIRD FLOOR PLAN
SCALE 1:50

REV	DATE	ISSUED FOR TENDER	DETAILS	JSP	DALP
-	27.03.2019	ISSUED FOR TENDER	DETAILS	JSP	DALP
consulting · engineering · designing LONDON OFFICE 020 8940 7810 EXETER OFFICE 01392 363497 info@structurehaus.com www.structurehaus.com					
1 CHESTER PLACE REGENTS PARK LONDON NW1 4NB					
REPAIR DETAILS TO THIRD FLOOR					
1:50 @ A1					
DRAWING NUMBER	02962L/05				REVISION
Drawn by	JSP	Checked by	DALP	Date	28.02.2019
Date	26.02.2019	Date	28.02.2019

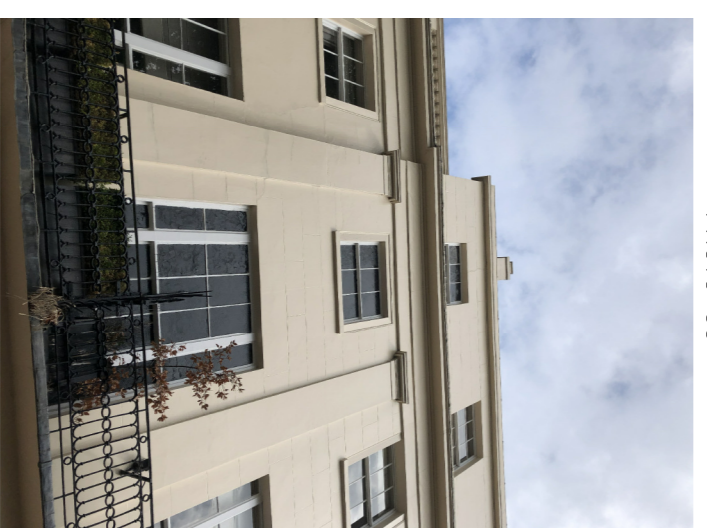
CRACKING OVER WINDOW FRONT ELEVATION REPAIR B
PHOTO 53

REPAIR SCHEDULE	
Repair A	Hack off plaster to full length of crack. Replace any cracked bricks using NHL 3:5 mortar in 1:2½ mix. Install hallow every third course of brick in accordance with manufacturers details and instructions. Make good plaster and finishes for completion.
Repair B	Repair as schedule A but with external stucco/render. Make good stucco/render and decorate on completion.
Repair C	Install helifix bowties and bowtie HD's to floor, including noggin, fully in accordance with manufacturers instructions at approx 1200mm centres.
Repair D	Form heliobeam bar bonds from 4 no. bars in 5mm stainless steel at 225mm vertical centres fully in accordance with manufacturers instructions of each floor plate.
Repair E	Strip back plaster and finishes. Fix existing timber stud back to flank wall with resin bolts – see details.
Repair F	Hack off plaster for brickwork inspection. Allow for partial rebuild/making good of masonry and possible additional hallow to two faces as per repair A

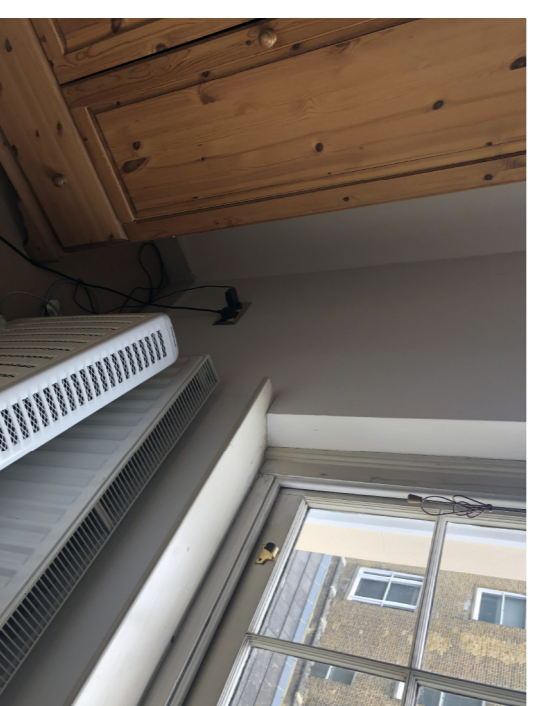
SLIGHT CRACKING ABOVE AND BELOW WINDOW REPAIR A
PHOTO 52
