FOR TENDER

ELEVATION 4-4

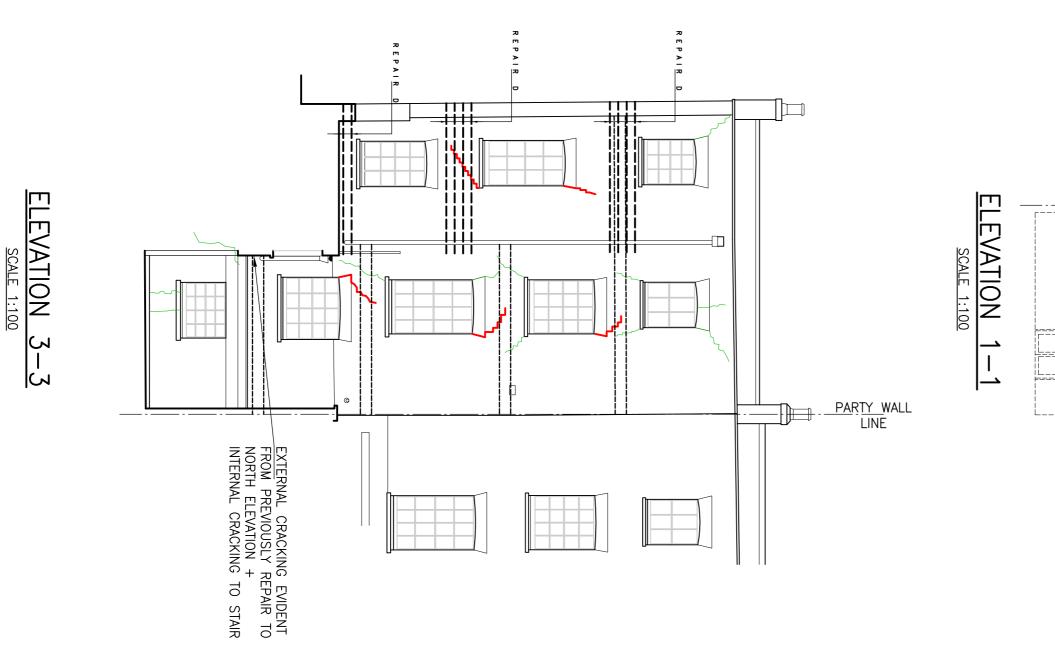
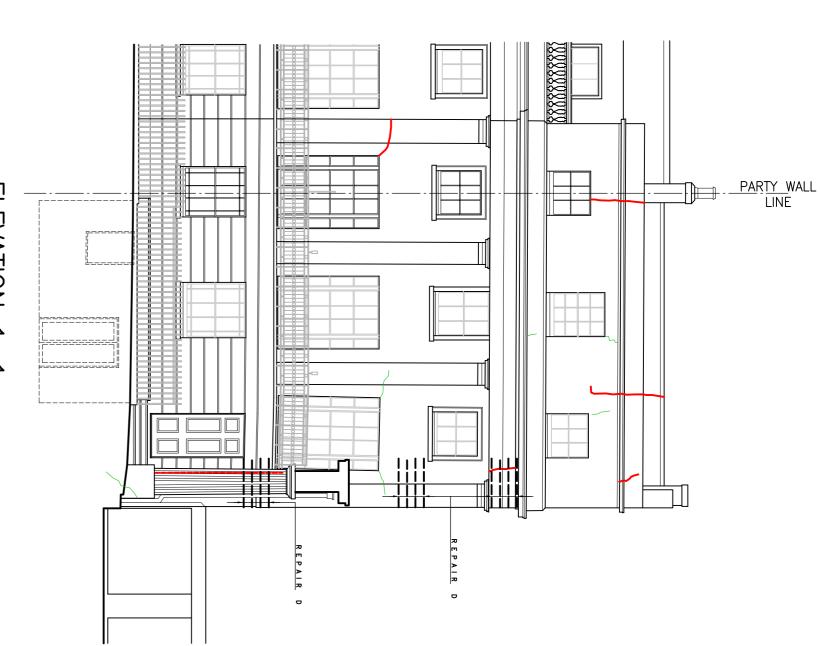
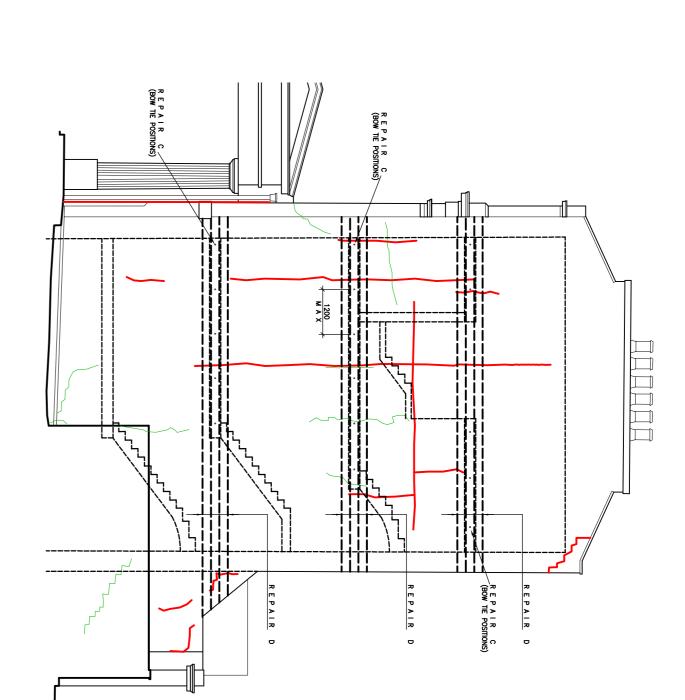
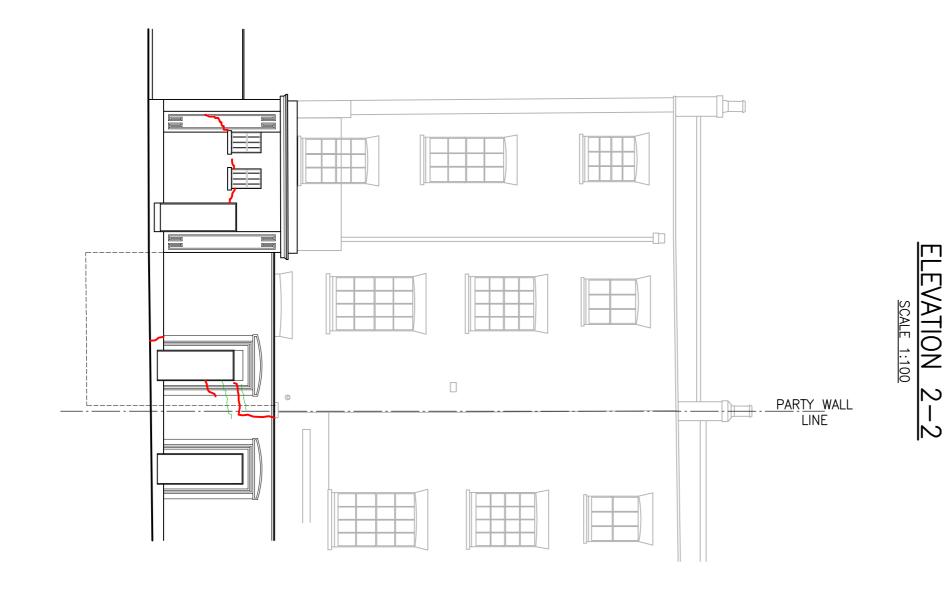
EVIDENCE OF EXTERNAL CRACKING

EVIDENCE OF INTERNAL CRACKING

Repair A
Hack off plaster to full length of crack. Replace any cracked bricks using NHL 3.5 mortar in 1:2½ mix. Install helibar every third course of brick in accordance with manufacturers details and instructions. Make good plaster and finishes for completion.

Repair B
Repair as schedule A but with external stucco/render. Make good stucco/render and decorate on completion.

Repair C
Install helifix bowties and bowtie HD's to floor, including noggins, fully in accordance with manufacturers instructions at approx 1200mm centres.

Repair D
Form helibeam bar bands from 4 no. bars in 5mm stainless steel at 225mm vertical centres fully in accordance with manufacturers instructions at each floor plate.

Repair E
Strip back plaster and finishes. Fix existing timber stud back to flank wall with resin bolts — see details.

Repair F
Hack off plaster fro brickwork inspection. Allow for partial rebuild/making good of masonry and possible additional helibar to two faces as per repair A
