## Tree Inspection Report

22 Churchill Road, London NW5 1AN

13<sup>th</sup> March 2019

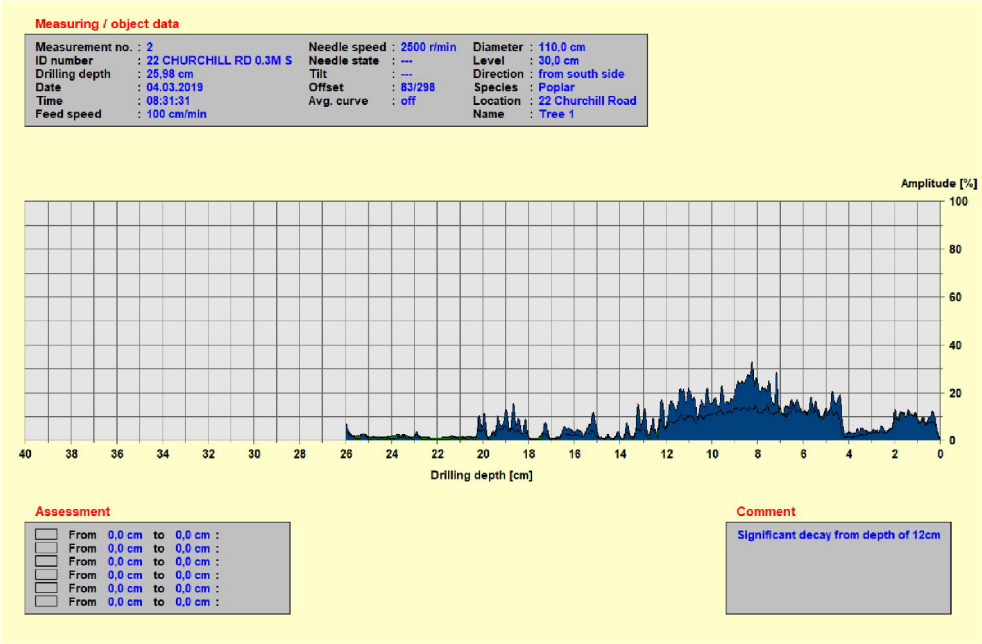
Figure 2. PD resi test. Tree 1. 0.3m above ground level on south side

- 3.2.3 Previous drill tests undertaken from the south, west and east sides indicated that the stem had a residual wall of sound wood with thicknesses of around 22-23cm at a height of 1 metre. During the most recent site visit, drill tests from 22 Churchill Road indicated wall thicknesses of around 12cm from the south side and 26cm from the west side (see Figures 2&3).

- The apparent reduction in sound wall thickness on the southern side - previously this was noted at around 22cm; however the most recent drill test indicates it to be 12cm.

- 4.3 From these observations it appears that the stem has deteriorated in quality within a relatively short time scale. The tree has a very wide stem, particularly below the pollard point with weight imbalance caused by its lean, and I consider that failure is now foreseeable. Given the nature of the tree species and the fungus involved I consider it entirely likely that deterioration in wood quality will continue, resulting in an ever-increasing hazard of tree failure.
- 4.4 I do not consider that realistic pruning options remain, and I recommend that the tree is removed within the next three months.

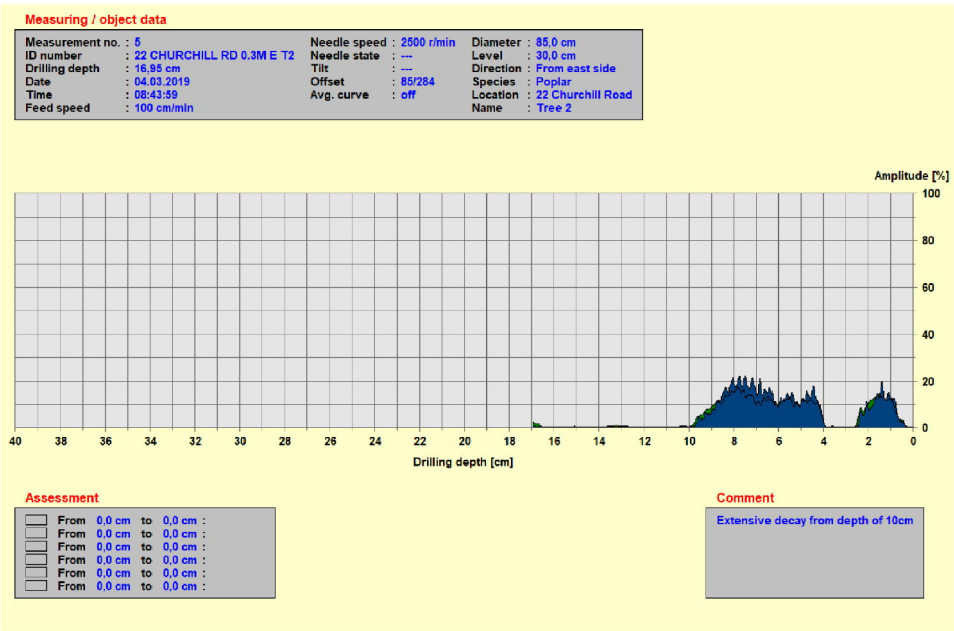
Figure 4. PD resi test. Tree 2. 0.3m above ground level on east side

- 5.2.1 The tree has a single, upright, ivy-covered stem to a height of 7 metres. The view of the tree's top is obscured by ivy; however it is apparent that it has been subjected to the same management as Tree 1, and it is likely that there are large decaying wounds where the primary scaffold branches were severed in the past. The tree has re-grown from past pollarding undertaken since the previous inspection with 1-2 seasons' re-growth.
- 5.2.2 Use of a sounding mallet implied the presence of decay on the east side. I undertook drill tests in three locations where the tree could be accessed on the north, east and south sides (see Figures 4-6)

- 6.1 It is apparent that the tree has significant decay on its eastern side; however from the north and south sides it has sound wall thickness of 36 - 37cm which I consider provides good support, particularly given the tree's small size and upright form.
- 6.2 It is possible that with time the tree's condition might deteriorate to a point where the stem becomes unstable; however this is unlikely to occur for several years at least and I consider that the tree can reasonably be retained on the basis that it is re-pollarded every two to three years.

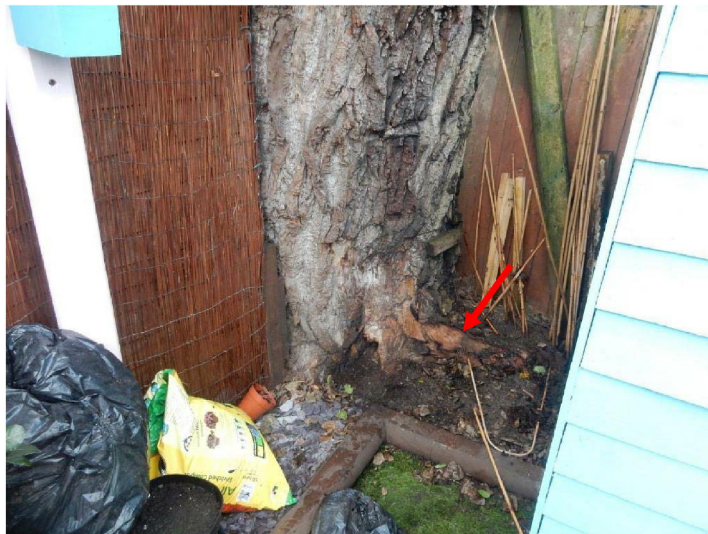
Photograph 2

- 3.2.4 During my previous inspection I noted that the tree's base was extensively decayed on the north-east side as viewed from the garden of 24 Spencer Rise. During the most recent site visit I observed that this had deteriorated further, with a surface root now dead and decayed. I undertook a drill test on this side of the tree which indicated that the sound wood around the outside of the stem has a thickness of 13cm (see Figure 1).

Tree 1. View of base  
from 24 Spencer Rise.  
Arrow points to dead and  
decaying surface root
