Tree Inspection Report

22 Churchill Road, London NW5 1AN

13th March 2019

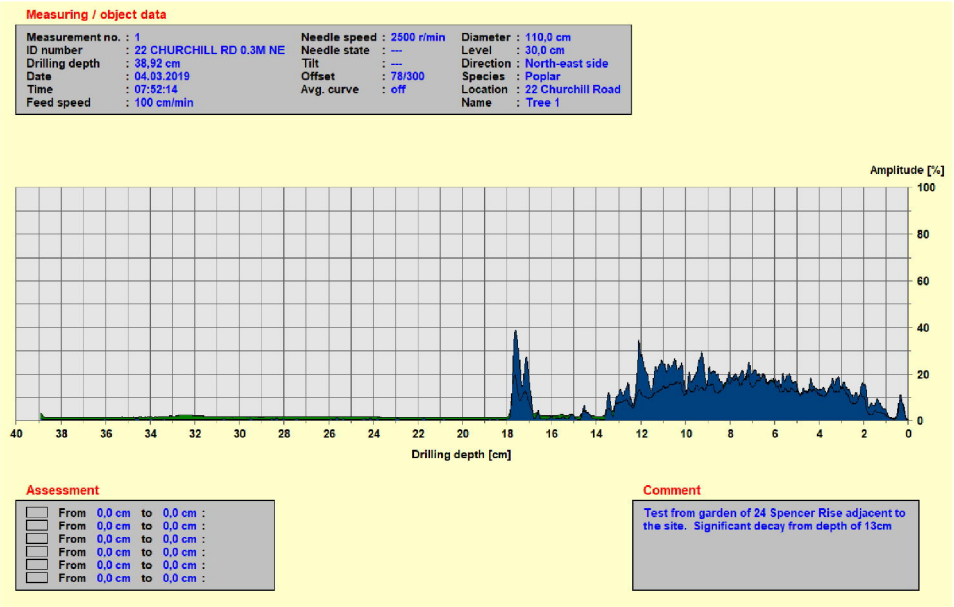
Figure 1. PD resi test. Tree 1. 0.3m above ground level on north-east side (from 24 Spencer Rise)

- 3.2.4 During my previous inspection I noted that the tree's base was extensively decayed on the north-east side as viewed from the garden of 24 Spencer Rise. During the most recent site visit I observed that this had deteriorated further, with a surface root now dead and decayed. I undertook a drill test on this side of the tree which indicated that the sound wood around the outside of the stem has a thickness of 13cm (see Figure 1).

- The death and decay of a surface root on the north-east side in the garden of the property adjacent.

- 4.3 From these observations it appears that the stem has deteriorated in quality within a relatively short time scale. The tree has a very wide stem, particularly below the pollard point with weight imbalance caused by its lean, and I consider that failure is now foreseeable. Given the nature of the tree species and the fungus involved I consider it entirely likely that deterioration in wood quality will continue, resulting in an ever-increasing hazard of tree failure.
- 4.4 I do not consider that realistic pruning options remain, and I recommend that the tree is removed within the next three months.

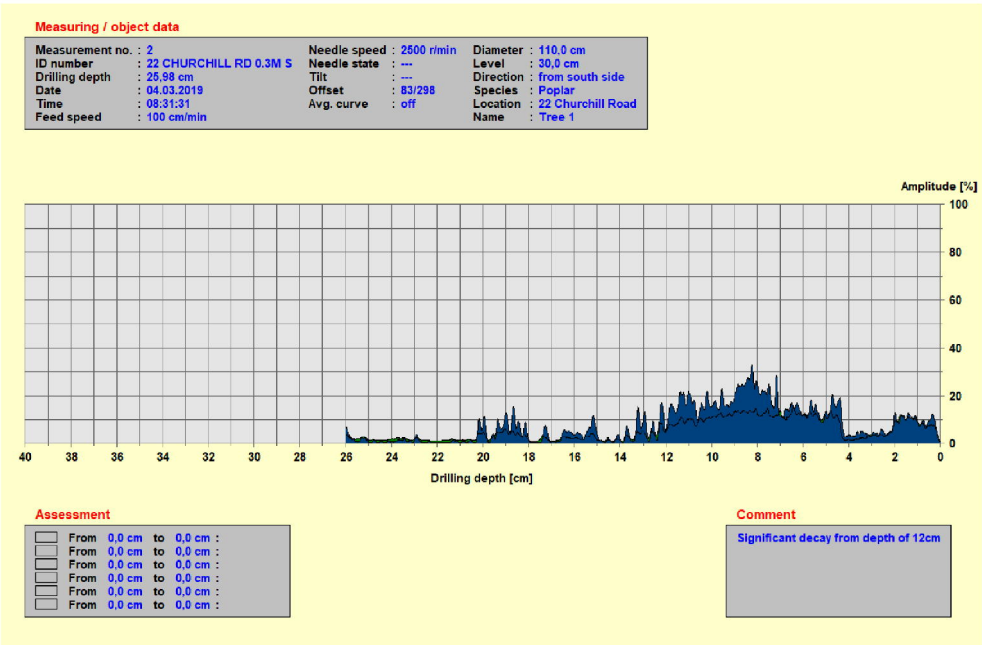
Figure 2. PD resi test. Tree 1. 0.3m above ground level on south side

- 3.2.3 Previous drill tests undertaken from the south, west and east sides indicated that the stem had a residual wall of sound wood with thicknesses of around 22-23cm at a height of 1 metre. During the most recent site visit, drill tests from 22 Churchill Road indicated wall thicknesses of around 12cm from the south side and 26cm from the west side (see Figures 2&3).

- The apparent reduction in sound wall thickness on the southern side - previously this was noted at around 22cm; however the most recent drill test indicates it to be 12cm.

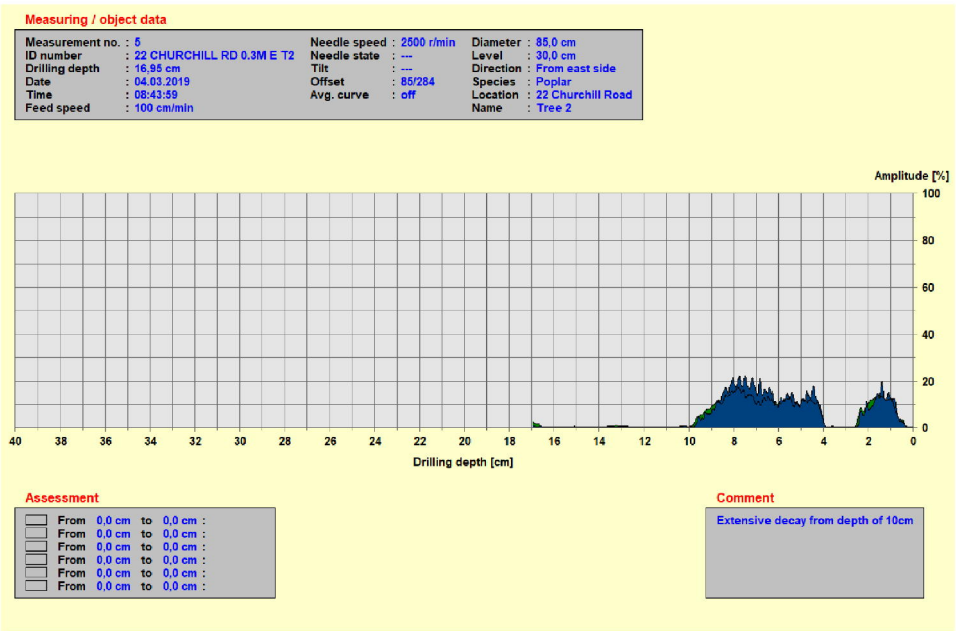
Figure 4. PD resi test. Tree 2. 0.3m above ground level on east side

- 5.2.1 The tree has a single, upright, ivy-covered stem to a height of 7 metres. The view of the tree's top is obscured by ivy; however it is apparent that it has been subjected to the same management as Tree 1, and it is likely that there are large decaying wounds where the primary scaffold branches were severed in the past. The tree has re-grown from past pollarding undertaken since the previous inspection with 1-2 seasons' re-growth.
- 5.2.2 Use of a sounding mallet implied the presence of decay on the east side. I undertook drill tests in three locations where the tree could be accessed on the north, east and south sides (see Figures 4-6)

- 6.1 It is apparent that the tree has significant decay on its eastern side; however from the north and south sides it has sound wall thickness of 36 - 37cm which I consider provides good support, particularly given the tree's small size and upright form.
- 6.2 It is possible that with time the tree's condition might deteriorate to a point where the stem becomes unstable; however this is unlikely to occur for several years at least and I consider that the tree can reasonably be retained on the basis that it is re-pollarded every two to three years.

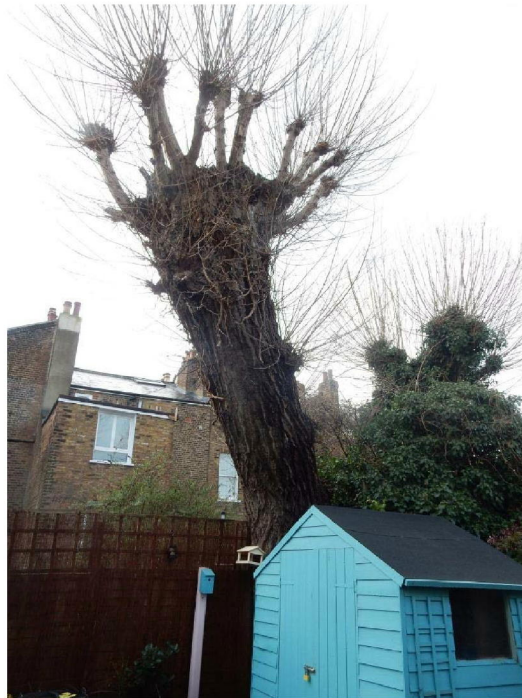
Photograph 1

View of Tree 1 from 24
Spencer Rise

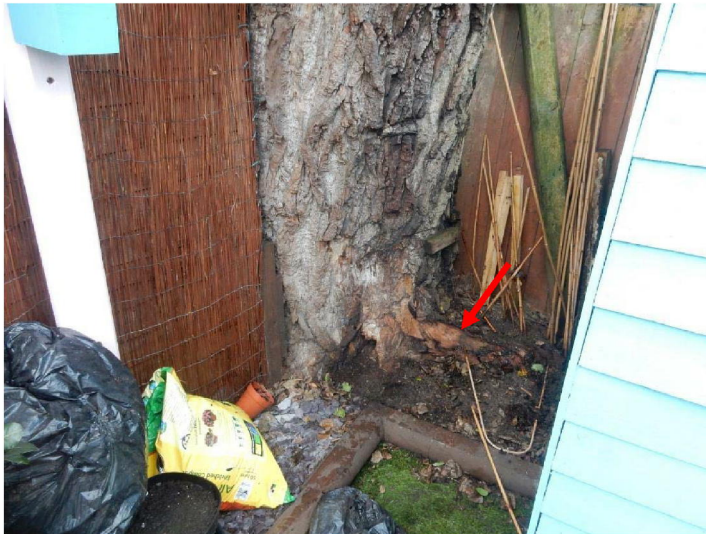
Photograph 2

Tree 1. View of base
from 24 Spencer Rise.
Arrow points to dead and
decaying surface root

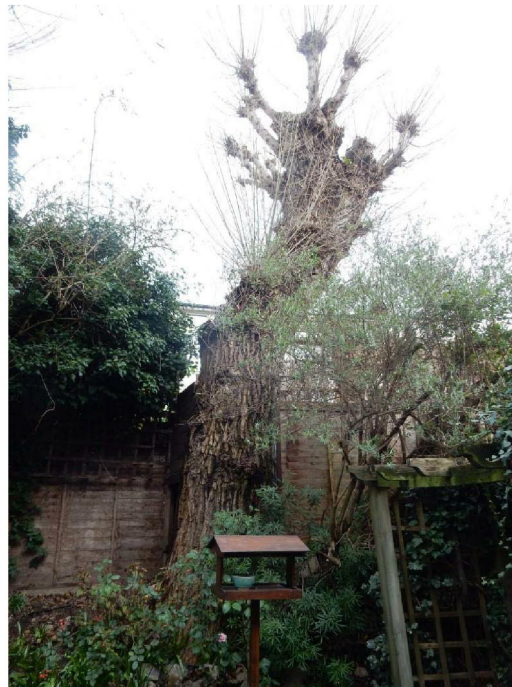
Photograph 3

Tree 1. View
from 22
Churchill Road

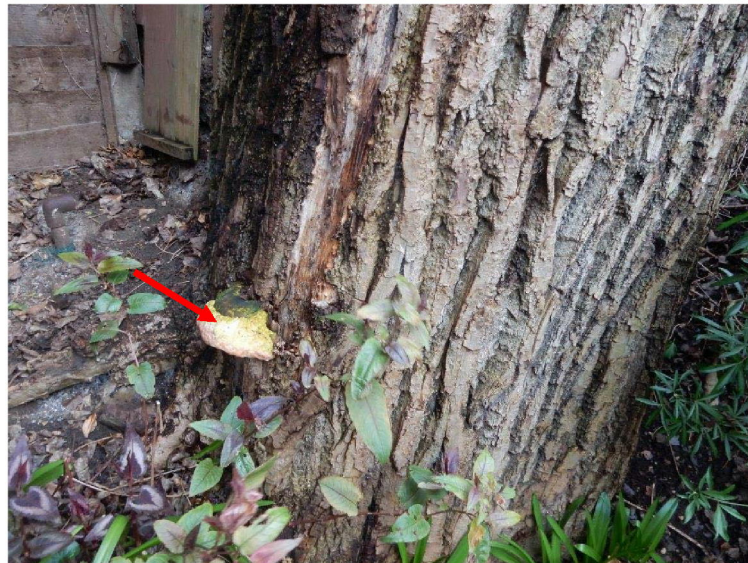
Photograph 4

- 4.2 Since my previous inspection of the tree there are significant changes to its condition, notably:
- The presence of a *Perenniporia fraxinea* fungal fruiting body on the south-western side of the stem. This is a fungus that causes extensive decay and the emergence of a fruiting body on the tension side (the tree leans to the north-east) is a cause for concern.

Tree 1.
Perenniporia
fraxinea fruiting
body on south-
west side

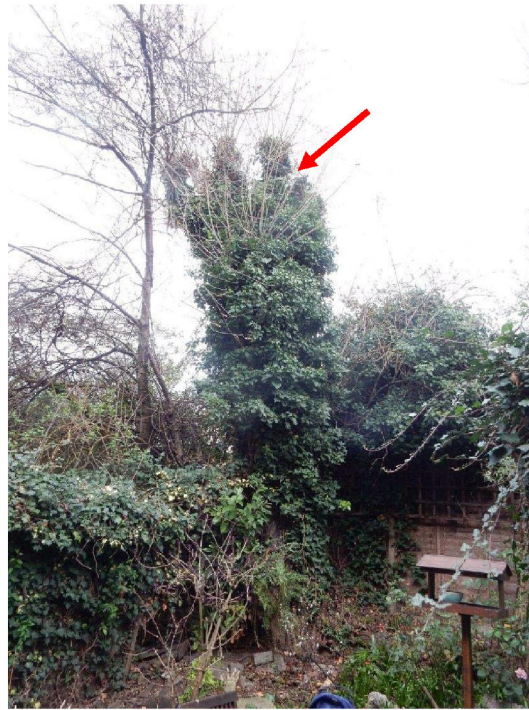
Photograph 5

Tree 2
