Project Description: WinCan Import in Miraculix Standard

Project Date: 07/10/2018

Section Inspection - 28/09/2018 - REAR WWGX

Following your notification, we attended site on the 28th September 2018 to carryout a CCTV survey of the drainage system.

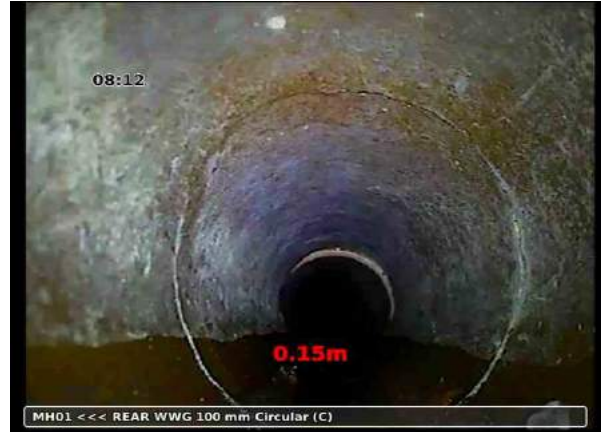
<table><tr> <td style="text-align: right;">0.00</td> <td>MH</td> <td>Start node type, manhole, reference number: MH01</td> <td>00:00:04</td> <td></td> <td></td> <td></td> </tr><tr> <td style="text-align: right;">0.15</td> <td>FC</td> <td>Fracture, circumferential from 12 o'clock to 12 o'clock</td> <td>00:00:22</td> <td></td> <td></td> <td style="text-align: center;">3 / 2</td> </tr></table>

, 00:00:22, 0.15 m
 Fracture, circumferential from 12 o'clock to 12 o'clock

Town or Village: Road: Location: Surface Type:	London 9 Nassington Road	Inspection Direction: Inspected Length: Total Length: Joint Length:	Upstream 7.18 m 7.18 m 0.00 m	Upstream Node: Upstream Pipe Depth: Downstream Node: Downstream Pipe Depth:	REAR WWG 0.000 m MH01 550.000 m
Use: Type of Pipe: Year Constructed: Flow Control: Inspection Purpose:	Combined Gravity drain/sewer 1900 No flow control Sample survey to determine asset condition of a sewer system	Pipe Shape: Dia/Height: Pipe Material: Lining Type:	Circular 100 mm Vitrified clay pipe Lining Material:		
Comments: Recommendations:	Damage identified in pipe which requires repair Install 5m of 100mm flexible liner

To install 5m of 100mm flexible liner from MH1 upstream to Rear WWG

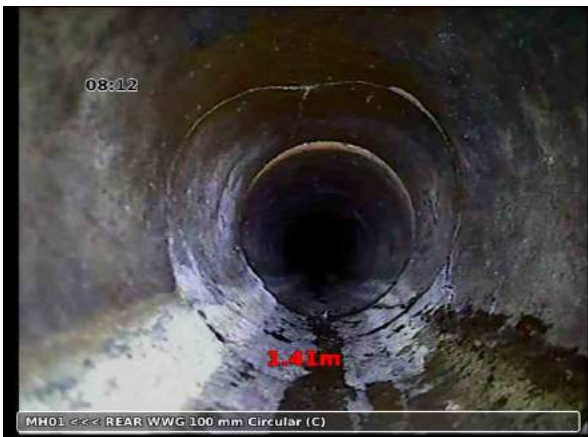
<table><tr> <td style="text-align: right;">0.00</td> <td>MH</td> <td>Start node type, manhole, reference number: MH01</td> <td>00:00:04</td> <td></td> <td></td> <td></td> </tr><tr> <td style="text-align: right;">1.41</td> <td>FC</td> <td>Fracture, circumferential from 12 o'clock to 12 o'clock</td> <td>00:00:33</td> <td></td> <td></td> <td style="text-align: center;">3 / 2</td> </tr></table>

, 00:00:33, 1.41 m
 Fracture, circumferential from 12 o'clock to 12 o'clock

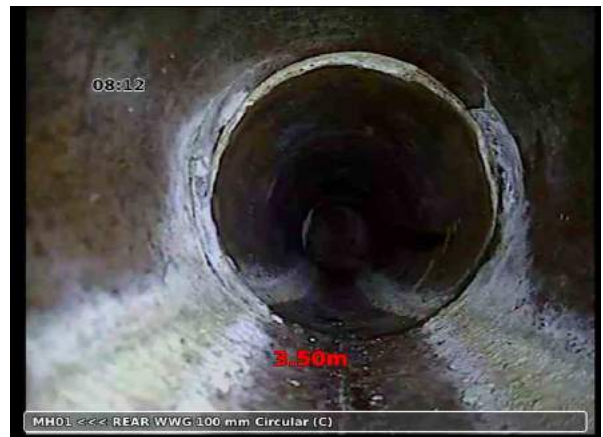
<table><tr> <td style="text-align: right;">0.00</td> <td>MH</td> <td>Start node type, manhole, reference number: MH01</td> <td>00:00:04</td> <td></td> <td></td> <td></td> </tr><tr> <td style="text-align: right;">3.50</td> <td>CC</td> <td>Crack, circumferential from 7 o'clock to 11 o'clock</td> <td>00:00:49</td> <td></td> <td></td> <td style="text-align: center;">2 / 2</td> </tr></table>

, 00:00:49, 3.50 m
 Crack, circumferential from 7 o'clock to 11 o'clock

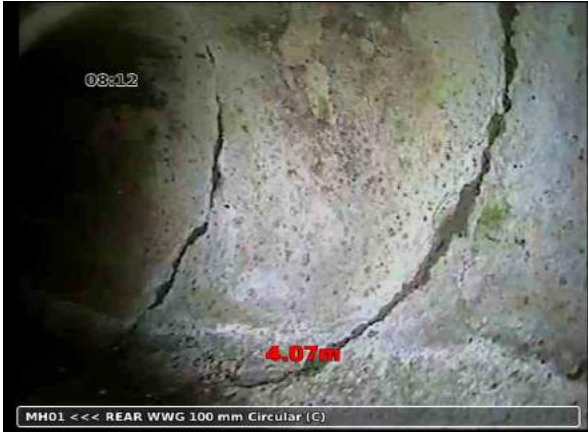
<table><tr> <td style="text-align: right;">0.00</td> <td>MH</td> <td>Start node type, manhole, reference number: MH01</td> <td>00:00:04</td> <td></td> <td></td> <td></td> </tr><tr> <td style="text-align: right;">4.07</td> <td>FC</td> <td>Fracture, circumferential from 1 o'clock to 5 o'clock</td> <td>00:00:55</td> <td></td> <td></td> <td style="text-align: center;">3 / 2</td> </tr></table>

, 00:00:55, 4.07 m
 Fracture, circumferential from 1 o'clock to 5 o'clock

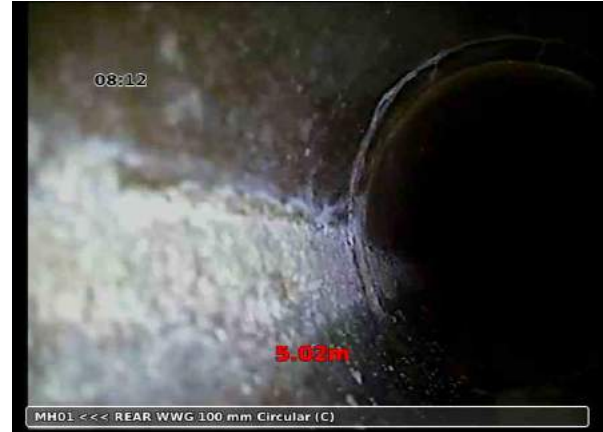
<table><tr> <td style="text-align: right;">0.00</td> <td>MH</td> <td>Start node type, manhole, reference number: MH01</td> <td>00:00:04</td> <td></td> <td></td> <td></td> </tr><tr> <td style="text-align: right;">5.02</td> <td>FC</td> <td>Fracture, circumferential from 8 o'clock to 2 o'clock</td> <td>00:01:00</td> <td></td> <td></td> <td style="text-align: center;">3 / 2</td> </tr></table>

, 00:01:00, 5.02 m
 Fracture, circumferential from 8 o'clock to 2 o'clock

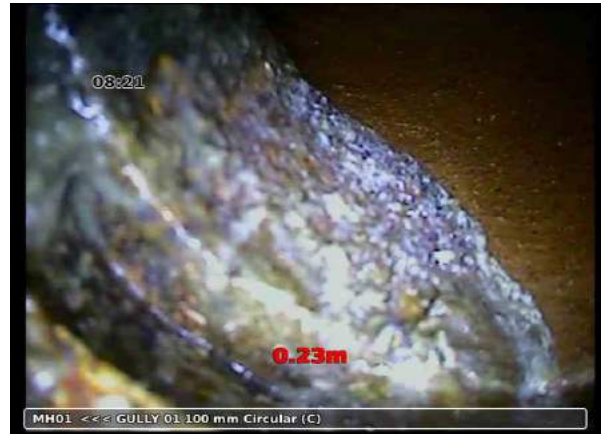
<table><tr> <td style="text-align: right;">0.00</td> <td style="text-align: left;">MH</td> <td style="text-align: left;">Start node type, manhole</td> <td style="text-align: right;">00:00:03</td> <td></td> <td></td> </tr><tr> <td style="text-align: right;">0.22</td> <td style="text-align: left;">OJM</td> <td style="text-align: left;">Open joint, medium</td> <td style="text-align: right;">00:00:27</td> <td></td> <td style="text-align: right;">1</td> </tr><tr> <td style="text-align: right;">0.22</td> <td style="text-align: left;">JDM</td> <td style="text-align: left;">Joint displaced, medium</td> <td style="text-align: right;">00:00:27</td> <td></td> <td style="text-align: right;">1 / 3</td> </tr></table>

, 00:00:27, 0.22 m
 Open joint, medium

Town or Village: London	Inspection Direction: Upstream	Upstream Node: GULLY 01
Road: 9 Nassington Road	Inspected Length: 0.23 m	Upstream Pipe Depth: 0.000 m
Location:	Total Length: 0.23 m	Downstream Node: MH01
Surface Type:	Joint Length: 0.00 m	Downstream Pipe Depth: 550.000 m
Use: Combined	Pipe Shape: Circular	
Type of Pipe: Gravity drain/sewer	Dia/Height: 100 mm	
Year Constructed: 1900	Pipe Material: Vitrified clay pipe	
Flow Control: No flow control	Lining Type:	
Inspection Purpose: Sample survey to determine asset condition of a sewer system	Lining Material:	
Comments: Open and displaced joint identified which requires repair		
Recommendations: To install a 100mm flexible resin patch liner

To install a 100mm flexible patch liner from MH1 upstream to Gully1

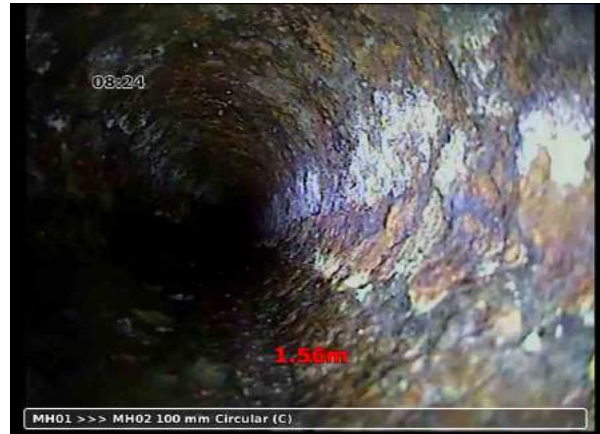
<table><tr> <td style="text-align: right;">0.04</td> <td style="text-align: center;">MH</td> <td>Start node type, manhole, reference number: MH01</td> <td style="text-align: right;">00:00:18</td> <td></td> <td></td> <td></td> </tr><tr> <td style="text-align: right;">1.60</td> <td style="text-align: center;">DES</td> <td>Settled deposits, fine, 10% cross-sectional area loss</td> <td style="text-align: right;">00:00:39</td> <td></td> <td></td> <td style="text-align: center;">3</td> </tr></table>

, 00:00:39, 1.60 m
Settled deposits, fine, 10% cross-sectional area loss

Town or Village:	London	Inspection Direction:	Downstream	Upstream Node:	MH01
Road:	9 Nassington Road	Inspected Length:	2.89 m	Upstream Pipe Depth:	550.000 m
Location:		Total Length:	2.93 m	Downstream Node:	MH02
Surface Type:		Joint Length:	0.00 m	Downstream Pipe Depth:	1,950.000 m
Use:	Combined	Pipe Shape:	Circular		
Type of Pipe:	Gravity drain/sewer	Dia/Height:	100 mm		
Year Constructed:	1900	Pipe Material:	Cast iron		
Flow Control:	No flow control	Lining Type:			
Inspection Purpose:	Sample survey to determine asset condition of a sewer system		Lining Material:		
Comments:	Slight build up of debris				
Recommendations:	By use of specialist cutting machinery, remove settled and hardened deposits to restore full flow

To remove debris with specialist machinery from MH1 downstream to MH2

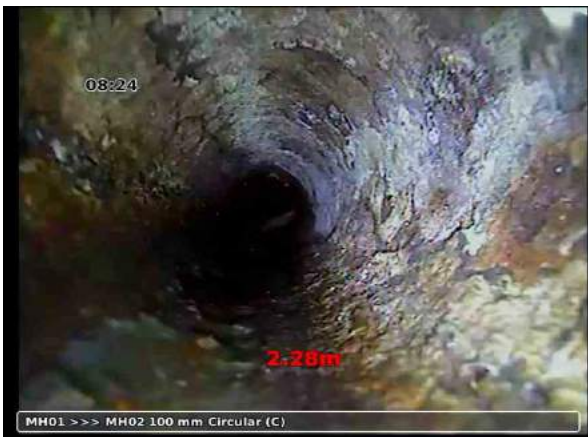
<table><tr> <td style="text-align: right;">0.04</td> <td style="text-align: center;">MH</td> <td>Start node type, manhole, reference number: MH01</td> <td style="text-align: right;">00:00:18</td> <td></td> <td></td> <td></td> </tr><tr> <td style="text-align: right;">2.28</td> <td style="text-align: center;">DES</td> <td>Settled deposits, fine, 5% cross-sectional area loss</td> <td style="text-align: right;">00:00:45</td> <td></td> <td></td> <td style="text-align: center;">3</td> </tr></table>

, 00:00:45, 2.28 m
Settled deposits, fine, 5% cross-sectional area loss

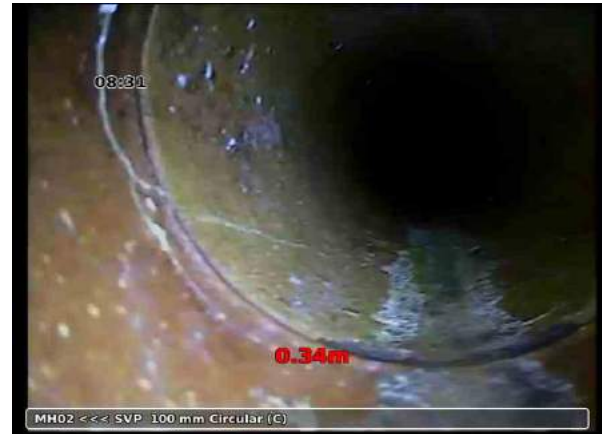
, 00:00:25, 0.34 m
Crack, circumferential from 7 o'clock to 11 o'clock

Town or Village:	London	Inspection Direction:	Upstream	Upstream Node:	SVP
Road:	9 Nassington Road	Inspected Length:	1.75 m	Upstream Pipe Depth:	0.000 m
Location:		Total Length:	1.75 m	Downstream Node:	MH02
Surface Type:		Joint Length:	0.00 m	Downstream Pipe Depth:	1,950.000 m
Use:	Combined	Pipe Shape:	Circular	Dia/Height:	100 mm
Type of Pipe:	Gravity drain/sewer	Pipe Material:	Vitrified clay pipe	Lining Type:	
Year Constructed:	1900	Lining Material:			
Flow Control:	No flow control				
Inspection Purpose:	Sample survey to determine asset condition of a sewer system				
Comments:	Crack identified but currently deemed as serviceable				
Recommendations:	Carryout CCTV survey in 12 to 18 months time to assess pipe condition

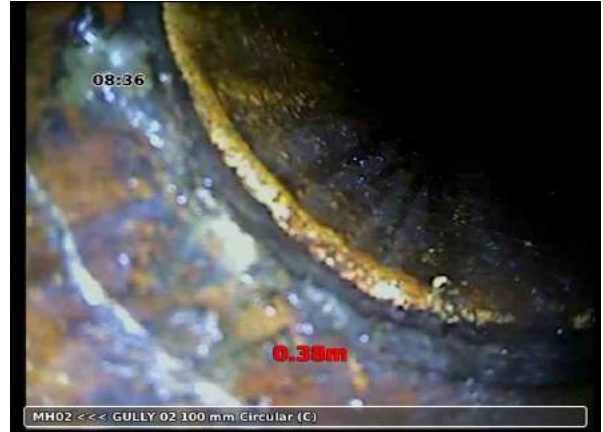
, 00:00:17, 0.38 m
 Fracture, circumferential from 6 o'clock to 8 o'clock

Town or Village:	London	Inspection Direction:	Upstream	Upstream Node:	GULLY 02
Road:	9 Nassington Road	Inspected Length:	0.34 m	Upstream Pipe Depth:	0.000 m
Location:		Total Length:	0.49 m	Downstream Node:	MH02
Surface Type:		Joint Length:	0.00 m	Downstream Pipe Depth:	1,950.000 m
Use:	Combined	Pipe Shape:	Circular		
Type of Pipe:	Gravity drain/sewer	Dia/Height:	100 mm		
Year Constructed:	1900	Pipe Material:	Vitrified clay pipe		
Flow Control:	No flow control	Lining Type:			
Inspection Purpose:	Sample survey to determine asset condition of a sewer system		Lining Material:		
Comments:	Survey abandoned as camera unable to push round bend. Fracture identified				
Recommendations:	To break into gully and complete survey and install a 100mm flexible patch liner

To break into Gully2 and complete survey downstream to MH2. We also recommend to install a 100mm flexible patch liner from MH2 upstream to Gully02

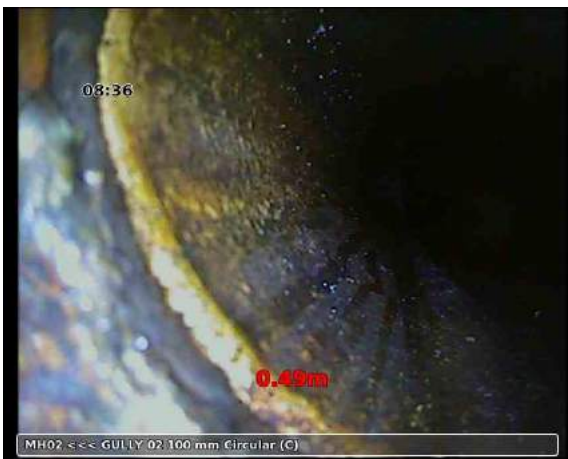
, 00:00:29, 0.49 m
 Survey abandoned, UNABLE TO PUSH UP

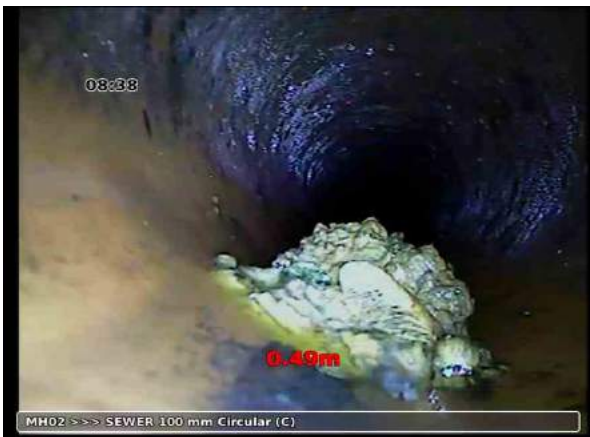
<table><tr> <td style="width: 15%; text-align: right;">0.00</td> <td style="width: 10%;">MH</td> <td style="width: 40%;">Start node type, manhole, reference number: MH02</td> <td style="width: 10%;">00:00:06</td> <td></td> <td></td> <td></td> </tr><tr> <td style="text-align: right;">0.49</td> <td>DER</td> <td>Settled deposits, coarse, 15% cross-sectional area loss</td> <td>00:00:18</td> <td></td> <td></td> <td style="text-align: center;">3</td> </tr></table>

, 00:00:18, 0.49 m
Settled deposits, coarse, 15% cross-sectional area loss

Town or Village:	London	Inspection Direction:	Downstream	Upstream Node:	MH02
Road:	9 Nassington Road	Inspected Length:	11.74 m	Upstream Pipe Depth:	1,950.000 m
Location:		Total Length:	11.74 m	Downstream Node:	SEWER
Surface Type:		Joint Length:	0.00 m	Downstream Pipe Depth:	0.000 m
Use:	Combined	Pipe Shape:	Circular		
Type of Pipe:	Gravity drain/sewer	Dia/Height:	100 mm		
Year Constructed:	1900	Pipe Material:	Vitrified clay pipe		
Flow Control:	No flow control	Lining Type:			
Inspection Purpose:	Sample survey to determine asset condition of a sewer system		Lining Material:		
Comments:	Root ingress identified and damage noted off the property boundary which is Thames Water asset				
Recommendations:	Root cut and install 100mm liner to short of boundary

To carry out high pressure water jetting with specialist root cutting equipment and line from MH2 downstream to short of boundary.

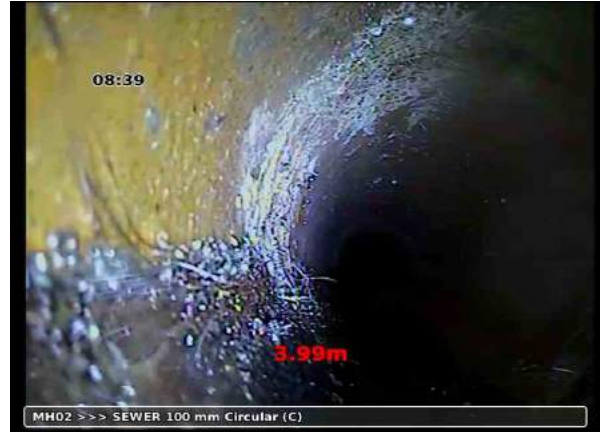
<table><tr> <td style="width: 15%; text-align: right;">0.00</td> <td style="width: 10%;">MH</td> <td style="width: 40%;">Start node type, manhole, reference number: MH02</td> <td style="width: 10%;">00:00:06</td> <td></td> <td></td> <td></td> </tr><tr> <td style="text-align: right;">3.99</td> <td>RMJ</td> <td>Roots, mass at joint, 5% cross-sectional area loss</td> <td>00:00:58</td> <td></td> <td></td> <td style="text-align: center;">3</td> </tr></table>

, 00:00:58, 3.99 m
Roots, mass at joint, 5% cross-sectional area loss

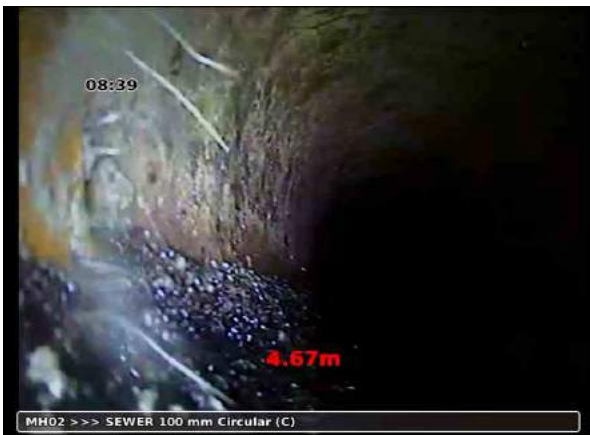
<table><tr> <td style="width: 15%; text-align: right;">0.00</td> <td style="width: 10%;">MH</td> <td style="width: 40%;">Start node type, manhole, reference number: MH02</td> <td style="width: 10%;">00:00:06</td> <td></td> <td></td> <td></td> </tr><tr> <td style="text-align: right;">4.67</td> <td>RFJ</td> <td>Roots, fine at joint</td> <td>00:01:04</td> <td></td> <td></td> <td style="text-align: center;">2</td> </tr></table>

, 00:01:04, 4.67 m
Roots, fine at joint

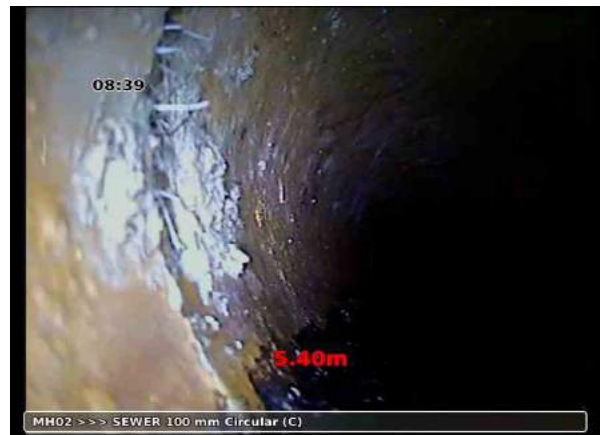
<table><tr> <td style="width: 15%; text-align: right;">0.00</td> <td style="width: 10%;">MH</td> <td style="width: 40%;">Start node type, manhole, reference number: MH02</td> <td style="width: 10%;">00:00:06</td> <td></td> <td></td> <td></td> </tr><tr> <td style="text-align: right;">5.40</td> <td>RFJ</td> <td>Roots, fine at joint</td> <td>00:01:08</td> <td></td> <td></td> <td style="text-align: center;">2</td> </tr></table>

, 00:01:08, 5.40 m
Roots, fine at joint

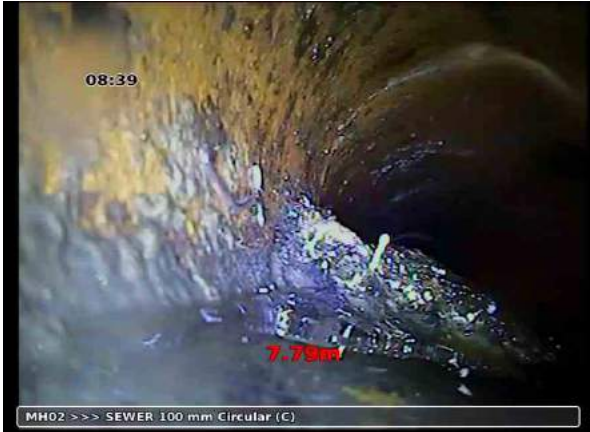
<table><tr> <td style="width: 15%; text-align: right;">0.00</td> <td style="width: 10%;">MH</td> <td style="width: 40%;">Start node type, manhole, reference number: MH02</td> <td style="width: 10%;">00:00:06</td> <td></td> <td></td> <td></td> </tr><tr> <td style="text-align: right;">7.79</td> <td>DEE</td> <td>Attached deposits, encrustation from 5 o'clock to 8 o'clock, 20% cross-sectional area loss</td> <td>00:01:26</td> <td></td> <td></td> <td style="text-align: center;">3</td> </tr></table>

, 00:01:26, 7.79 m
Attached deposits, encrustation from 5 o'clock to 8 o'clock,
20% cross-sectional area loss

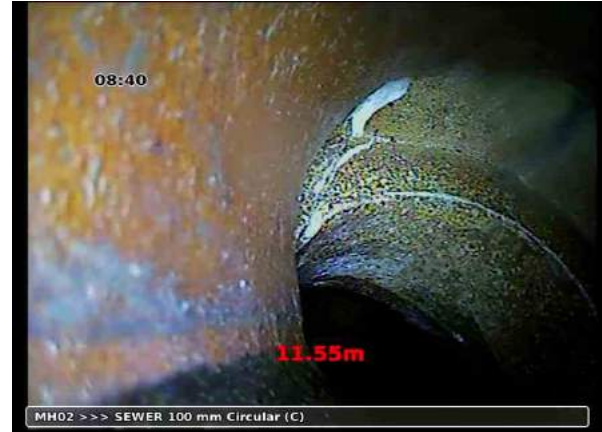
<table><tr> <td style="width: 15%; text-align: right;">0.00</td> <td style="width: 10%;">MH</td> <td style="width: 40%;">Start node type, manhole, reference number: MH02</td> <td style="width: 10%;">00:00:06</td> <td></td> <td></td> <td></td> </tr><tr> <td style="text-align: right;">11.55</td> <td>B</td> <td>Broken pipe from 10 o'clock to 1 o'clock</td> <td>00:01:54</td> <td></td> <td></td> <td style="text-align: center;">4</td> </tr></table>

, 00:01:54, 11.55 m
Broken pipe from 10 o'clock to 1 o'clock
