Project name:
24 Belsize Lane - Pre-Con

Contract number:
040918A

Inspection report

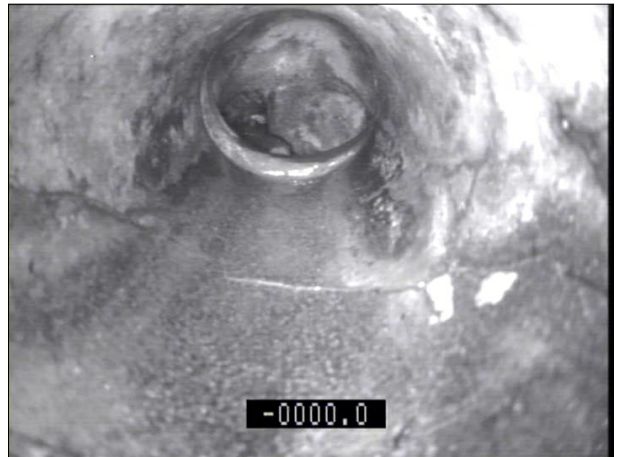
0.00	WL	Water level, 0 % height/diameter	(Serv) 0	
	0.00	CC	Circumferential Crack, from 03 to 08 o'clock	(Struct) 2	
	0.00	LU	Line of Sewer deviates up	(Serv) 0

Photo: 3_3a
0m, Circumferential Crack, from 03 to 08 o'clock

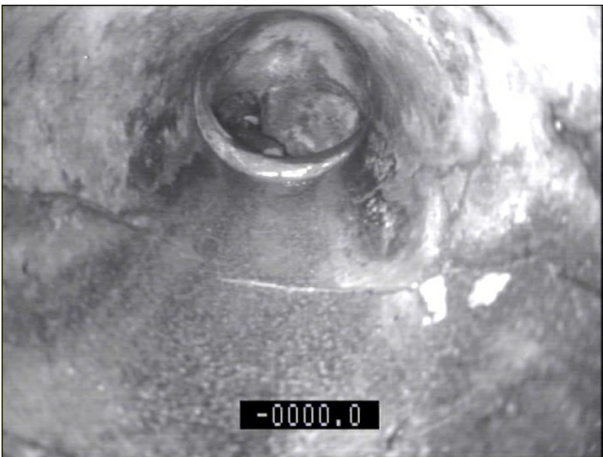
Photo: 4_4a
0m, Line of Sewer deviates up

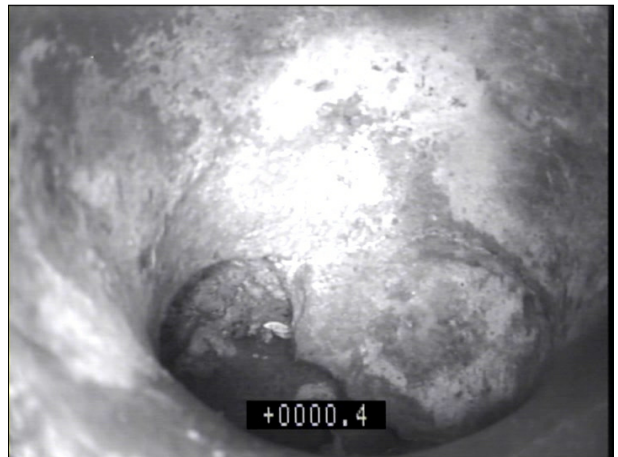
0.40	X	Collapsed Pipe, 95 % cross-sectional area loss	(Struct) 5	
	0.40	SA	Survey abandoned	(Misc) 0

Photo: 5_5a
0.4m, Collapsed Pipe, 95 % cross-sectional area loss

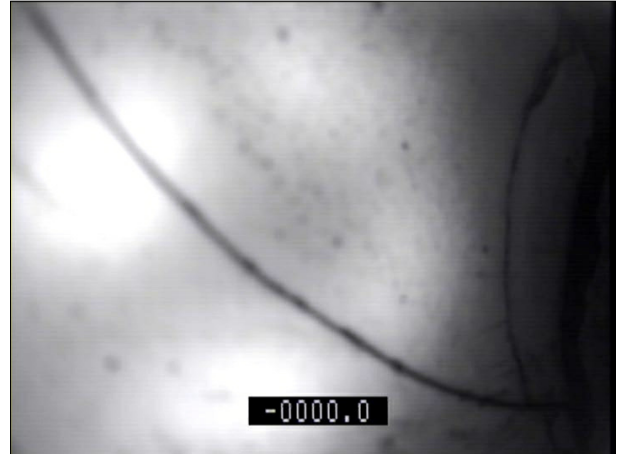
Photo: 9_3a
0m, Line of Sewer deviates right

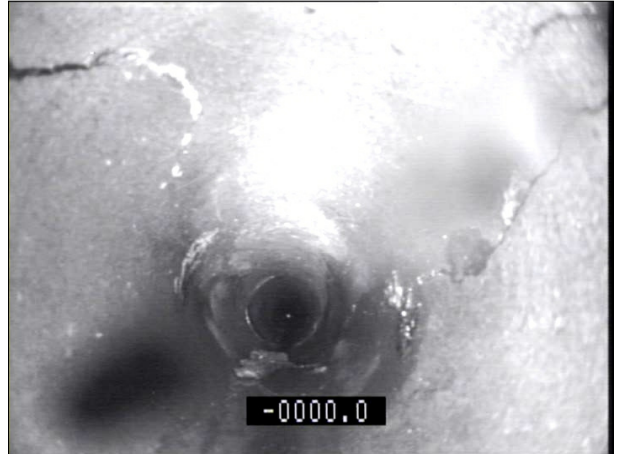
Photo: 14_3a
0m, Longitudinal Fracture at 10 o'clock

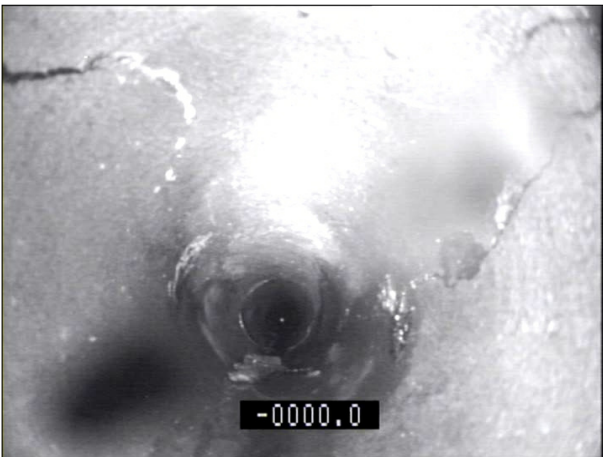
Photo: 15_4a
0m, Longitudinal Fracture at 03 o'clock

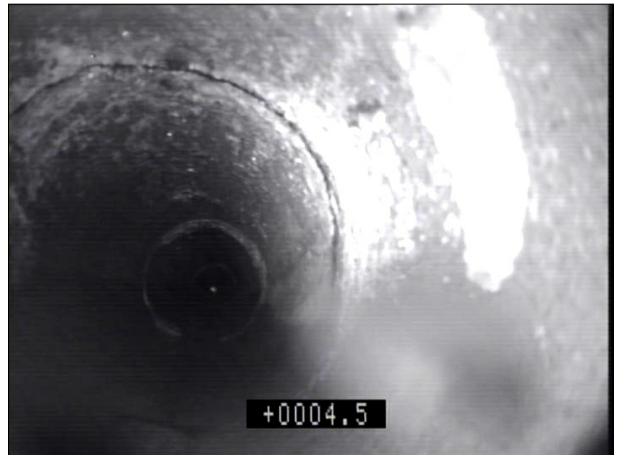
4.50	CC	Circumferential Crack, from 10 to 02 o'clock	(Struct) 2	
	6.70	JDM	Joint displaced. Medium	(Struct) 1

Photo: 18_7a
4.5m, Circumferential Crack, from 10 to 02 o'clock

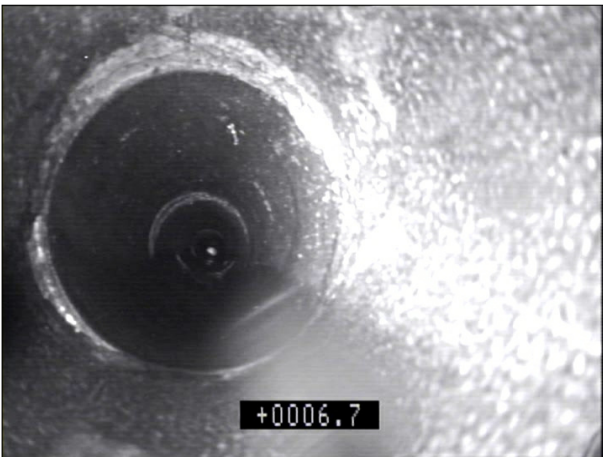
Photo: 19_8a
6.7m, Joint displaced. Medium

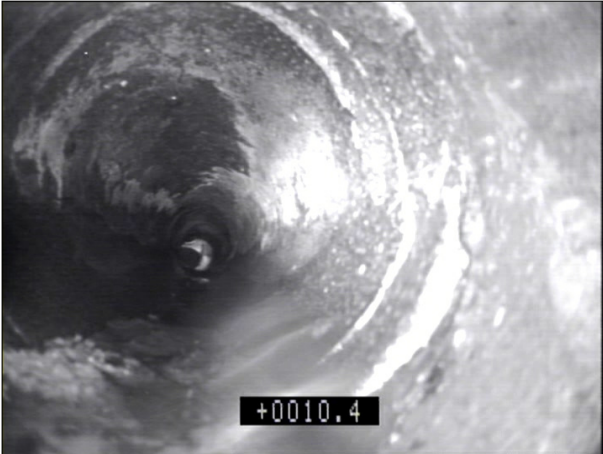
10.40	FC	Circumferential Fracture, from 03 to 09 o'clock	(Struct) 3

Photo: 21_10a
10.4m, Circumferential Fracture, from 03 to 09 o'clock
