> Our ref: 15600/D3 14<sup>th</sup> May 2019

## Re: 1 Ferncroft Avenue - Side Boundary Wall

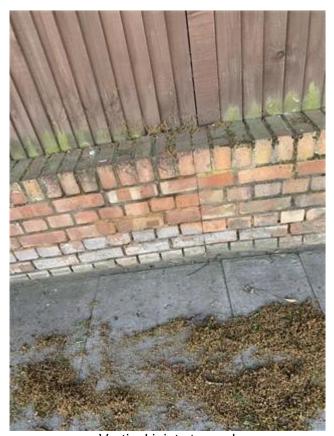
Vertical joint stagged

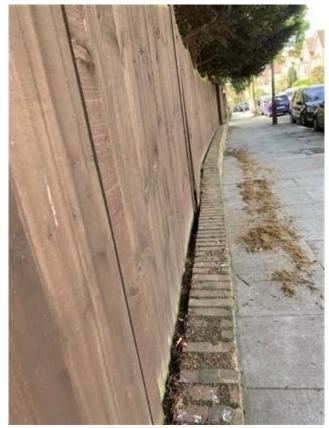
- 2.0 A row of trees run along the boundary brick wall. Along with a large tree that may have a TPO on it. This tree is quite close to the wall.
  - 2.1 The wall was noted to be leaning outward. The deflection increases as we move close to the large tree noted above. This together with vertical shear cracks. We believe that it is not long before the wall could reach critical stage leading to collapse.

Note - movement

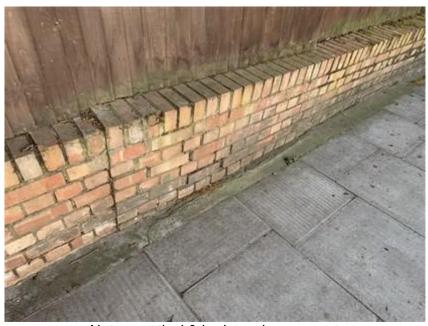
Note – vertical & horiztonal movement

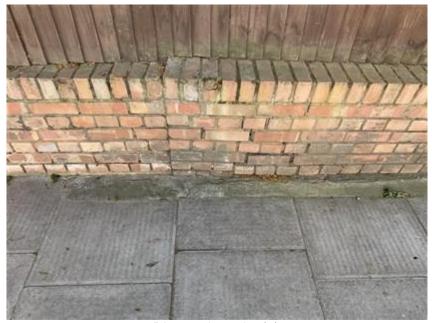
Diagonal cracks (1)

- 3.0 We suggest the following
  - 3.1 Remove the wall and have it rebuilt in line with its surrounding.
    - Remove row of trees.
    - The large tree we understand needs to be kept.

- 3.2 Regards wall's foundations.
  - Traditional strip footing after giving time for soil to come to its natural state. This after the removal of trees.
  - Around the large tree to protect its tree roots. Use steel screw piles with concrete reinforced beam above, below the brick wall on this concrete. Vertical expansion joint will be needed to allow for differential movement.
- 3.3 Wall should be enhanced by brick piers.

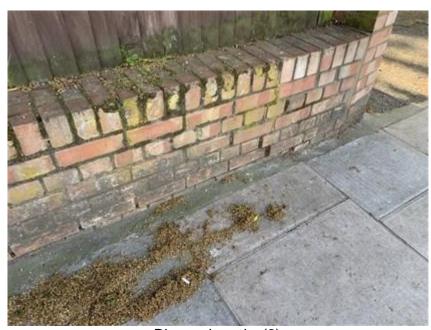
Diagonal cracks (2)
