West Hampstead Fire Station

327B West End Lane

Further to our recent discussions and subsequent site visit we have outlined below a brief report following removal of the low-level cementitious render coating to the front, side and rear elevations.

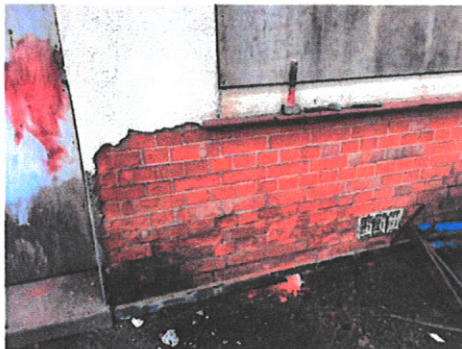
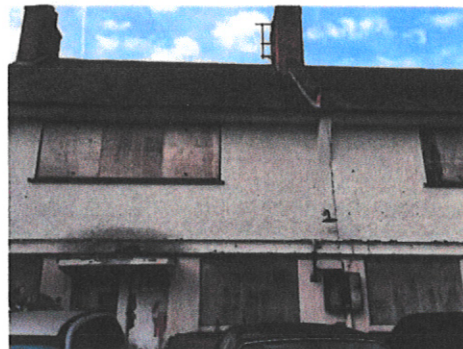
1. We were asked to attend the above address to remove small areas of render to further determine the extent of damage to the faced brickwork below. There is clear evidence to the already exposed areas that the brickwork has suffered from a lack of maintenance over a long period.

2. We commenced with removal to the areas either side of the front elevation door ways. These areas exposed brickwork that is generally in good condition, and the Removal was met without difficulty, with the use of hand tools.
3. We then attempted to remove the render to the window cills, these areas were much tougher and damage to the face of the brickwork accrued in the attempted removal process.

The use of mechanical tools should be avoided as far as is possible, however in certain instances where a hard-cementitious coating has been applied to the brickwork, notably along the front of the window cills then the use of hand chisels and small breakers may be the only solution.

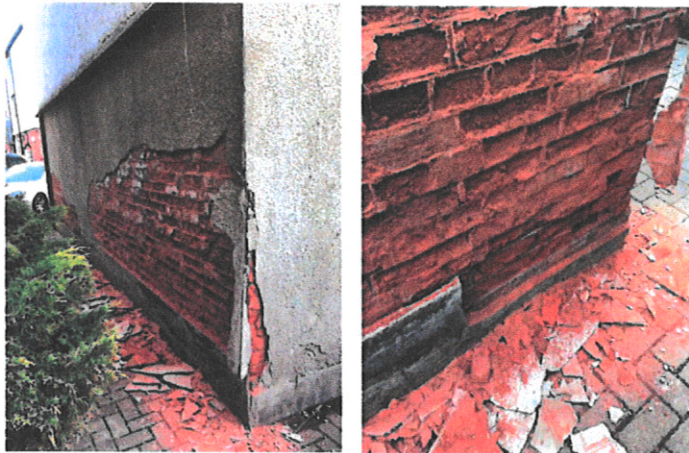
4. The render to the side elevation was again removed without difficulty.

5. The underlying faced brickwork is showing a large deterioration and spalling to the face. These areas are majority to the lower sections.
6. A large build up effervesce and salts can also be seen to the face of the brickwork.

Proposed remedial works are repairs of the existing brickwork substrate and to then re-apply a lime-based render coating.

1. Upon completion of the removal of the existing coatings a condition survey should be undertaken to exposed brickwork
2. Any remedial works undertaken to the localised brickwork should be carried out with like for like materials, samples can be provided:

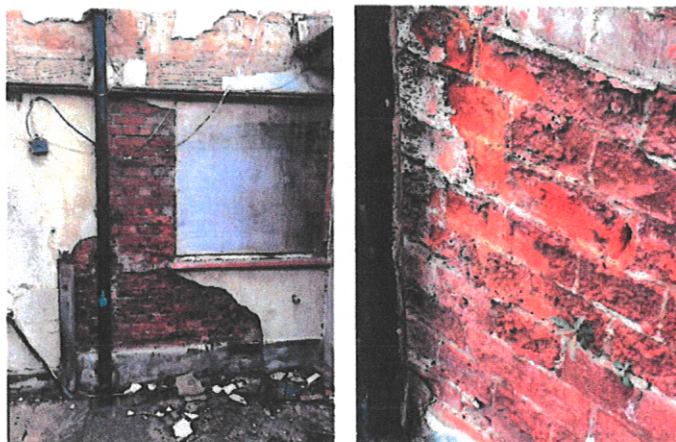
1. The final elevation exposed more of the same as the two previous elevations, with repeat evidence of heavy deterioration to the brickwork. Water damage is also clearly evident.
