ARBORICULTURAL ASSESSMENT REPORT

For:	Client:	QuestGates Ltd
	Insurer:	
Site:	Policyholder:	
	Risk Address:	28 Montpelier Grove, London, NW5 2XD
Refs:	PRI Ref:	
	Client Ref:	
	Insurer Ref:

Arborist Name:	Ross Lane	Date:	19/03/2019
-----------------------	-----------	--------------	------------

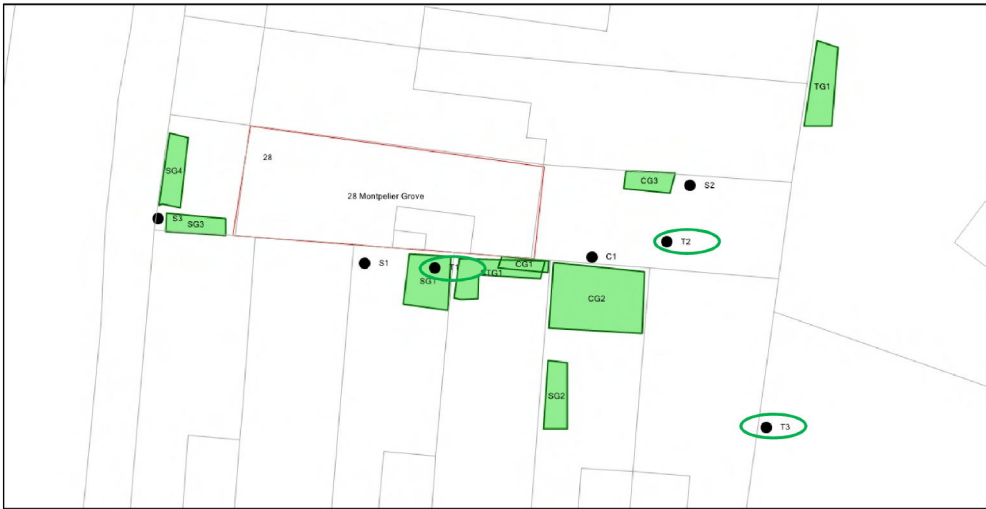
7.0 APPENDIX 2: SITE PLAN

Tree No:	Species	Works Required
T1	Loquat	Fell and treat stump.
CG1	Ivy	Fell and treat stump.
CG2	Mixed species group	Remove section of Shrub group to allow a minimum clearance of 8m from the side and rear of the property. No work to remaining Shrubs in group. (Total 6m in length approx). Treat stumps.
T2	Willow	Fell and treat stump.
