Drainage Investigation Report

28 Montpelier Grove, London, NW5 2XD

Client	Questgates Subsidence
Client ref	
Visit date	31/01/2019
Report date	31/01/2019
Loss Adjuster	David Clare
Prepared by	AS

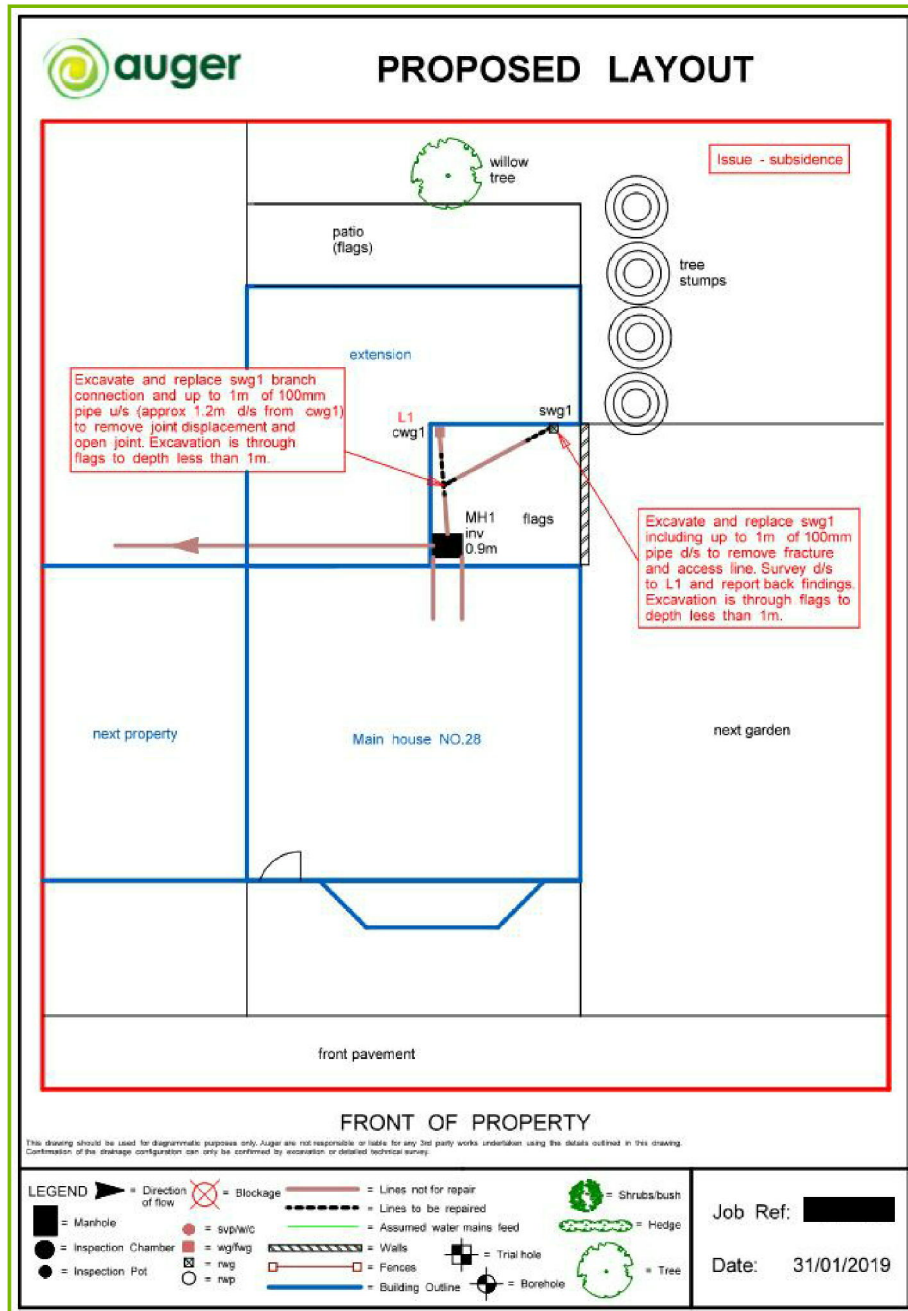
Findings	Visual Inspection 1) We noted that surface water gully 1 has fractured.
	CCTV Survey Line 1 - Manhole 1 upstream to combined waste gully 1 Our survey revealed a joint displacement and open joint on the left-hand bend approximately 1.2m upstream from the manhole.
Refer Back	We will now refer this claim back to Questgates Subsidence and await your further instruction on how to proceed.

Repairs	We believe repairs are needed to line 1 and surface water gully 1. Please see the proposed layout below for details of our repair recommendations.
----------------	---
