TECHNICAL REPORT ON A SUBSIDENCE CLAIM

**24 Langbourne Avenue
London
N6 6AL**

SUBSIDENCE CLAIM

DATE 22 January 2019

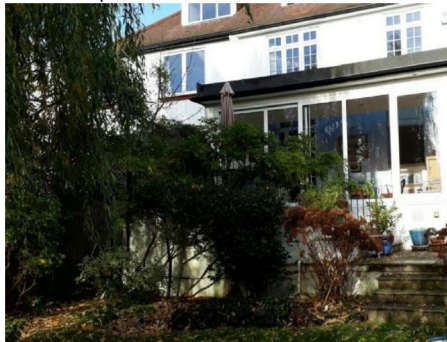
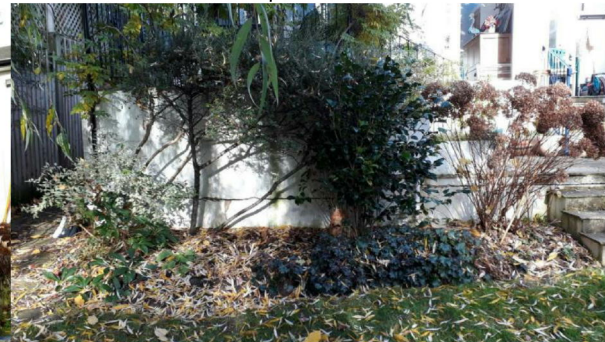
Close up of 10-12mm horizontal cracks in
rear wall of raised patio area

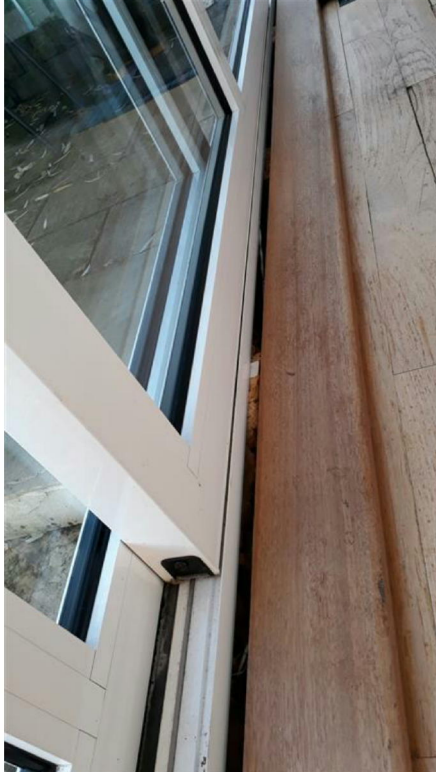
Distortion of door/window openings of the patio doors to rear extension. A section of the wooden flooring in the extension room is being pulled away leaving a gap beneath the patio window and doors. In addition minor cracking, less than 1mm, was noted in some of the areas of the rear extension room and side rear utility room.

Patio doors and windows pulling away as seen by gap in floor edge

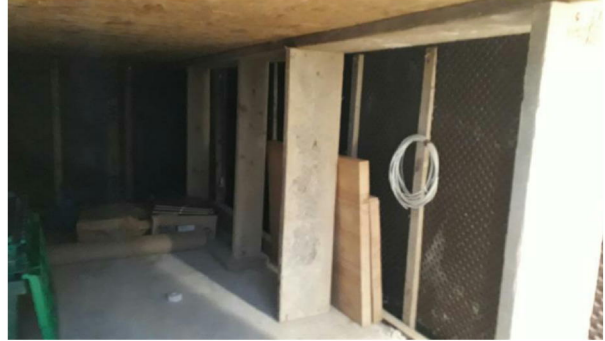
Storage area below rear single story extension-- No damage noted
