## Arboricultural Appraisal Report

### Subsidence Damage Investigation at:

24 Langbourne Avenue  
London  
N6 6AL

CLIENT:	Crawford & Company
CLIENT REF:	[REDACTED]
MWA REF:	[REDACTED]
MWA CONSULTANT:	Steve Swinburne
REPORT DATE:	01-04-2019

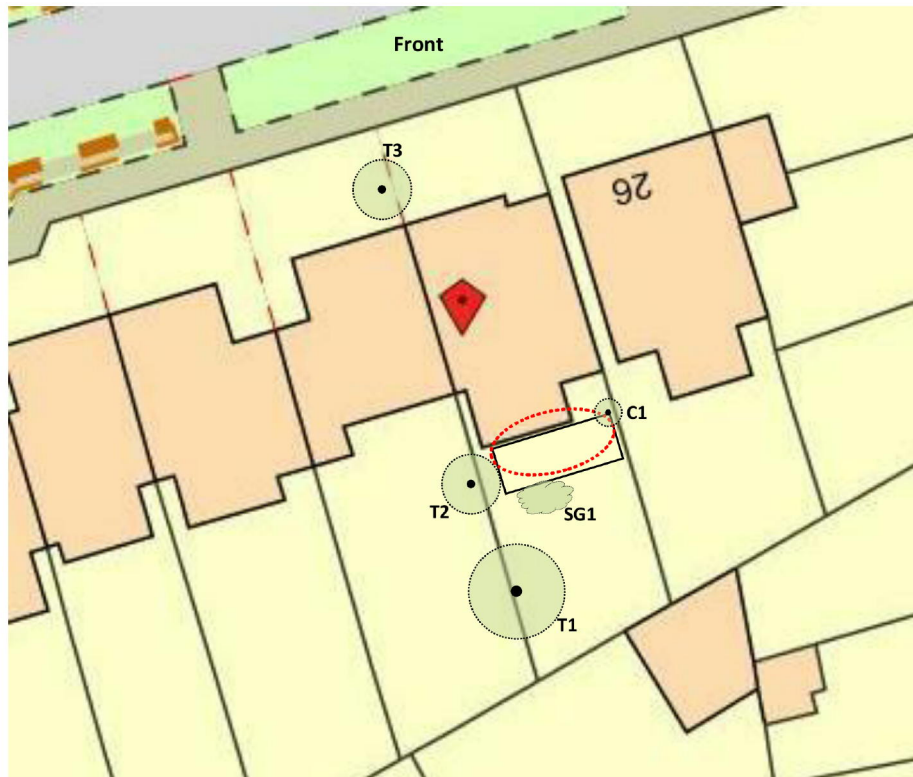
Site Plan

Approximate areas of damage

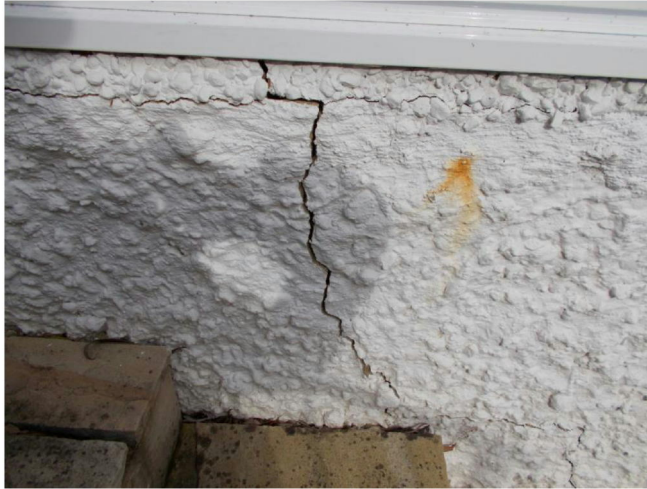
The current damage affects the raised patio area attached to the rear single-storey extension, which is pulling away from the main house causing damage to the rear extension, as well as to the concrete pad on which the rear patio is laid. The damage was first noticed in August 2018. For a more detailed synopsis of the damage please refer to the building surveyor's technical report.

At the time of the building surveyor's inspection (14/11/2018) the structural significance of the damage was found to fall within Category 4 (severe) of Table 1 of BRE Digest 251.

View of cracking to rear elevation

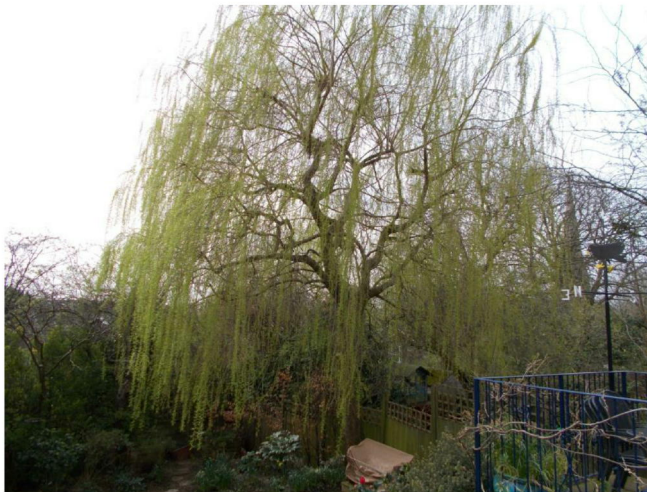
The vegetation likely to be most significant in relation to the current damage is T1 with a likely contribution from T2 and SG1. Other vegetation recorded represents a future risk.

View of T1

If an arboricultural solution is to be implemented to mitigate the influence of the trees/shrubs considered to be responsible for the damage we recommend that T1, T2 and SG1 are removed.

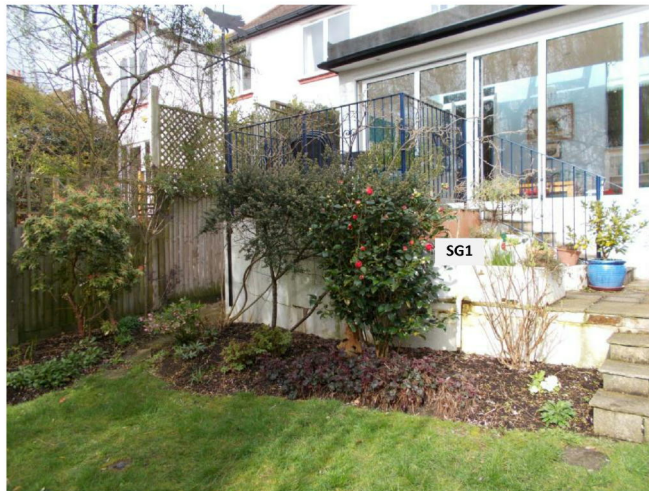
View of SG1

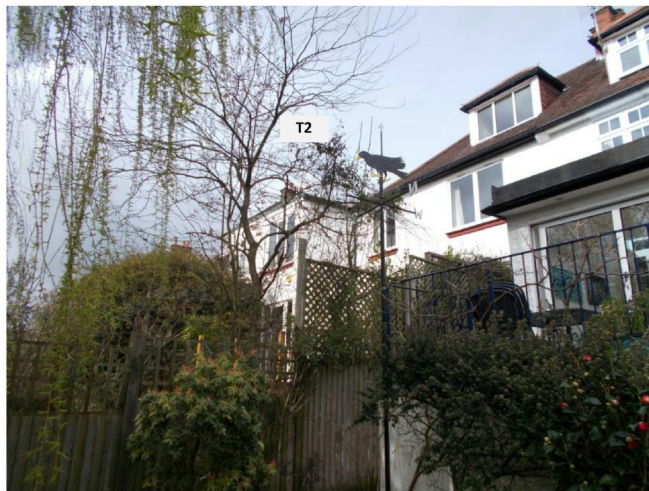
View of T2
