## Arboricultural Appraisal Report

### Subsidence Damage Investigation at:

31 Inglewood Road  
London  
NW6 1QT

| REPORT DATE: | 29/03/2019 |

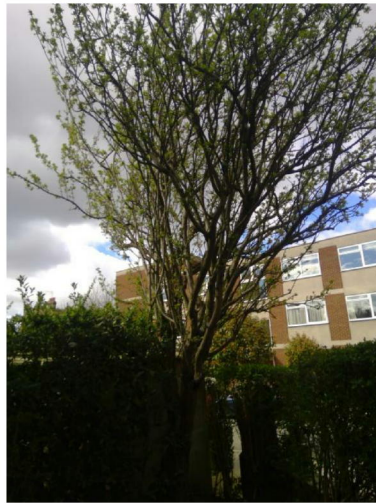
Roots were observed to a depth of 800mm and 2200mm bgl in TP/BH1 and TP/BH2 respectively. Recovered samples have been positively identified (using anatomical analysis) as *Pomoideae* gp. and *Cupressaceae* spp., the origin of which will be T1 (*Crataegus* sp) and T3 (*Cypress*) confirming their influence on soils at and below the foundations.

| Tree No. | Species | Ht (m) | Dia (mm) | Crown Spread (m) | Dist. to building (m) | Age Classification | Ownership |
|---|---|---|---|---|---|---|---|
| T1 | Crataegus sp. | 5 | 280 * | 4.5 | 3.5 | Younger than Property | Policy Holder |

View of T1 Crataegus sp., current claim.

| Tree No. | Species | Ht (m) | Dia (mm) | Crown Spread (m) | Dist. to building (m) | Age Classification | Ownership |
|---|---|---|---|---|---|---|---|
| Recommendation | | Remove (fell) to near ground level and treat stump to inhibit regrowth. | | | | | |

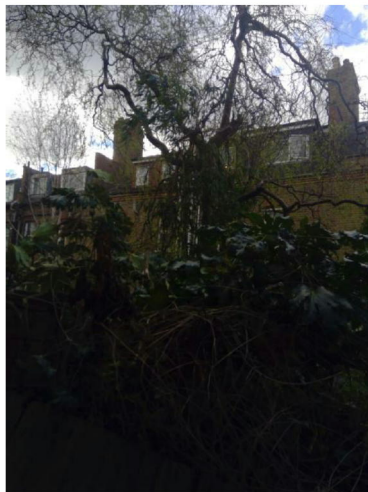
Irrespective of the identification of recovered root samples, the roots of T2 (Willow) and T4 (Bay) are also likely to be present below foundation level in proximity to the area of movement/damage and influencing soil moisture and volumes. It is noted that H1 contains *Pyracantha* and roots from this genus were recovered from TP/BH1 although H1 is not considered to be significant.

| Tree No. | Species | Ht (m) | Dia (mm) | Crown Spread (m) | Dist. to building (m) | Age Classification | Ownership |
|---|---|---|---|---|---|---|---|
| T2 | Willow | 5 | 150 * | 5 * | 3.5 * | Younger than Property | Third Party:<br>9 Holmdale Road<br>NW6 1BE |

View of T2 Willow, current claim.

| Tree No. | Species | Ht (m) | Dia (mm) | Crown Spread (m) | Dist. to building (m) | Age Classification | Ownership |
|---|---|---|---|---|---|---|---|
| Recommendation | | Remove (fell) to near ground level and treat stump to inhibit regrowth | | | | | |

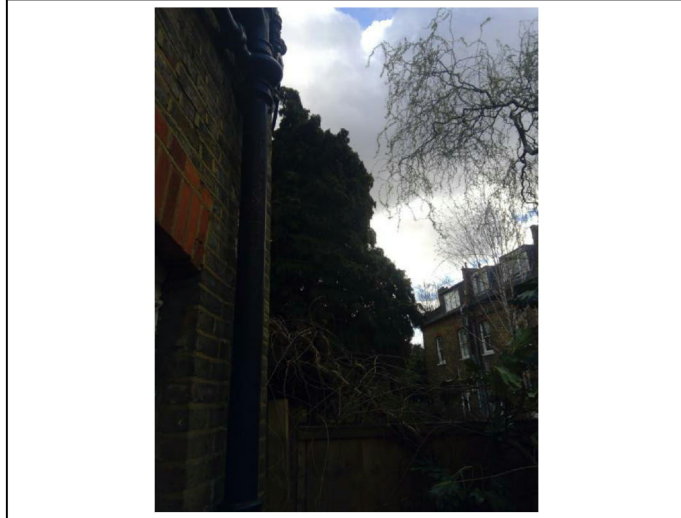
| Tree No. | Species | Ht (m) | Dia (mm) | Crown Spread (m) | Dist. to building (m) | Age Classification | Ownership |
|---|---|---|---|---|---|---|---|
| T3 | Cypress | 9 | 190 * | 4.5 * | 1.5 | Younger than Property | Third Party:<br>5 Holmdale Road<br>NW6 1BE |

View of T3 Cypress, current claim.

| Tree No. | Species | Ht (m) | Dia (mm) | Crown Spread (m) | Dist. to building (m) | Age Classification | Ownership |
|---|---|---|---|---|---|---|---|
| Recommendation | | Remove (fell) to near ground level. | | | | | |

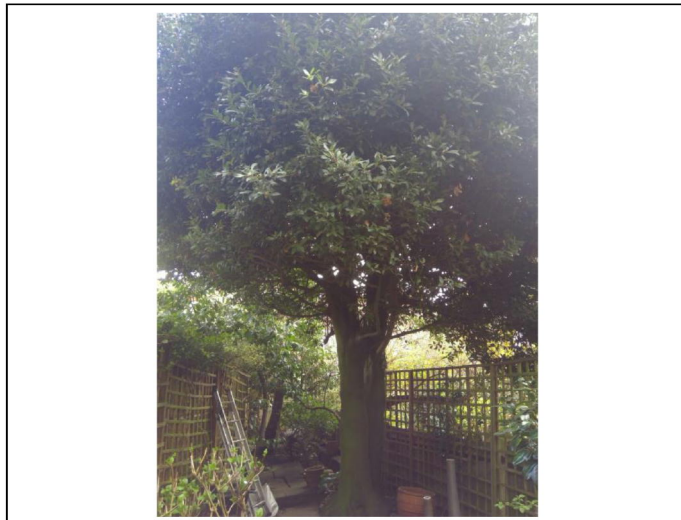
| Tree No. | Species | Ht (m) | Dia (mm) | Crown Spread (m) | Dist. to building (m) | Age Classification | Ownership |
|---|---|---|---|---|---|---|---|
| T4 | Bay | 9 | 400 Ms | 8 | 6.7 | Similar Age to Property | Policy Holder |

View of T4 Bay, current claim.

| Tree No. | Species | Ht (m) | Dia (mm) | Crown Spread (m) | Dist. to building (m) | Age Classification | Ownership |
|---|---|---|---|---|---|---|---|
| Recommendation | | Remove (fell) to near ground level and treat stump to inhibit regrowth. | | | | | |
