TECHNICAL REPORT ON A SUBSIDENCE CLAIM

31 Inglewood Road
London
NW6 1QT

SUBSIDENCE CLAIM

DATE 9th November 2018

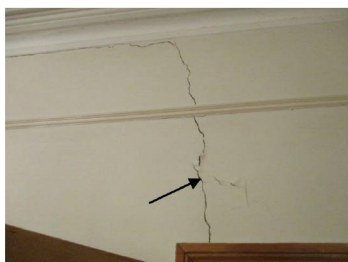
Cracking in Flat A lounge

Flat A - Lounge - 6mm vertical tapering crack above door to hall continues along wall / ceiling junction on piano room partition, various cracks to ceiling and coving, 3mm vertical crack down front bedroom partition junction, French doors are sticking however significant historic distortions noted to frame.

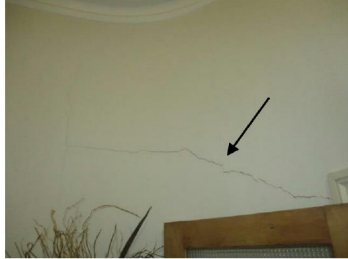
Hallway - 4mm diagonal tapering crack to kitchen partition, 2mm vertical crack above door to lounge, various cracks to ceiling.

Cracking in Flat A hall

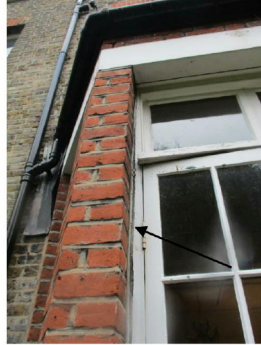
Rear Elevation - 3mm vertical cracking below both sides of piano room window, 5mm vertical cracking above both sides of piano room window, 10mm separation down side of French door frame, 4mm vertical crack to right hand side of bay, slabs have dropped around left hand corner.

Movement to rear bay

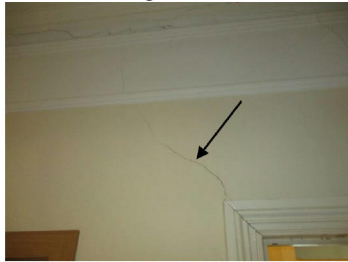
Flat B - Rear Left Hand Bedroom - 3mm diagonal crack above door to hall continues along wall / ceiling junction on rear bedroom partition, 2mm diagonal crack above left hand side of rear window, 2mm vertical crack down front left hand corner junction.

Cracking in Flat B rear left hand bedroom

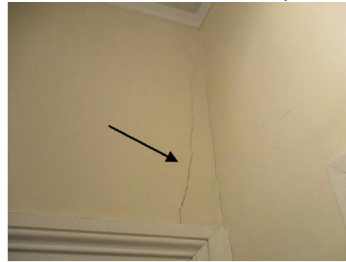
Hall - 2mm vertical crack above rear left hand bedroom door, cracking to ceiling and covings.

Cracking in Flat B hall

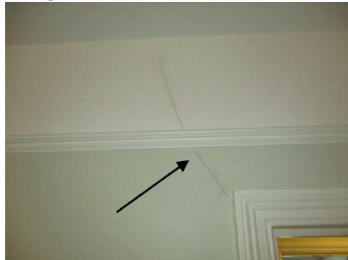
Flat C - Lounge - 2mm diagonal crack above door to hall, door is sticking, cracking to ceiling, hairline diagonal cracking to rear bedroom partition towards rear, 1mm vertical cracking below both sides of rear window, 5mm gap in skirting in rear right hand corner.

Cracking in Flat C lounge

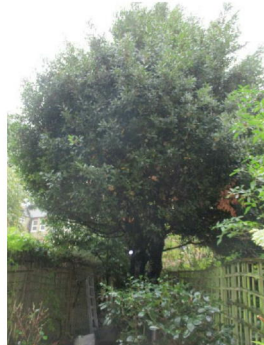
The Bay (Laurus) is an evergreen that can reach heights of between 10 – 14mtrs. It's a slow growing tree (150mm p.a.) with weak root activity.

View of insured's bay tree to rear

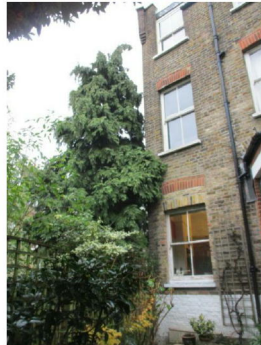
Generally they have less invasive roots and lower water demands than broadleaved species, but cypresses are often associated with subsidence as they are very fast growing, popular hedge plants that are frequently planted near houses.

View of third party conifer to rear
