## Arboricultural Appraisal Report

### Subsidence Damage Investigation at:

31 Inglewood Road  
London  
NW6 1QT

CLIENT:	Crawford & Company
CLIENT REF:	██████████
MWA REF:	██████████
MWA CONSULTANT:	George Peters BSc. (Hons)
REPORT DATE:	29/03/2019

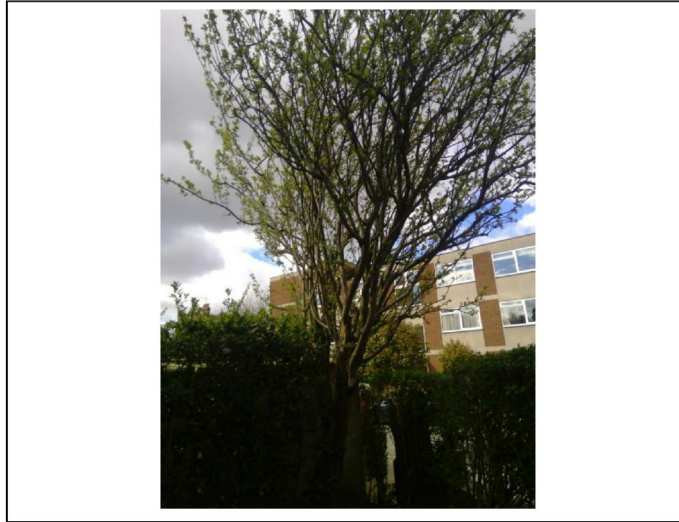
Roots were observed to a depth of 800mm and 2200mm bgl in TP/BH1 and TP/BH2 respectively. Recovered samples have been positively identified (using anatomical analysis) as Pomoideae gp. and Cupressaceae spp., the origin of which will be T1 (*Crataegus* sp) and T3 (*Cypress*) confirming their influence on soils at and below the foundations.

Based on the technical reports currently available, engineering opinion and our own site assessment we conclude the damage is consistent with shrinkage of the clay subsoil related to moisture abstraction by vegetation. Having considered the information currently available, it is our opinion that T1, T2, T3, and T4 are the principal cause of or are materially contributing to the current subsidence damage.

View of T1 Crataegus sp., current claim.

If an arboricultural solution is to be implemented to mitigate the influence of the implicated trees/vegetation we recommend that T1, T2, T3, and T4 are removed.

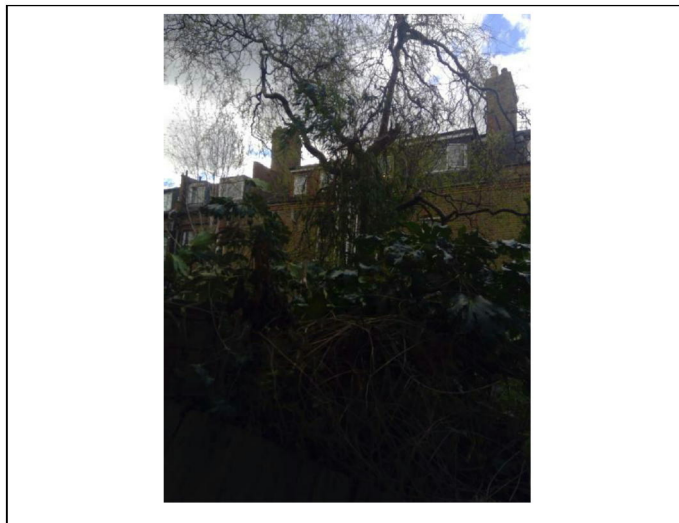
Irrespective of the identification of recovered root samples, the roots of T2 (*Willow*) and T4 (*Bay*) are also likely to be present below foundation level in proximity to the area of movement/damage and influencing soil moisture and volumes. It is noted that H1 contains *Pyracantha* and roots from this genus were recovered from TP/BH1 although H1 is not considered to be significant.

View of T2 Willow, current claim.

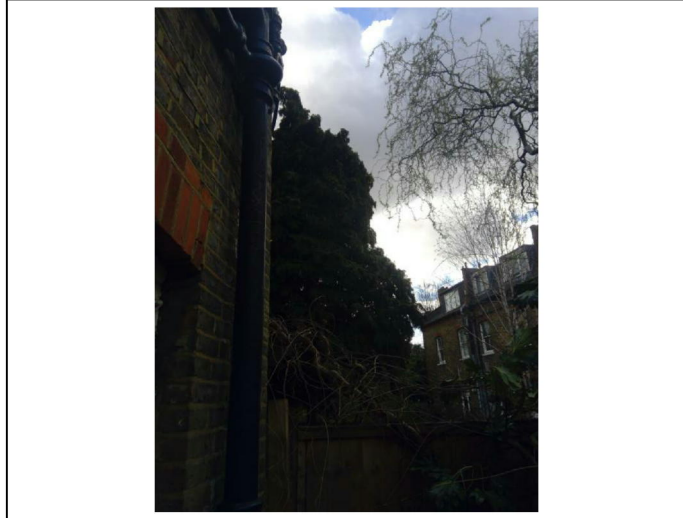
View of T3 Cypress, current claim.

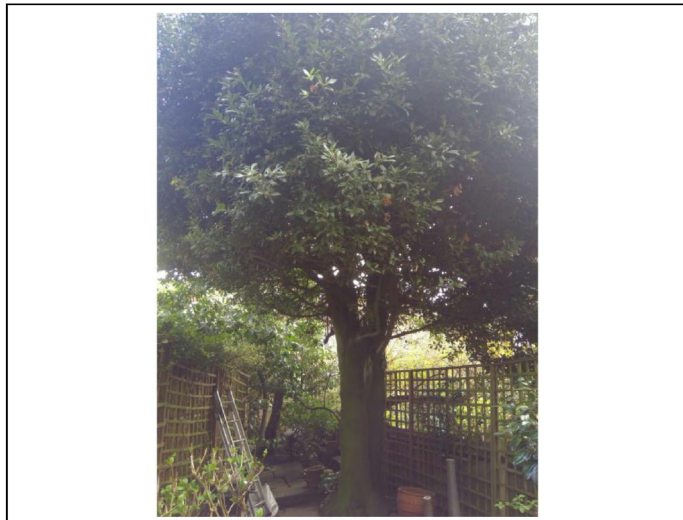
View of T4 Bay, current claim.
