TECHNICAL REPORT ON A SUBSIDENCE CLAIM

31 Inglewood Road
London
NW6 1QT

SUBSIDENCE CLAIM

DATE 9th November 2018

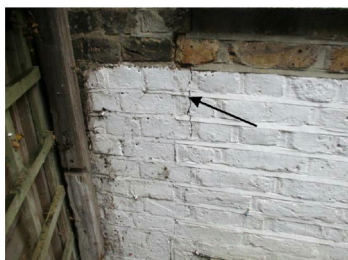
Cracking to rear elevation

Rear Elevation - 3mm vertical cracking below both sides of piano room window, 5mm vertical cracking above both sides of piano room window, 10mm separation down side of French door frame, 4mm vertical crack to right hand side of bay, slabs have dropped around left hand corner.

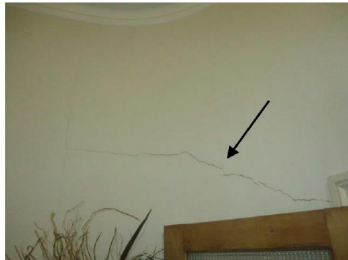
Hallway - 4mm diagonal tapering crack to kitchen partition, 2mm vertical crack above door to lounge, various cracks to ceiling.

Cracking in Flat A hall

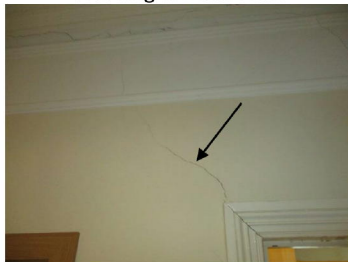
Flat B - Rear Left Hand Bedroom - 3mm diagonal crack above door to hall continues along wall / ceiling junction on rear bedroom partition, 2mm diagonal crack above left hand side of rear window, 2mm vertical crack down front left hand corner junction.

Cracking in Flat B rear left hand bedroom

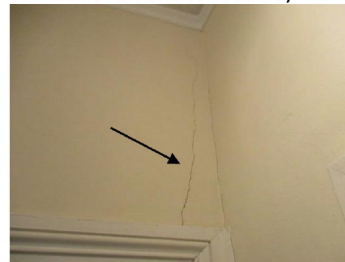
Hall - 2mm vertical crack above rear left hand bedroom door, cracking to ceiling and covings.

Cracking in Flat B hall

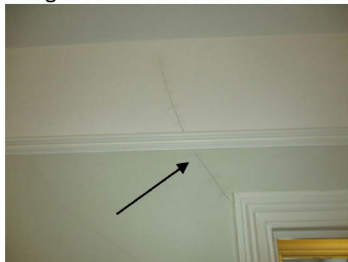
Flat C - Lounge - 2mm diagonal crack above door to hall, door is sticking, cracking to ceiling, hairline diagonal cracking to rear bedroom partition towards rear, 1mm vertical cracking below both sides of rear window, 5mm gap in skirting in rear right hand corner.

Cracking in Flat C lounge

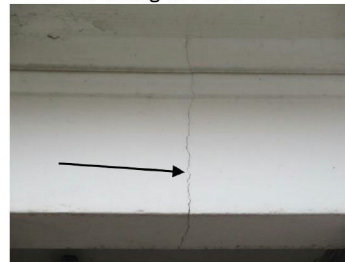
Porch - 5mm vertical tapering crack at high level above right hand side of front door, 1mm crack in lintel to porch.

Cracking to lintel above porch

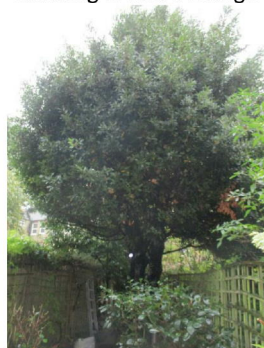
View of insured's bay tree to rear
