Arboricultural Appraisal Report

Subsidence Damage Investigation at:

161 West End Lane
London
NW6 2LG

CLIENT:	Crawford & Company
CLIENT REF:	██████████
MWA REF:	██████████
MWA CONSULTANT:	Steve Swinburne
REPORT DATE:	06-04-2019

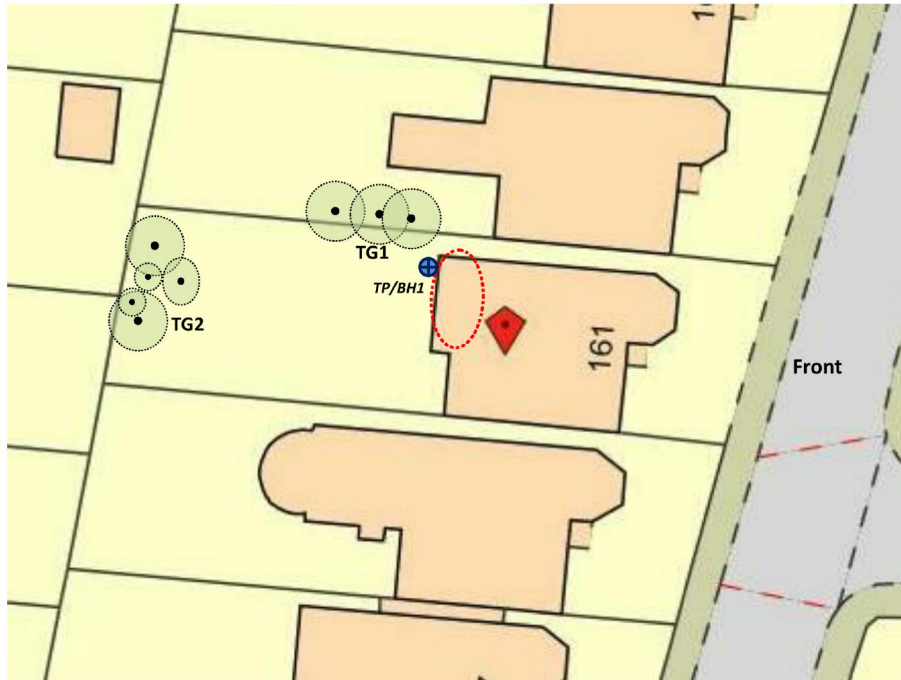
Site Plan

Approximate areas of damage

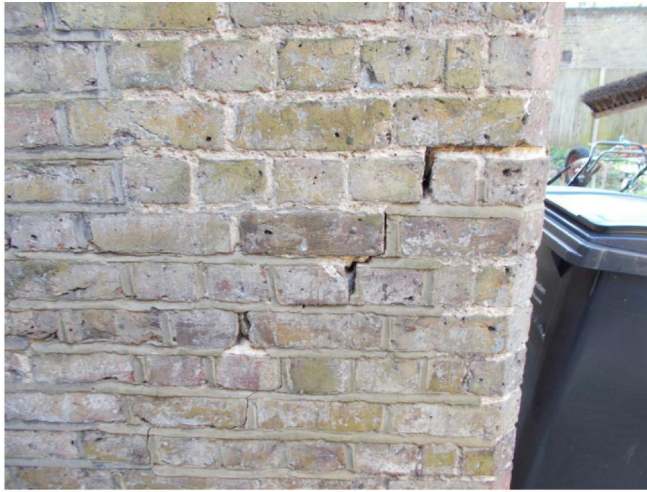
The current damage affects the rear, right hand section of the property and was first noticed over the summer of 2018. For a more detailed synopsis of the damage please refer to the building surveyor's technical report.

At the time of the building surveyor's inspection (23/11/2018) the structural significance of the damage was found to fall within Category 3 (moderate) of Table 1 of BRE Digest 251.

View of damage to rear right corner

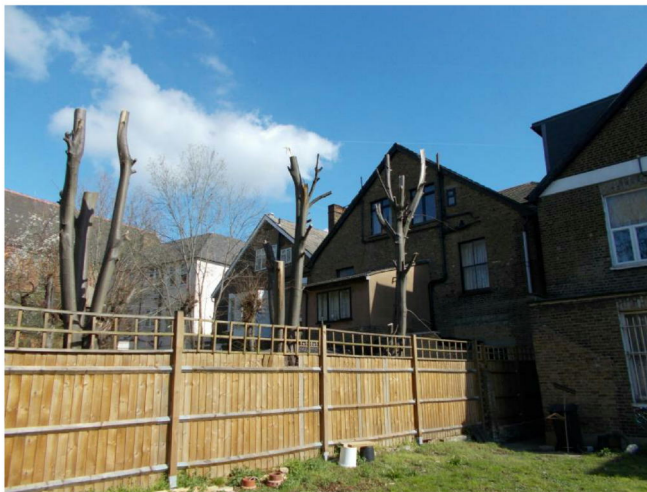
Based on the technical reports currently available, engineering opinion and our own site assessment we conclude the damage is consistent with shrinkage of the clay subsoil related to moisture abstraction by vegetation. Having considered the information currently available, it is our opinion that the trees within TG1 are the principal cause of or are materially contributing to the current subsidence damage.

Tree No.	Species	Ht (m)	Dia (mm)	Crown Spread (m)	Dist. to building (m)	Age Classification	Ownership
TG1	Tilia x 3	9	450*	0	Min 4	Younger than property	3 rd Party: 163 West End Lane NW6 2LG
Management history		Subject to a recent heavy reduction with the majority of the branches removed.					
Recommendation		Remove (fell) to near ground level and treat stump to inhibit regrowth.

View of the three trees that comprise TG1

Despite the recent significant reduction of TG1, we consider that due to their size and proximity, the trees should be removed.

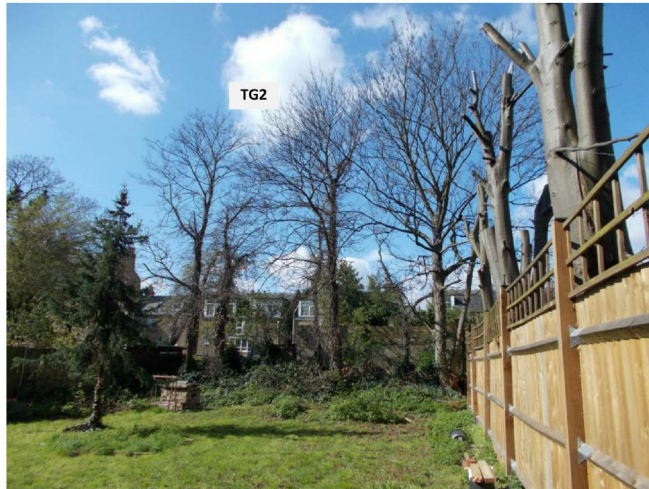
Tree No.	Species	Ht (m)	Dia (mm)	Crown Spread (m)	Dist. to building (m)	Age Classification	Ownership
TG2	Sycamore x 6	14	Ave 450	12	17.5	Younger than property	Policy Holder
Management history		No recent management noted.					
Recommendation		Do not allow to exceed current dimensions.

View of TG2 towards the rear boundary with TG1 to the right
