TECHNICAL REPORT ON A SUBSIDENCE CLAIM

161 West End Lane
London
NW6 2LG

SUBSIDENCE CLAIM

DATE 12th December 2018

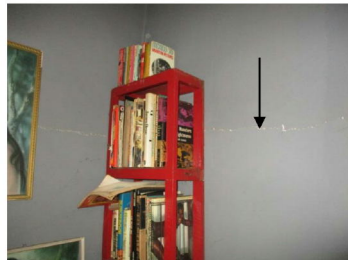
Cracking in flat 1 rear bedroom

Flat 1 - Rear Bedroom - 4mm horizontal cracking to rear right hand corner, 4mm diagonal cracking above and below rear window, wall / ceiling junction cracking along front face of beam downstand, 5mm vertical tapering crack to left hand partition.

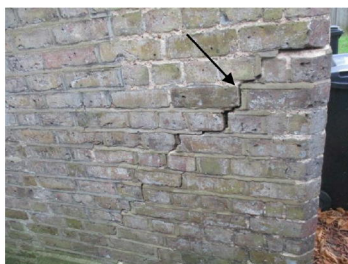
Cracking to rear right hand corner

Right Hand Flank - 9mm stepped tapering crack to rear corner continues around onto rear elevation.

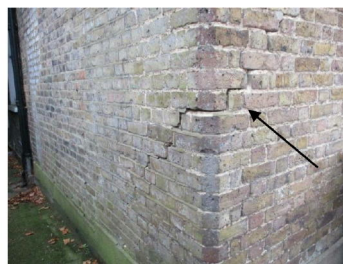
Cracking to rear right hand corner

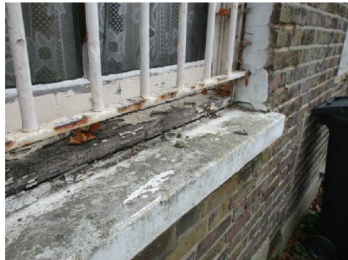
Rear Elevation - Movement noted to cill of ground floor left hand window (timber frame is extremely rotten - wear and tear issue), 3mm stepped crack below ground floor right hand window.

Cracking to cill (note rot to window frame - wear and tear issue)

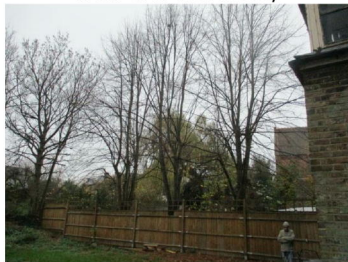
View of third party trees to rear

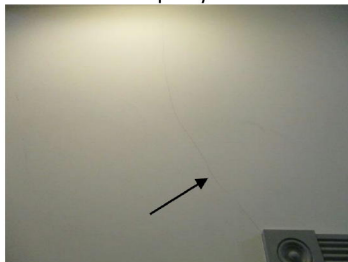
Communal Hall, Stairs and Landing - 3mm vertical tapering crack to right hand wall on half landing, 1mm vertical crack to left hand wall on half landing, 1mm vertical crack to right hand partition on 1st floor landing, hairline diagonal crack above door to flat 1, 1mm diagonal crack to flat 2 partition.

Cracking in communal hallway

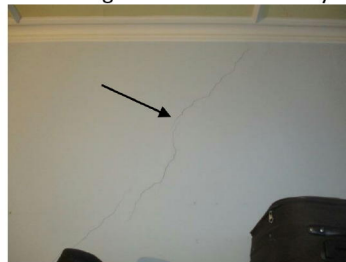
Lounge - 3mm diagonal previously repaired crack to communal hall partition, 2mm horizontal previously repaired crack to rear partition.

At the time of our inspection cracking was also noted internally within flat 2 towards the front of the property. The pattern and location of this area of cracking was indicative of some movement to the front section of the property. This cracking had been repaired previously and did not appear to be recent in appearance. Our records indicate that there was a previous subsidence claim to the left hand neighbouring property (number 159) and a row of significant conifer trees which were growing within the front garden of the neighbouring property were removed in 2006. In the absence of any remaining external influences which could be causing movement to the front section of the property we must conclude that the cracking evident here is historic and was the result of the effects of the third party conifers which have now been removed. On the basis that this is a separate issue from the movement to the rear of the property, it would appear appropriate that this area of cracking should simply be repaired using appropriate crack repair techniques.

Cracking in flat 2 lounge to front of property

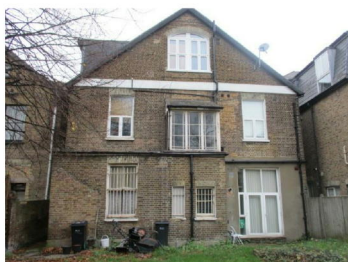
View of rear of property
