**STRUCTURAL INSPECTION  
OF BOUNDARY WALL**

**KEAT'S HOUSE,  
LONDON, NW3**

**REF: 217449 - NOVEMBER 2017**

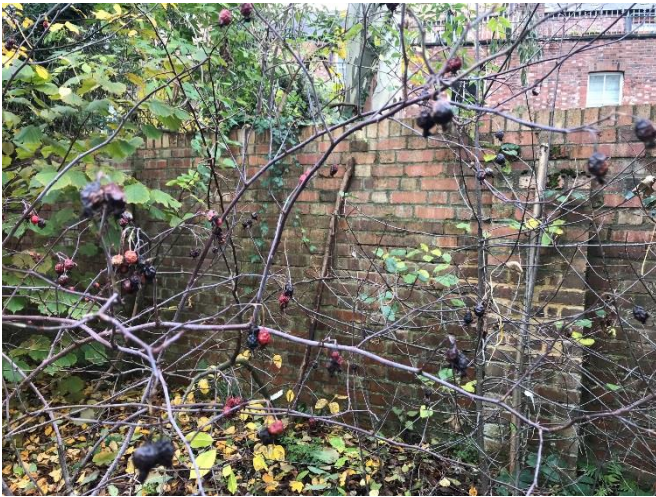
- 3.1 Panel 1 appeared in a reasonable condition and was relatively plumb, however it was difficult to inspect due to the amount of vegetation in front of the wall (see photograph 1).

- 3.2 The wall appeared to retain around 1.3m of the neighbouring garden.
- 3.3 The brickwork in front of the retained soil was stained.
- 3.4 Buttress 1 appeared in a reasonable condition but was difficult to inspect due to the vegetation in front of this section of the wall (see photograph 1).

- 3.5 Panel 2 appeared in a reasonable condition however there were some areas where the pointing was in a poor condition (see photograph 1).
- 3.6 The retained height of soil appeared similar to that of panel 1.

1. Panels 1 & 2, buttresses 1 & 2.

- 4.3 Based on this we would suggest that, at this stage, no major remedial works are required.
- 4.4 We recommend that the poor pointing in panel 2 should be carefully raked out and re-pointed in the near future.

- 4.5 It is likely that the vegetation close to the wall would need to locally be removed for this. We suggest that the vegetation covering panel 1 should also be locally removed so this panel could be inspected in detail.

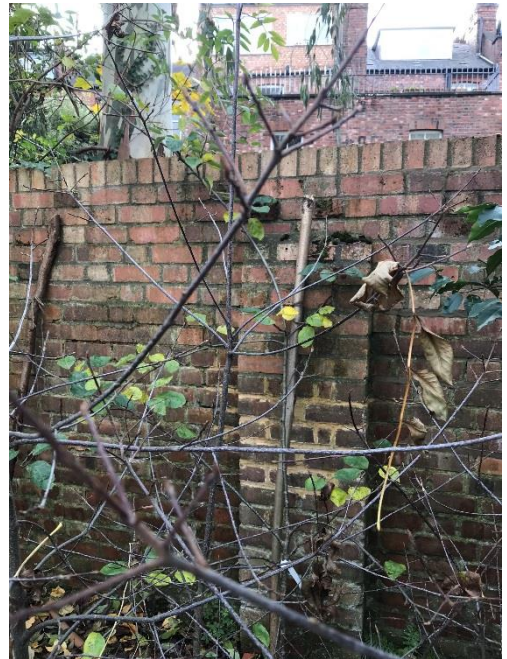
- 3.7 Buttress 2 appeared in a reasonable condition. There had been some remedial works carried out previously and no further movement was noted (see photograph 2).

2. Buttress 2. Note remedial repairs.

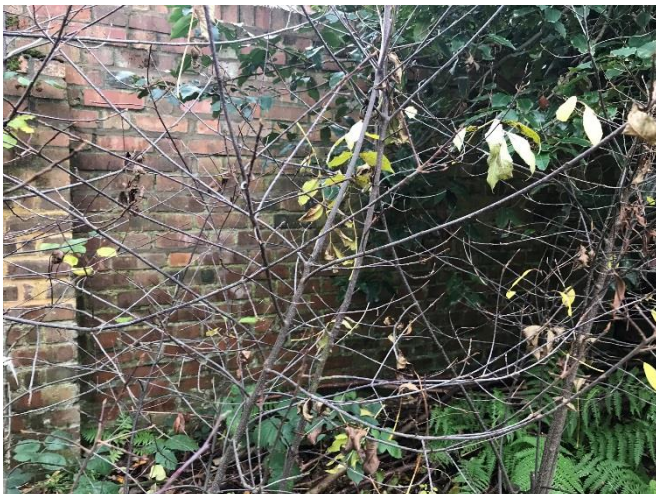
- 3.8 Panel 3 appeared in a reasonable condition.
- 3.9 There were some areas of poor pointing at low level in Panel 3 (see photograph 3).
- 3.10 Buttress 3 had some areas of poor pointing at low level (see photograph 4).

3. Panel 3.

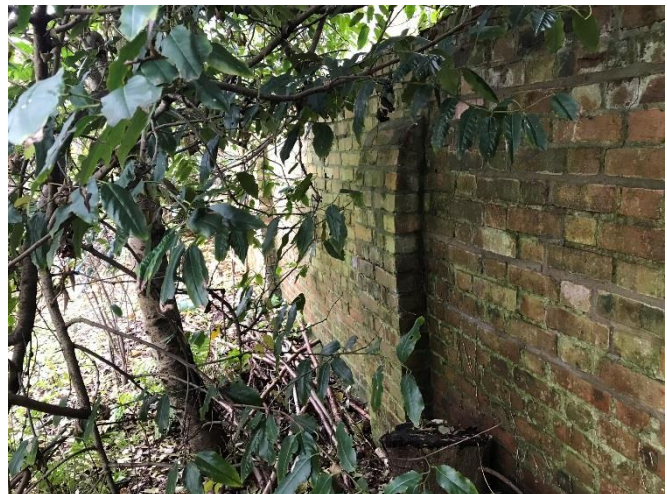
4. Buttress 3 & wall panel 4.

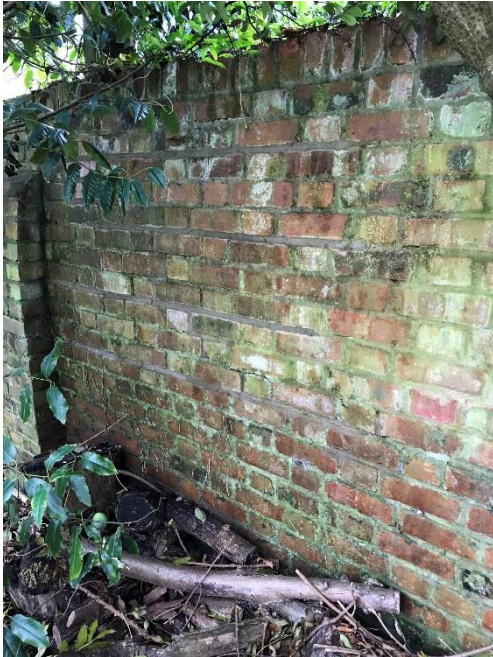
- 3.11 There was a silver birch in close proximity to the buttress.
- 3.12 Panel 4 appeared in a reasonable condition but had a slight belly in it approximately half way up the wall, which appeared historic (see photographs 5 & 6).

- 3.13 The pointing was in a poor condition below the 10<sup>th</sup> course.
- 3.14 It would appear that remedial works were carried out on this panel previously and the cracking noted in the MP report of 2011 had not re-appeared following these works.

5. Panel 4. Note previous Helibar remedial repairs and poor condition of mortar bottom 6 courses.

- 4.6 Around 50% of the pointing in panel 4 also requires carefully raking out and re-pointed in the near future.
- 4.7 The pointing of the lowest 7 courses of buttress 4 is in a poor condition and requires carefully raking out and re-pointed in the near future.

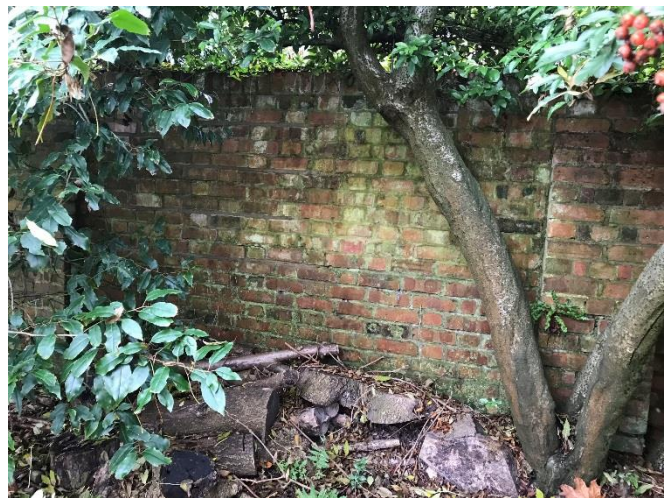
6. Panel 4 and buttress 4.

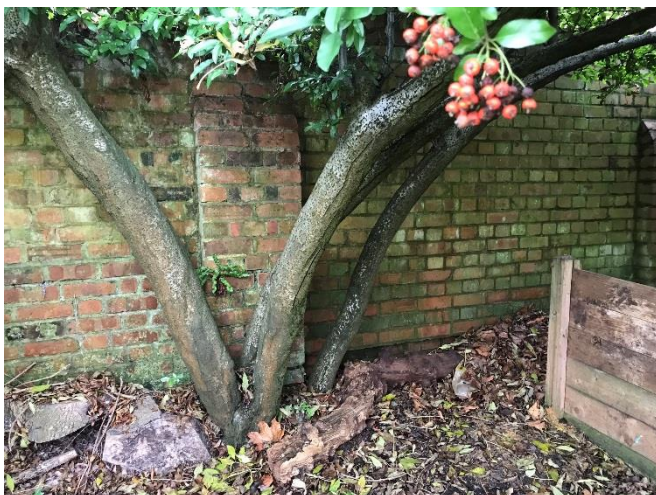
- 3.15 Buttress 4 appeared in a reasonable condition (see photograph 7).
- 3.16 There was a large silver birch in close proximity to the buttress.
- 3.17 Panel 5 was taller than the previous 4 panels by 225mm.

- 3.18 This panel had moved horizontally above the DPC level around 30mm, this movement appeared historic and no worse than that noted in the MP report.

- 
- 3.19 Apart from the horizontal movement the panel appeared in a reasonable condition (see photograph 7).
  - 3.20 Buttress 5 appeared in a reasonable condition, but had historic lateral movement above the DPC as panel 5 (see photograph 8).

7. Buttress 4 and panel 5.

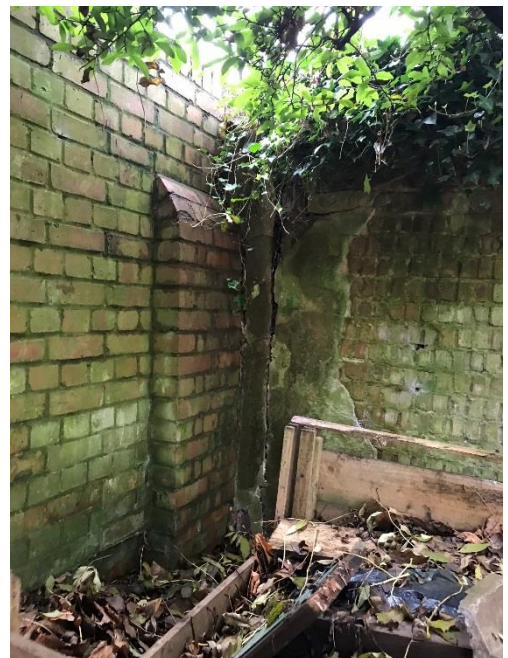
8. Buttress 5 & left hand side wall of oil store. Note crack in oil store wall.

- 4.10 There was a large crack between the left hand side wall of the oil store and the boundary wall. We suggest that the pier remaining is tied back to the boundary wall using 8mm diameter Helibars by Helifix, every 4<sup>th</sup> course as sketch SK/03 in the appendices.

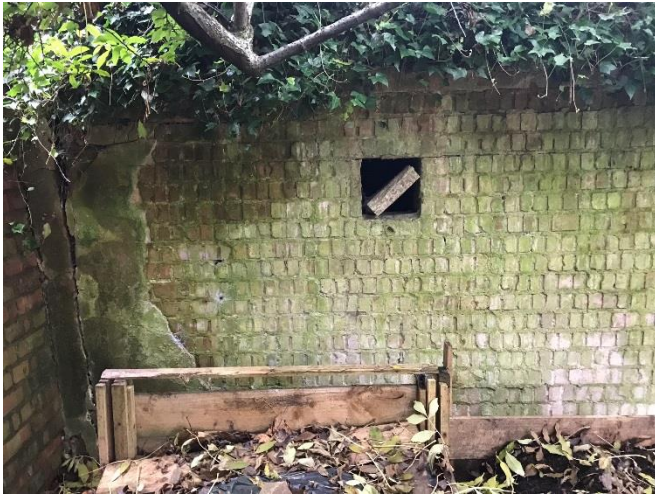
- 3.23 The oil store looked in a state of disrepair. It appeared to have been rendered in the past, but most of this seemed to have failed and was missing from the walls (see photographs 9-11).

- 3.24 There was cracking between the side walls of the oil store and the boundary wall (see photographs 9 & 11).
  - 3.25 Buttress 6 was next to the right hand side wall of the oil store and appeared in a reasonable condition (see photograph 12).

9. Left hand side wall of oil store.

- 4.8 It is our understanding that the client would like to remove the oil store in the future.
- 4.9 If the oil store is to be removed, we suggest that the side walls remain, cut back to a similar size as buttress 9, to help buttress the wall, see MNP sketch SK/02 for further details

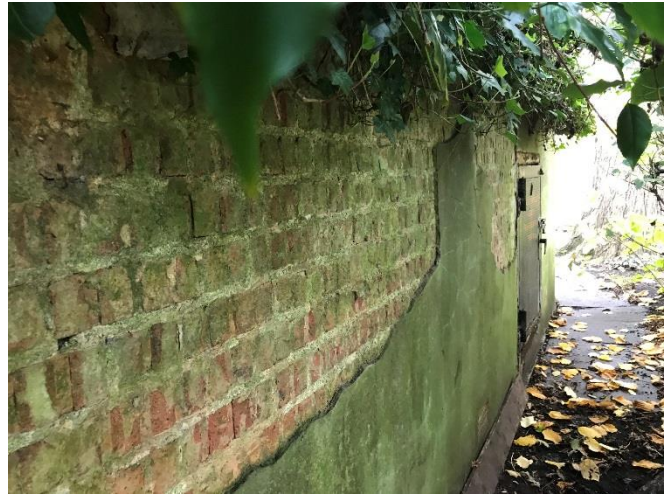
10. Front wall of oil store.

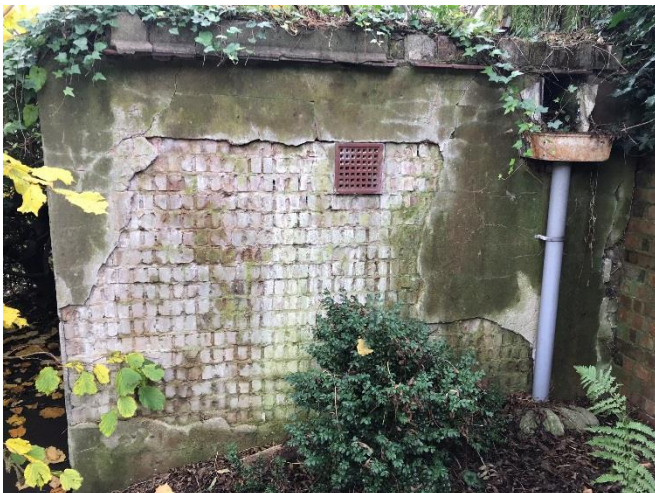
11. Right hand side of wall of oil store.

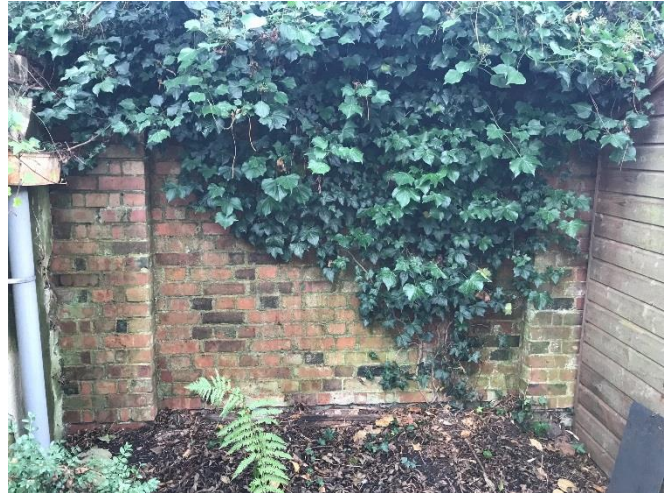
- 3.26 Panel 6 appeared in a reasonable condition however there was ivy present over around 50% of the wall so it was difficult to inspect in detail (see photographs 12-14).

12. Buttress 6 & 7 and wall panel 6.

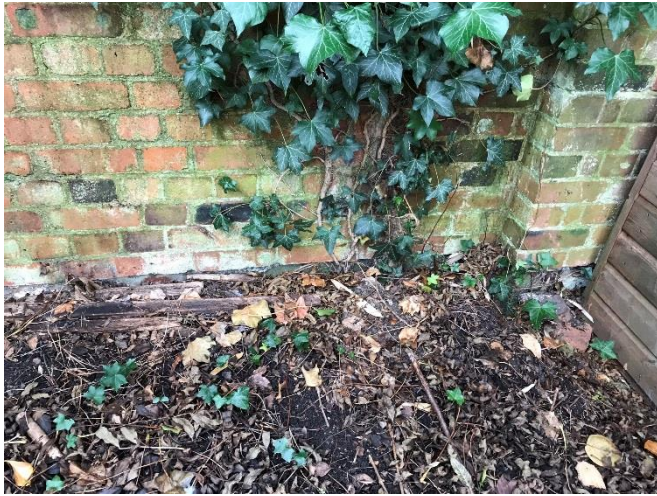
- 3.27 Similar to panel 5, the wall had moved laterally above DPC level by around 30mm.
  - 3.28 Buttress 7 had a horizontal crack present in the bed joint between the 13<sup>th</sup> and 14<sup>th</sup> courses of brickwork.

13. Low level of wall panel 6. Note wall moved laterally.

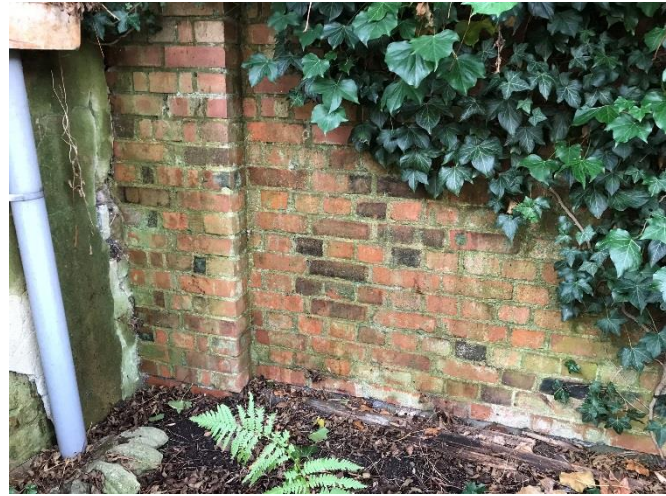
14. Buttress 6 and wall panel 6.

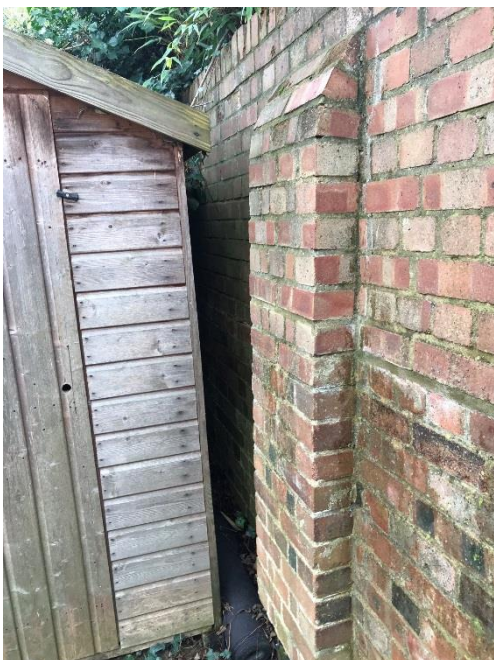
- 3.29 Panel 7 was hidden behind a timber shed and therefore was difficult to survey (see photograph 15).
  - 3.30 It had moved laterally similar to panels 5 and 6.

15. Buttress 8 and wall panel 7 (behind shed).

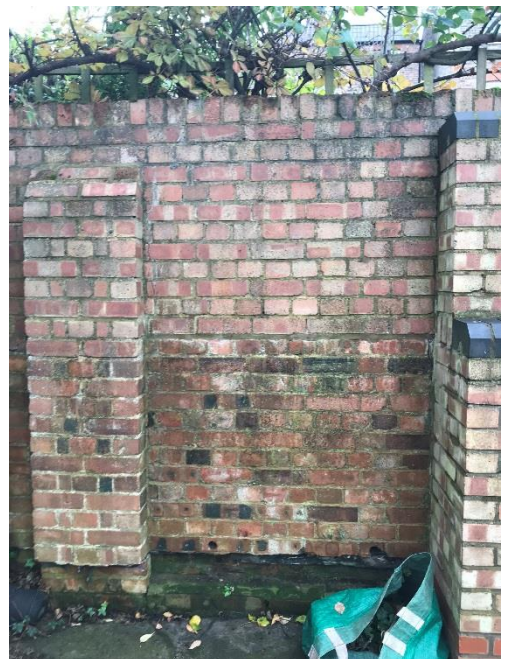
- 3.33 There were friable bricks on these courses.
  - 3.34 The soldier course at the head of the wall appeared in a poor condition.
  - 3.35 Buttress 8 had a similar horizontal crack in the bed joint between the 10<sup>th</sup> and 11<sup>th</sup> course (see photograph 16).

- 3.40 There was an historic vertical crack in the wall close to buttress 9.
  - 3.41 Remedial works had been carried out previously on this panel, including Helibar repairs as per MP report and forming 2 weep holes above the DPC (see photograph 16).

16. Buttress 7 and wall panel 8.

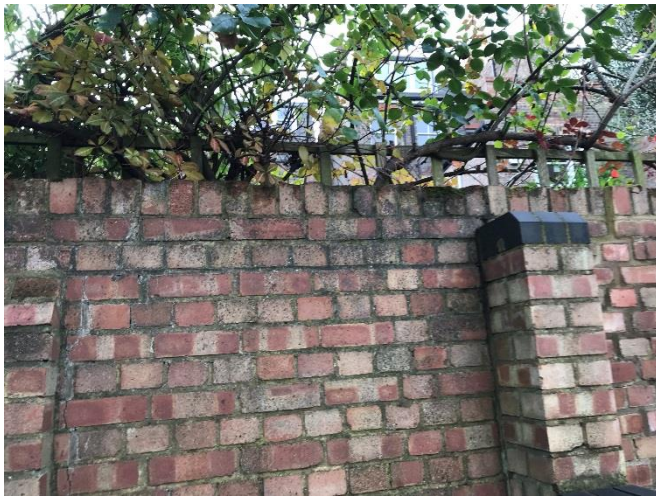
- 
- 3.37 Panel 8 was between an original buttress (buttress 8) and a more modern one (buttress 9), which was probably installed to prevent further lateral movement in the wall (see photographs 16 & 17).

- 3.38 This panel had moved between 50mm and 75mm laterally above DPC level.
  - 3.39 There was an historic vertical crack in the panel close to buttress 8.

17. High level of wall panel 8.

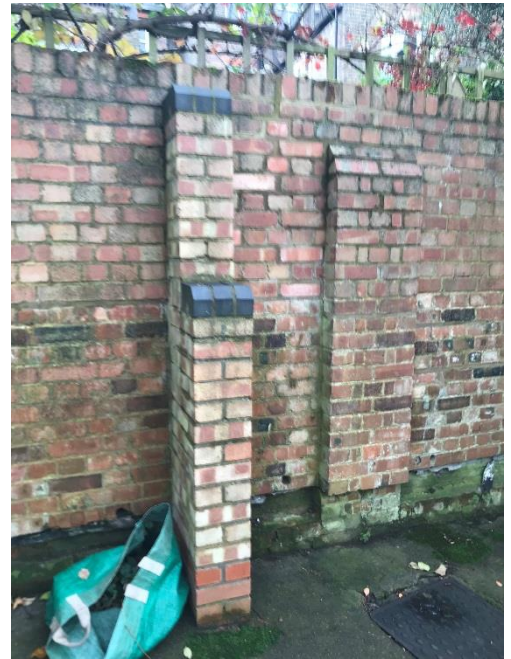
- 3.42 Buttress 9 appeared to have been constructed after the lateral movement had taken place (see photograph 18-21).
  - 3.43 This was constructed from fair faced brickwork with an engineering brick capping. This was 18" thick at the base and 9" around halfway up.

- 3.44 The buttress appeared in a reasonable condition.
  - 3.45 Panel 9 was a narrow panel around 550mm wide (see photograph 18).
  - 3.46 This had moved laterally similar to panel 8 and had friable brickwork at high level.

- 3.47 It would appear that remedial works were carried out to this wall previously as detailed by MP in 2011.
  - 3.48 This also had a weep hole that had been installed, most likely as part of the previous remedial works proposals (see photograph 18).

18. Buttress 9 & 10 and wall panel 9.

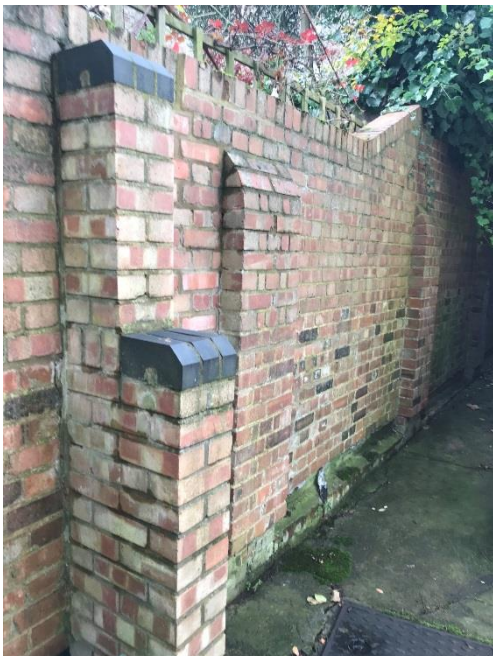
19. Buttress 9.

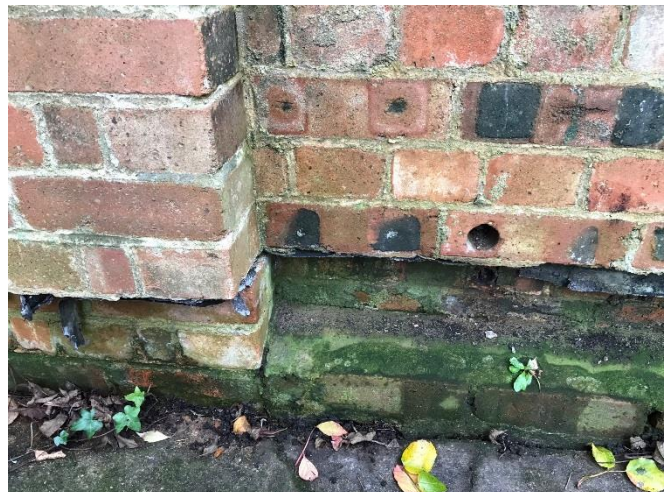
20. Low level of wall panel 9, note weep hole and lateral movement of wall.

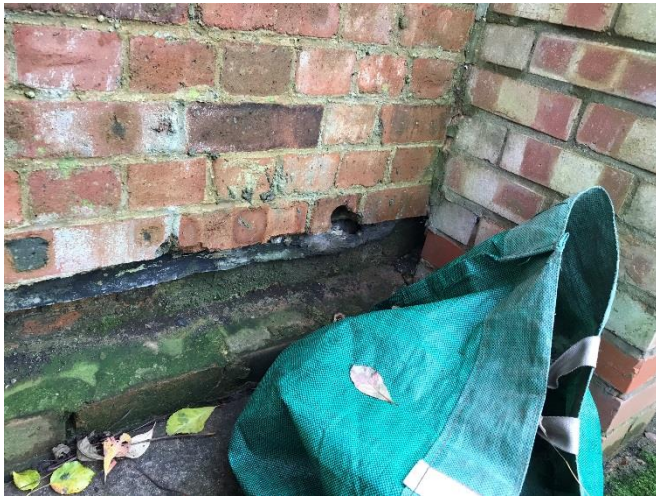
21. Low level of wall panel 8 and buttress 9, note weep hole. It would appear there has been no lateral movement since buttress 9 has been constructed.

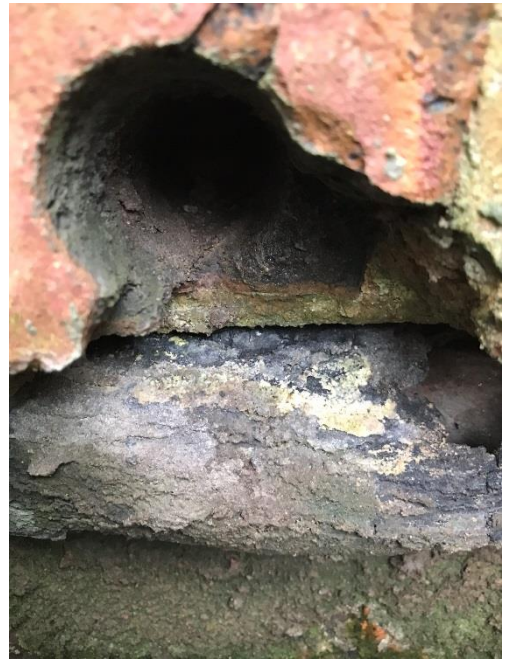
22. Close up of weep hole.

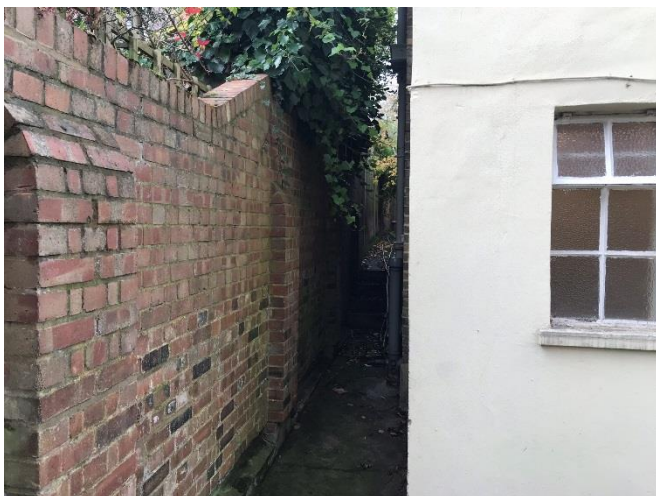
- 3.49 Buttress 10 appeared in a reasonable condition but had moved laterally similar to the previous panel (see photographs 23-24).
  - 3.50 Panel 10 was in a reasonable condition and there appeared to have been Helibar remedial works carried out on this wall previously as suggested by MP in 2011.

23. Buttress 10 and wall panel 10.

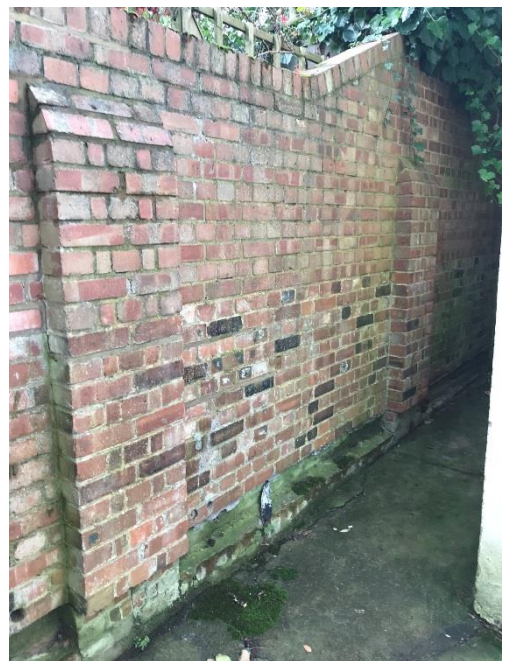
- 3.51 There were two weep holes present on this panel (see photograph 24).
  - 3.52 Panels 11 and 12 and their associated buttresses appeared in a reasonable condition apart from they had moved horizontally above DPC similar to the previous wall panels (see photographs 25-31).

24. Buttress 10 and wall panel 10.

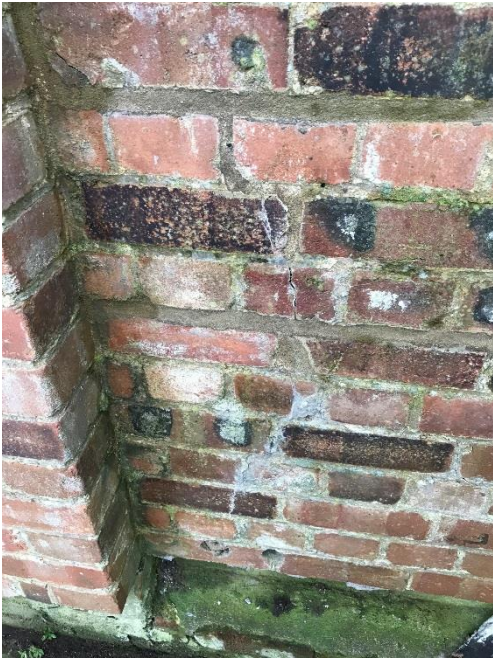
25. Low level of wall panel 10, note weep hole.

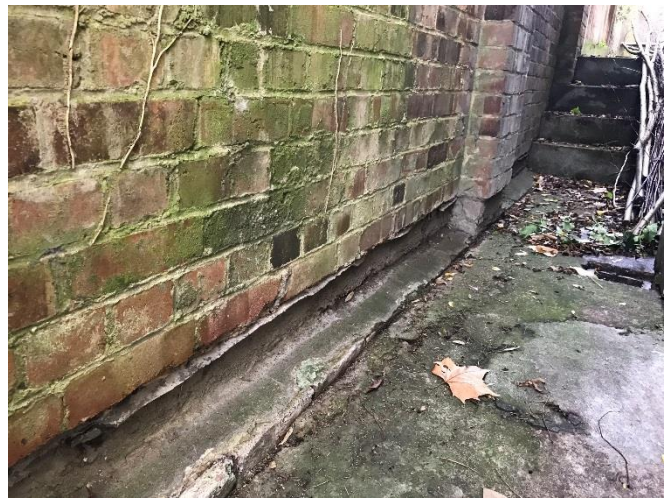
26. Low level of wall panel 10, note lateral movement above DPC.

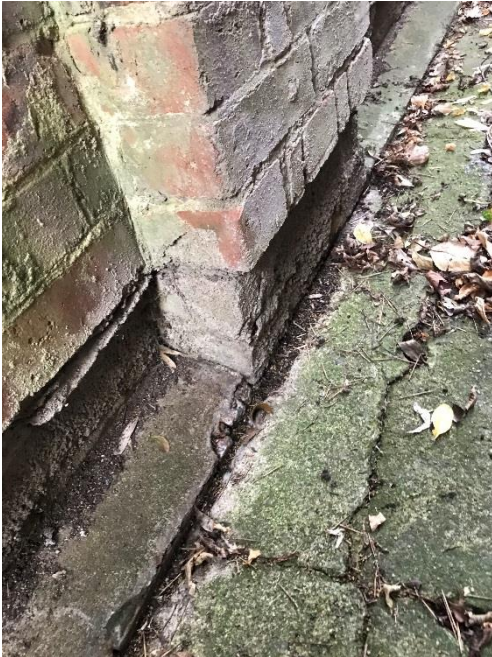
- 3.53 The horizontal movement was around 30mm.

29. Low level of buttress 11, note historic lateral movement above DPC.
