Project Name 79 Guildford Street, London WC1N 1DR	Project Number	Project Date 14/05/2018
---	-----------------------	-----------------------------------

Section Inspection - 14/05/2018 - MH01X

Site Report

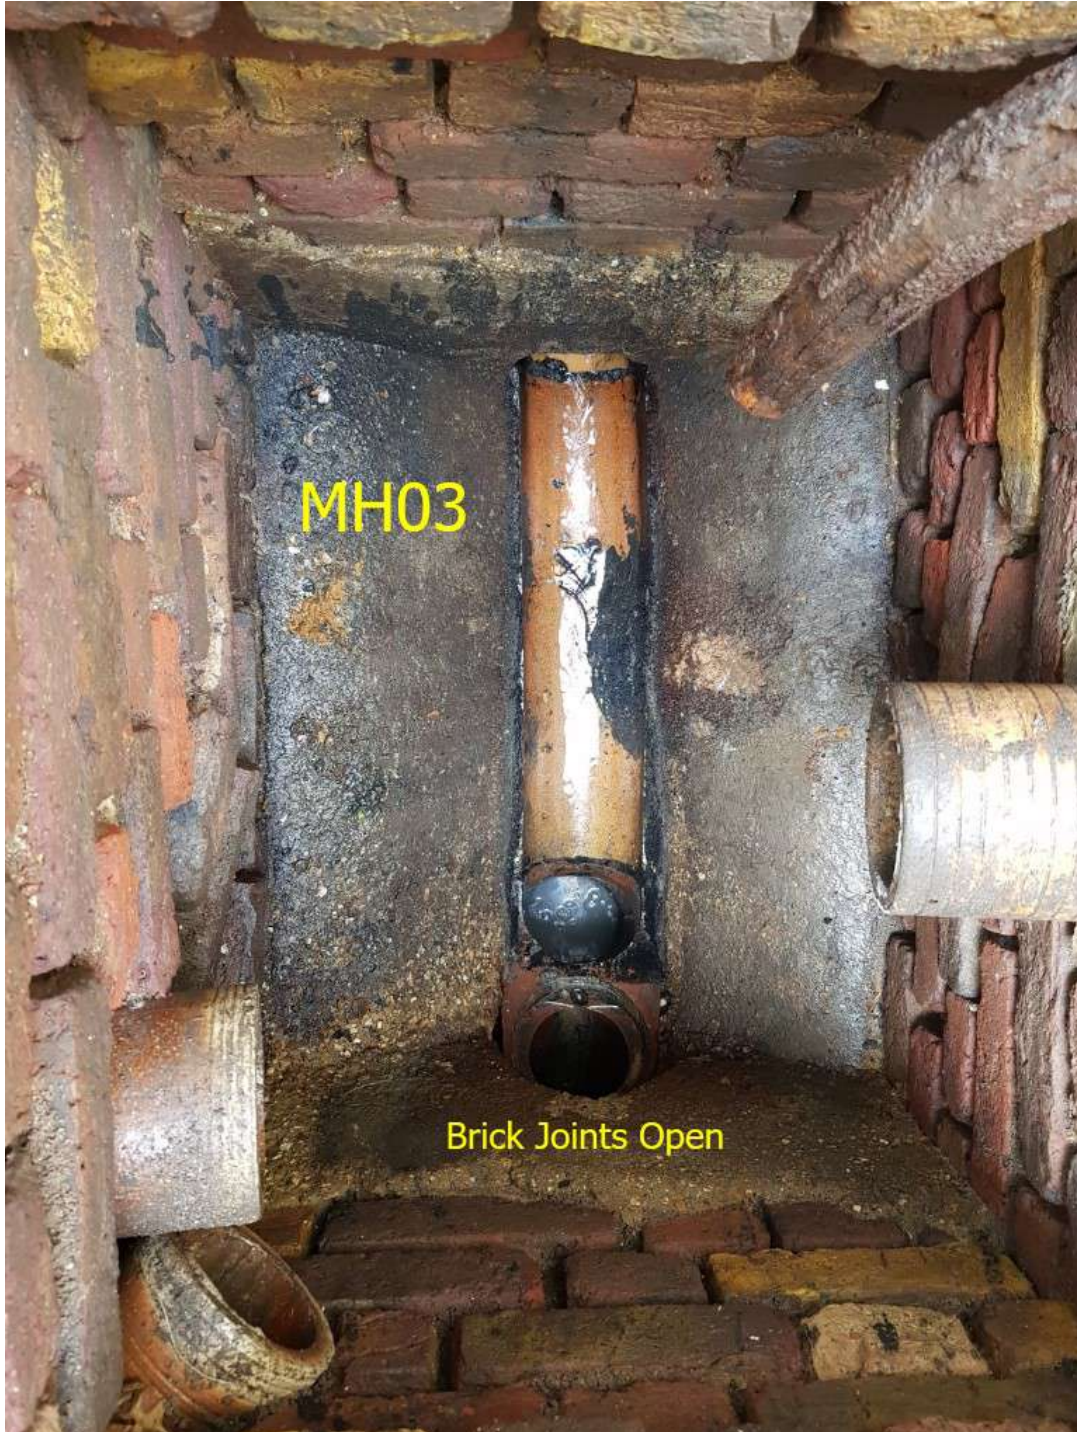
Section Drawing MH01X

Scale: 1:114	Position [m]	Code	Observation	Grade
<p>Depth: 1200.00 m</p> <p>MH03</p>				
	0.00	WL	Water level, 0% of the vertical dimension	
	0.00	IC	Start node type, inspection chamber, reference number: MH03	
	2.52	IC	Start node type, inspection chamber, reference number: MH02: MANHOLE SITUATED IN PROPERTY	
	5.66	S01 DEC	Settled deposits, hard or compacted, 5% cross-sectional area loss, start	
	8.71	GP	General photograph taken at this point: PHOTO OF SCALE	
	10.66	F01 DEC	Settled deposits, hard or compacted, 5% cross-sectional area loss, finish	4
	13.10	ICF	Finish node type, inspection chamber, reference number: MH01: BURIED MANHOLE REAR OF PROPERTY BENEATH DECKING	
<p>MH01</p> <p>Depth: m</p>

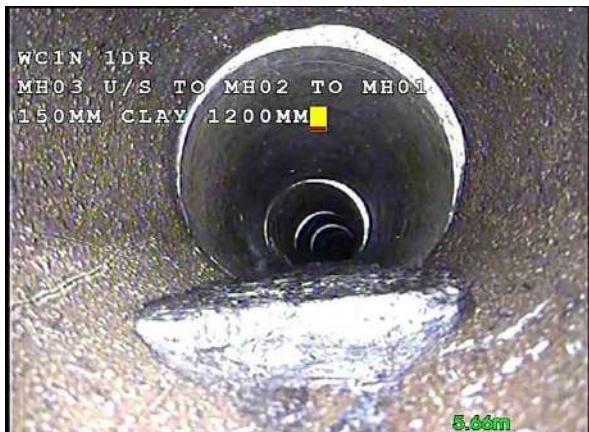
MH01X_cf1ed632-094b-4c90-9aed-09c6bcffc7b1_20180520_170938_300.jpg, 00:01:05, 5.66 m
Settled deposits, hard or compacted, 5% cross-sectional area

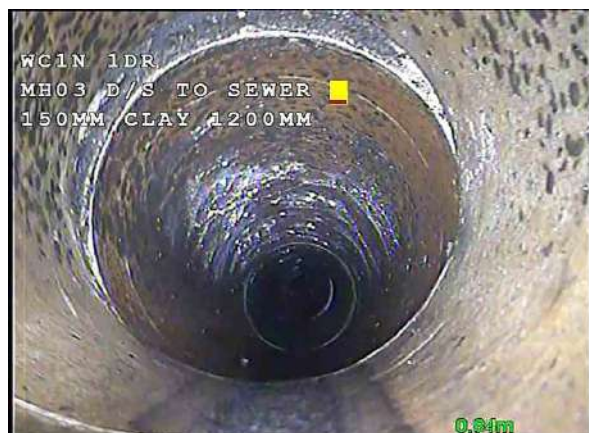
MH03X_61e378b2-d115-4780-bfc5-56fde129f536_20180520_171601_747.jpg, 00:00:13, 0.94 m
Joint displaced, medium

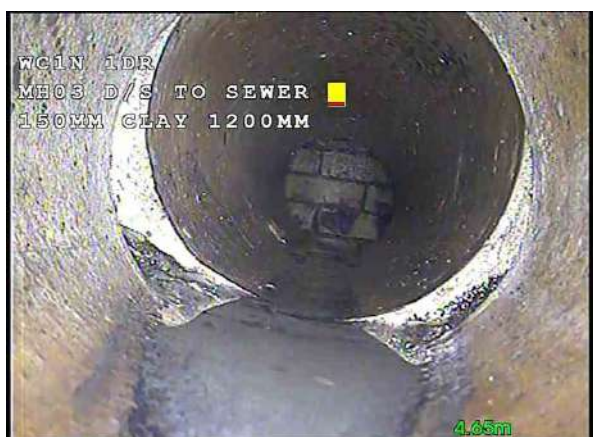
MH03X_db4c3902-a805-424c-9d19-91b8378396aa_20180520_171714_316.jpg, 00:00:42, 4.65 m
Joint displaced, large

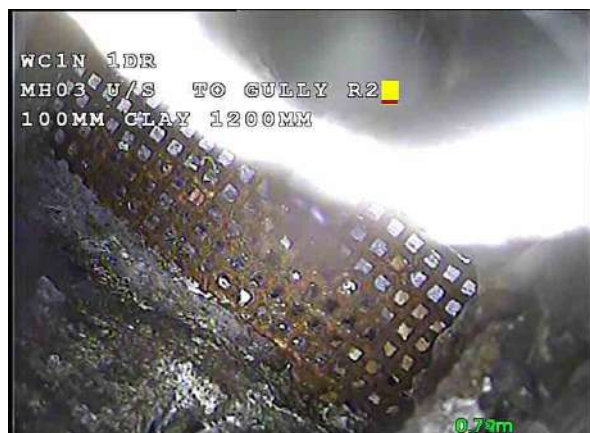
Scale: 1:50	Position [m]	Code	Observation	Grade
	0.00	WL	Water level, 0% of the vertical dimension	
	0.00	IC	Start node type, inspection chamber, reference number: MH03	
	0.71	GYF	Finish node type, gully, reference number: GULLY 2: GULLY WITH NO TRAP TO PREVENT RODENTS OR SEWER GASES FROM RISING

Town or Village:		Inspection Direction: Upstream		Upstream Node: GULLY 2	
Road:	79 Guildford Street	Inspected Length: 0.71 m		Upstream Pipe Depth:	
Location:	Gardens (within private property)	Total Length: 0.71 m		Downstream Node: MH03	
Surface Type:		Joint Length: 0.00 m		Downstream Pipe Depth: 1,200.000 m	
Use:	Combined			Pipe Shape: Circular	
Type of Pipe:	Gravity drain/sewer			Dia/Height: 100 mm	Width: 100 mm
Year Constructed:				Pipe Material: Vitrified clay pipe	
Flow Control:	No flow control			Lining Type: None	
Inspection Purpose:				Lining Material: None	
Comments:	NO TRAP WITHIN GULLY TO PREVENT SEWER GASES OR RODENTS				
Recommendations:	BY METHOD OF EXCAVATION, INSTALL A 110MM PVC TRAPPED GULLY

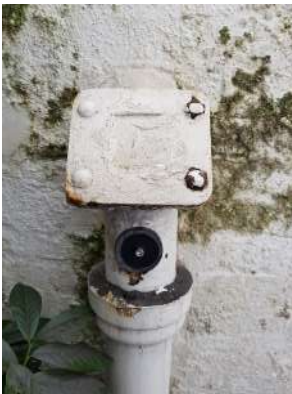
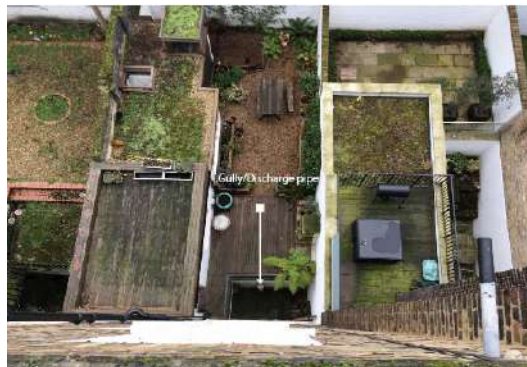
A CCTV survey was successfully carried out upstream to find it leads to either a gully or a discharge pipe at 1.9 metres.

Following this, a dye test was carried out from the SVP located in the rear garden for over 15 minutes and there was no evidence of dye in the interceptor located in the front garden.

I do not believe the SVP to be connected to the foul drainage system of 79 Guildford Street, however; there may be a pump chamber under the decking, deck boards should be removed and area inspected.
