### Level and Crack Monitoring

11/03/2019

| Address: | 54 Camden Square |
| Town: | London |

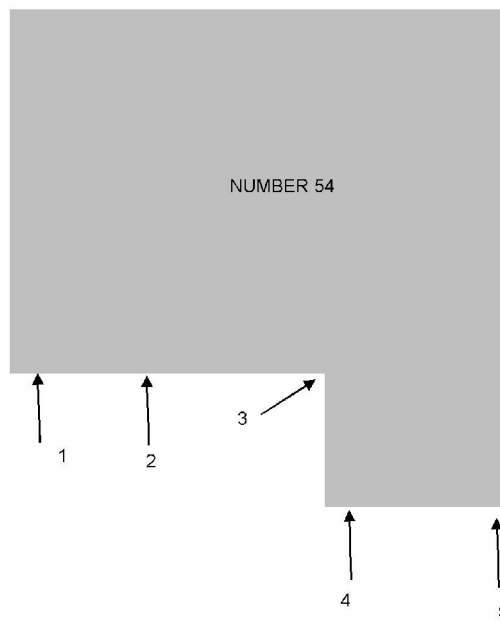
**Level and Crack Monitoring - Site Sketch**

TBM HILTI NAIL  
IN KERB

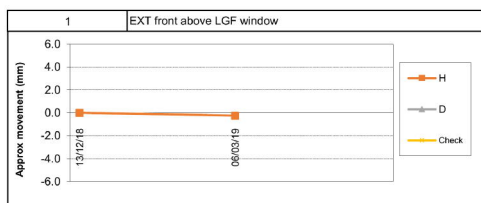
### Crack Monitoring - Movement Against Time

| 1 | EXT front above LGF window |

| Studs nos | Align-ment | Visit Date | 13/12/18 | Visit Date | 06/03/19 | Visit Date | | Visit Date | | Visit Date | | Visit Date | |
|---|---|---|---|---|---|---|---|---|---|---|---|---|---|
| 1 | H | 59.22 | 1.72 | 69.98 | 1.40 | | | | | | | | |
