Job Title  
Fenton House

Report Type  
Appraisal of Boundary Walls

Prepared for  
The National Trust

Date  
November 2017

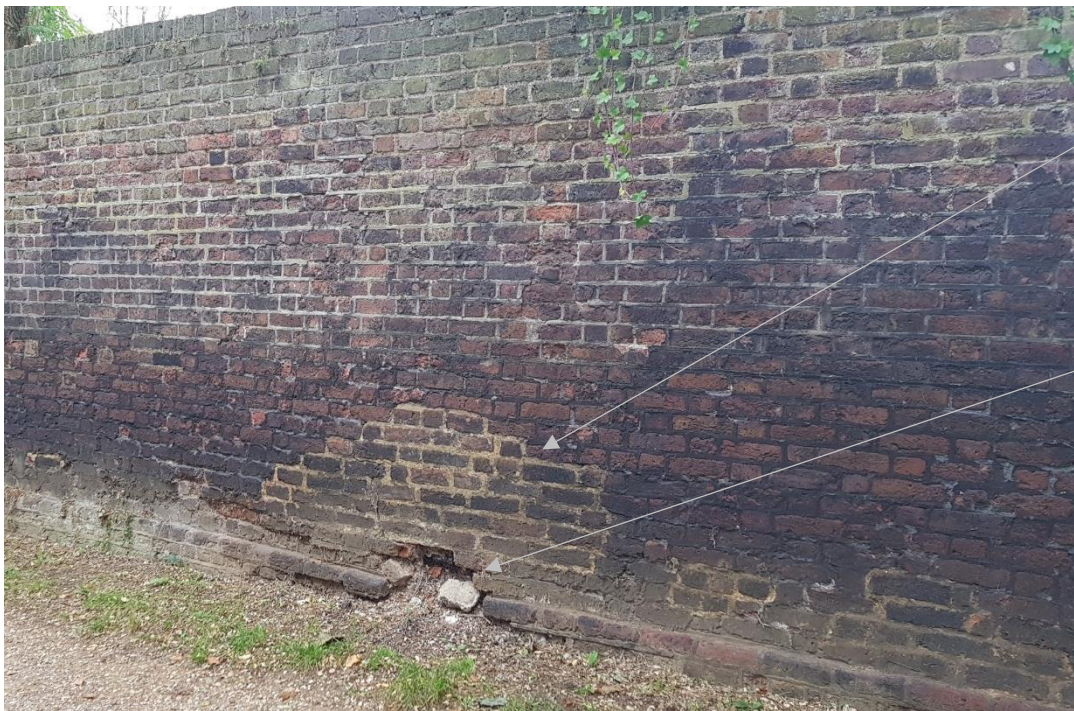
Figure 4 - Local repairs along surveyed section of boundary wall

Archived information collated from the National Trust Property Office at Fenton House, alongside visual inspection, indicated the section of boundary wall surveyed has been rebuilt in some sections. More specifically, within the surveyed section of the leaning boundary wall, the bottom of the wall where the Robinia pushes the inner face of the wall has been repaired, as also noted in the Quinquennial 2016. However, it is unclear when this was carried out, and from visual inspection, it is clear that damage is continuing to be caused by the tree trunk. See Figure 4 below.

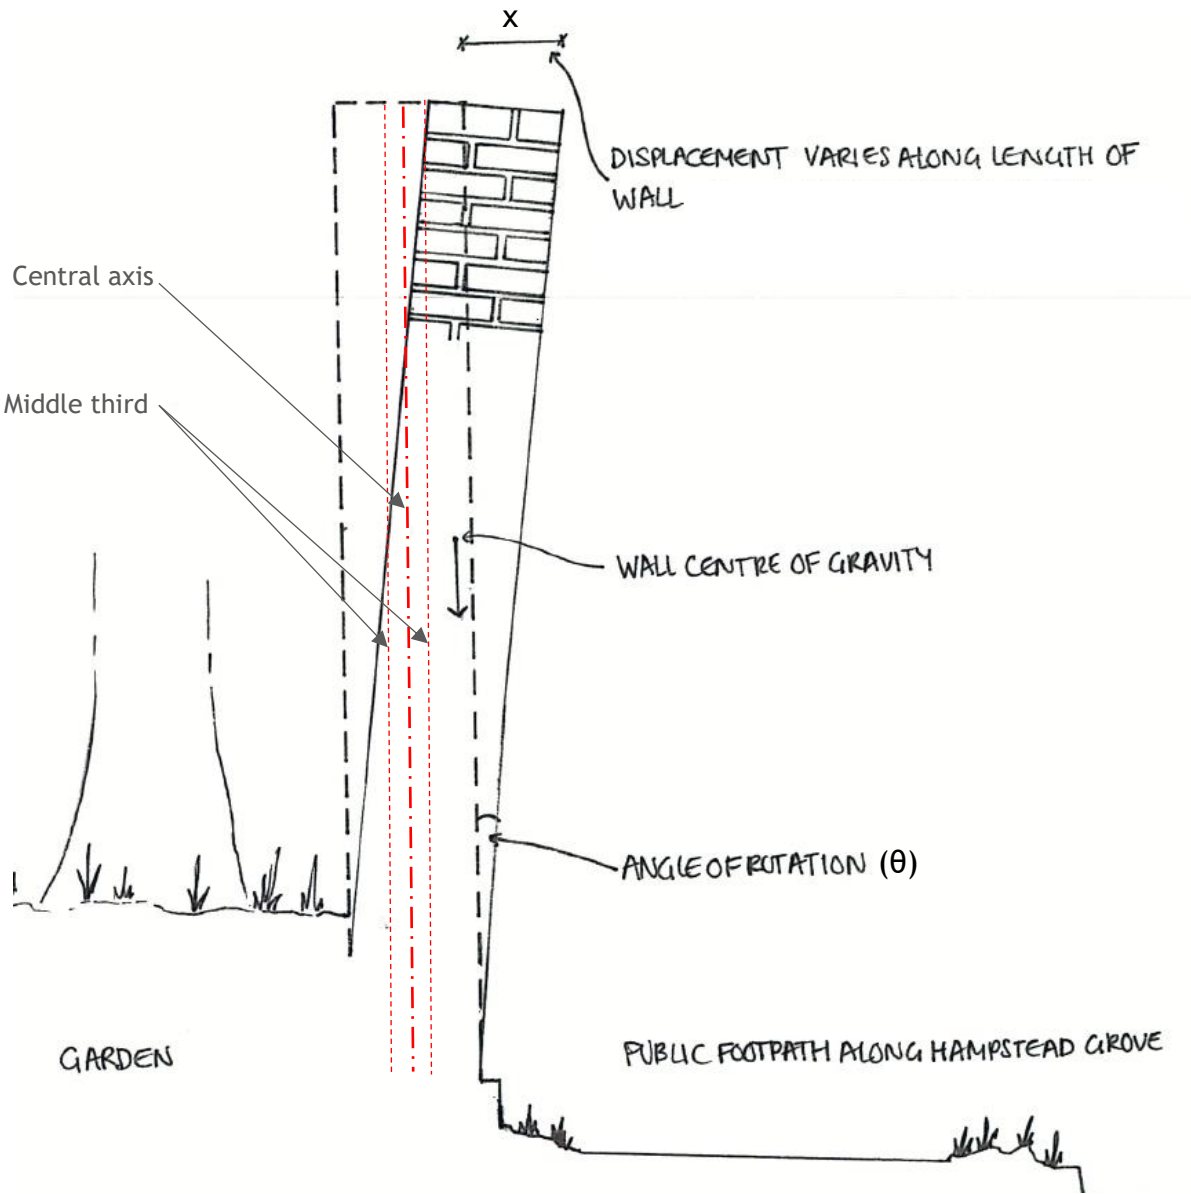
Figure 8 - Overturning of the eastern wall (see Figure 9 for values of x and θ)

- Measured from the bottom of the wall, at its maximum, the wall leans 270mm (5.9°). This is a critical lean, recognised by the centre of gravity (140mm from the central axis) located outside of the middle third of the base (60mm from the centre) (see Figure 8)

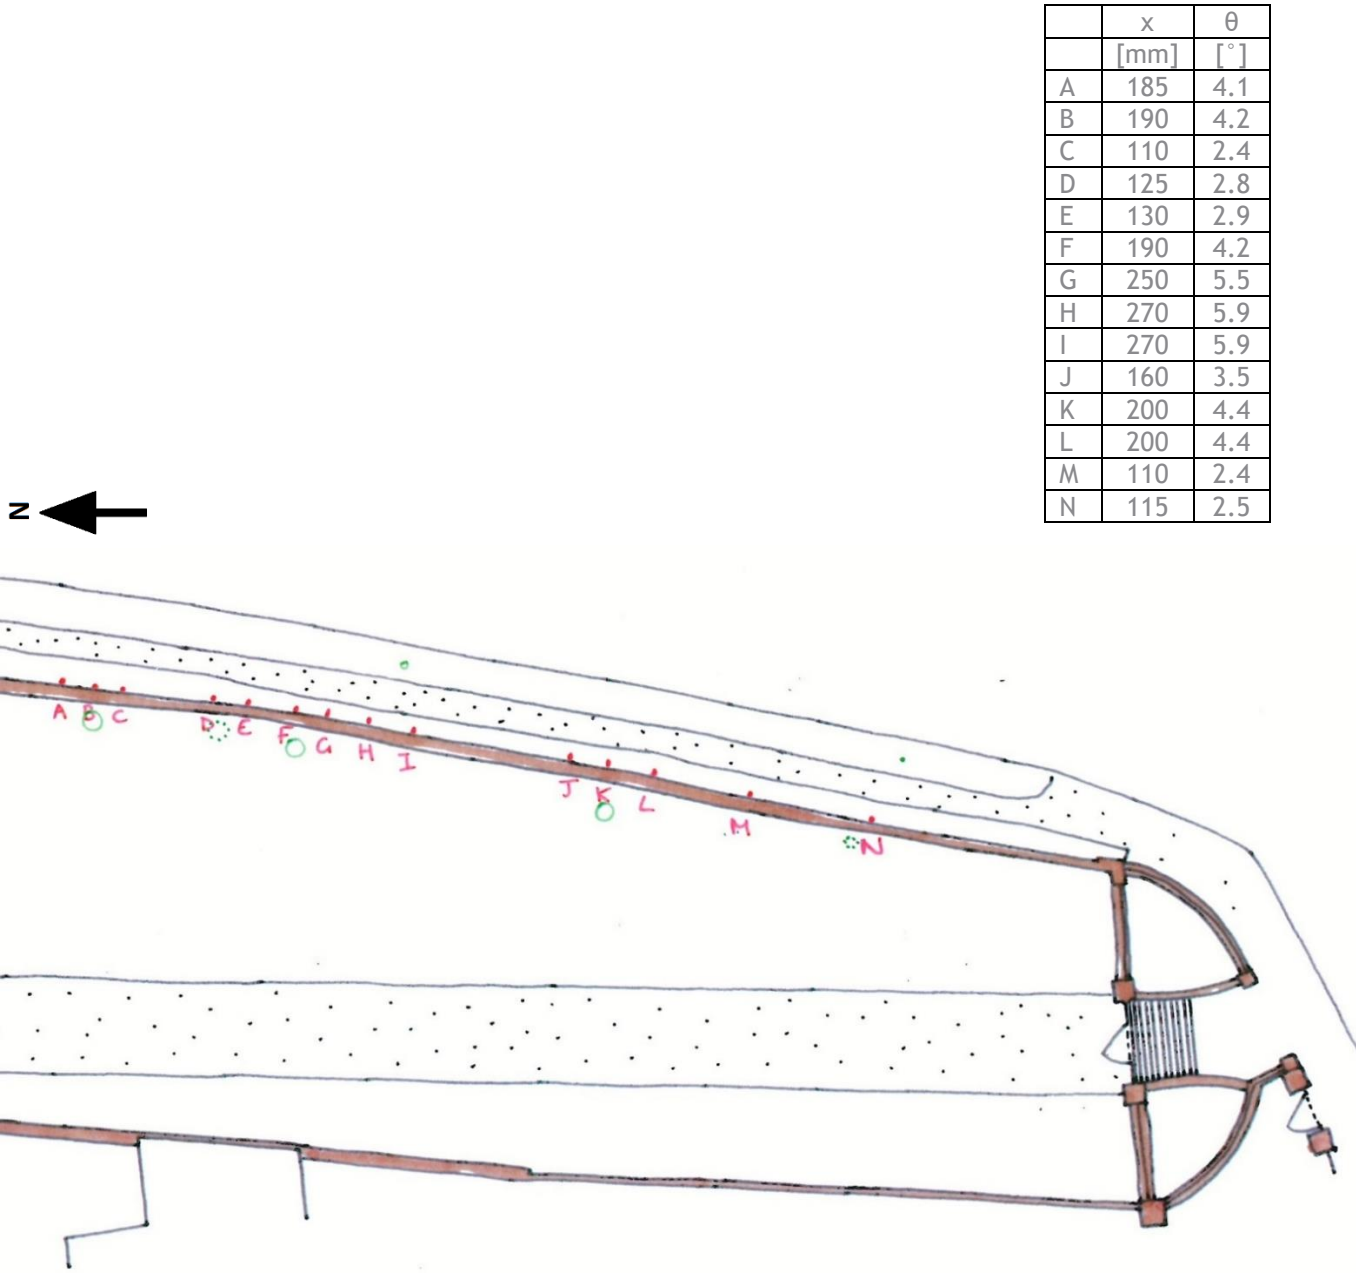
Figure 9 - Location of and measurements taken along the leaning boundary wall

As outlined in Section 2.1, the wall is leaning in an eastern direction, onto the public highway. Vertical measurements were taken during the site survey along the southern section of the boundary wall. The results can be found below in Figure 9.

- The wall is 360mm wide, 2.7m high on the highway side, and 2.15m high on the internal side, tilting by various degrees along the surveyed section.
- The trunk of a large Robinia is touching the inner face of the boundary wall, pushing out the bottom of the wall (at point K in Figure 9, Figures 10 and 11).

It is believed that the cause of the tilt along the surveyed section of the wall is likely to be associated with the tree growth near the wall, as the roots undermine and damage the foundations.

The lean is too significant to do nothing due to the risk of collapse into the public highway, remedial works are critical. The following remedial works have been identified, and are outlined further in Section 5.1:

- The wall needs to be stabilised and further overturning prevented.
- Consideration should be given to correcting the verticality of the wall, similar to earlier works carried out to the section further north, as identified in Section 2.2.
- Consideration should be given to removing some of the trees.

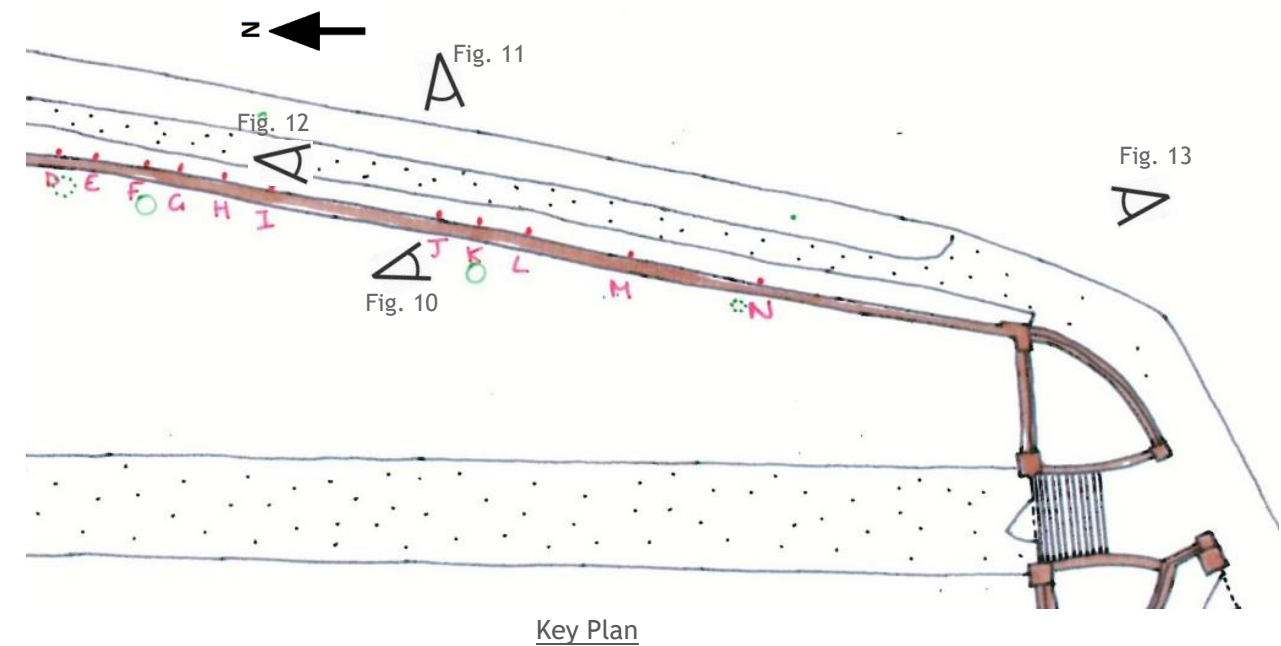
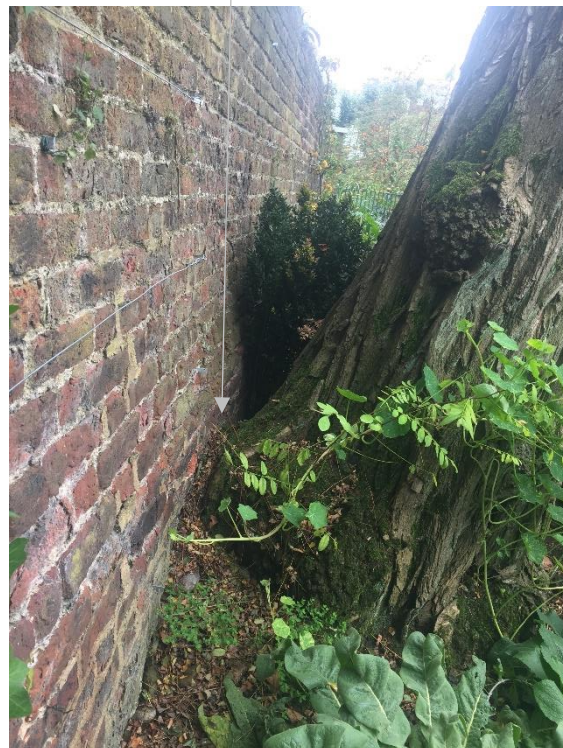
Figure 10 - Robinia pushing inner side of wall

Robinia pushing against the boundary wall at location K (Figure 7)

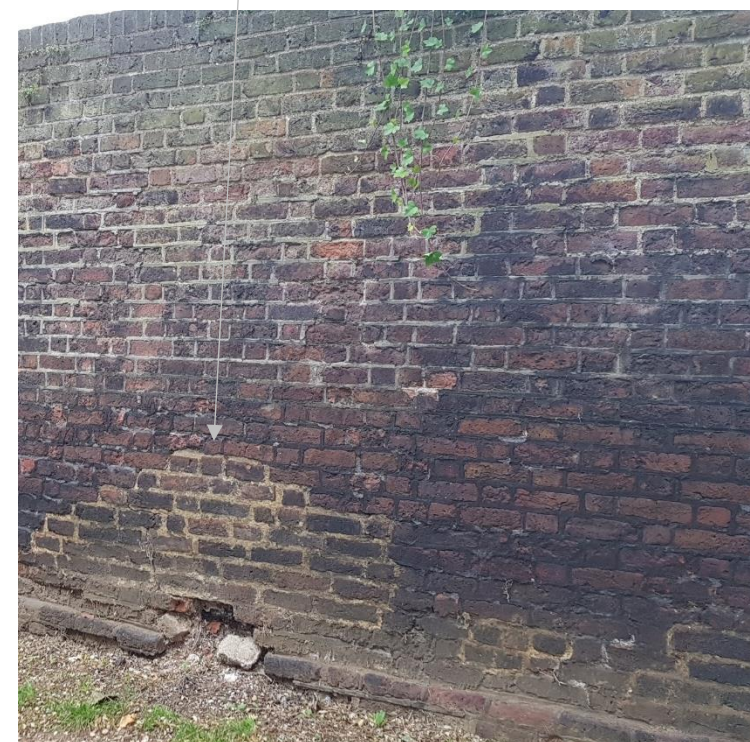
Figure 11 - External view of point K

- There is evidence of sections along the base of the wall that have been reset and repointed, but continuous pressure has caused localised cracking and fallen bricks onto the public footpath (Figure 11).

Robinia pushing against the boundary wall at location K (Figure 7) view from public highway

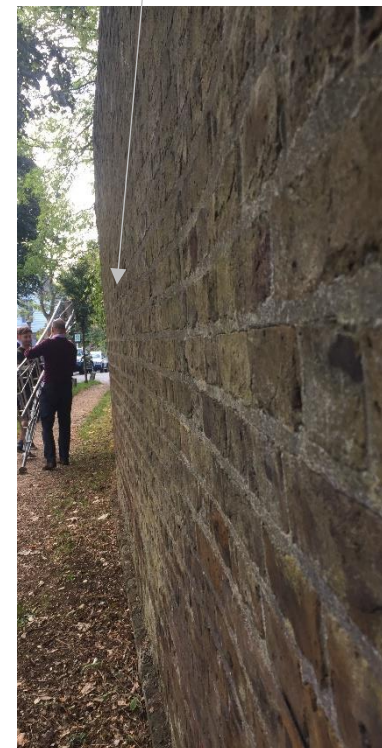
Figure 12 - Lean of wall

Lean of boundary wall

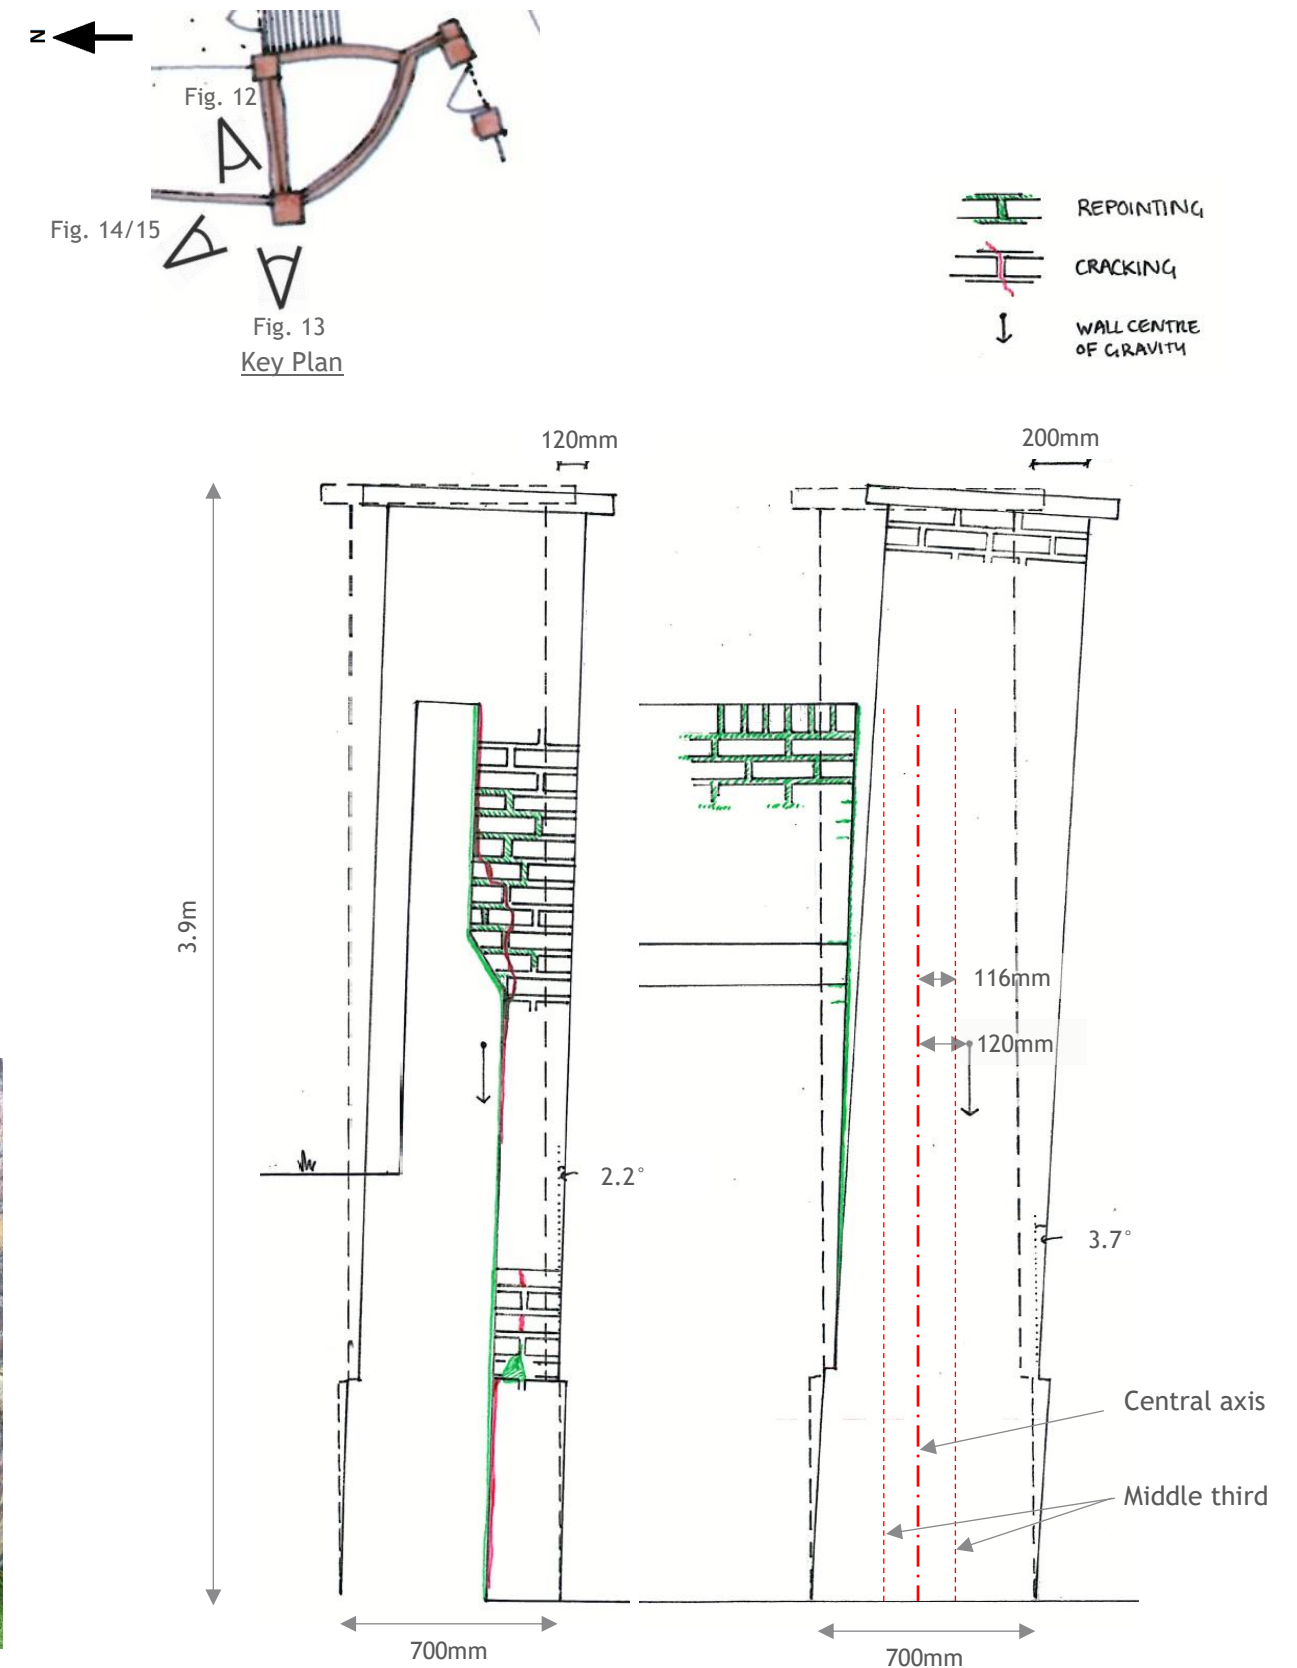
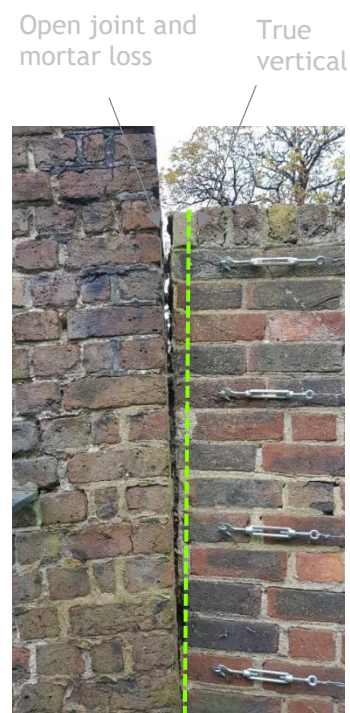
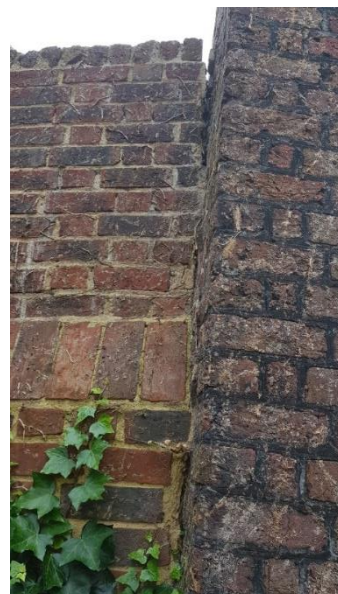
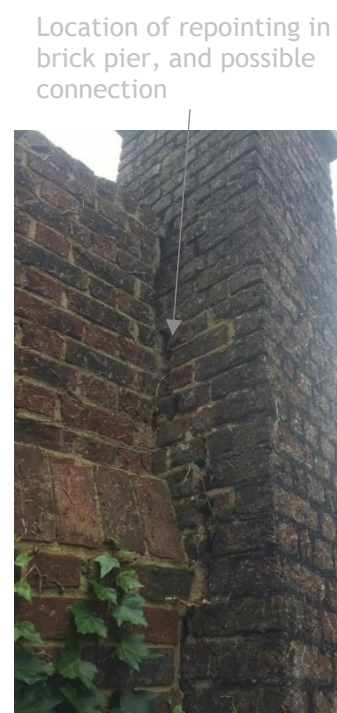
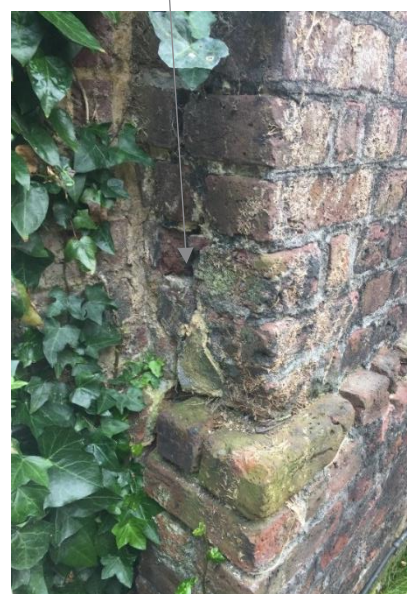
Figure 18 - Northern elevation of pier (left) Western elevation of pier (right)

- The pier is 700mm by 700mm in plan, and 3.9m high at its tallest point.
- The western party wall has been rebuilt, and is leaning where it meets the pier. Since this reconstruction, the pier has displaced further, creating a larger joint between the wall and the pier, as shown in Figures 14 and 15.
- Mortar loss where the pier meets the single skin party wall, as shown in Figures 14 and 15.
- Measured from 3.1m down the pier, the pier leans at 120mm (2.2°) to the west, and 200mm (3.7°) to the south. This is a critical lean, recognised by the centre of gravity (120mm from the central axis) located outside of the middle third of the base (116mm from the centre) (see Figure 18).
- Viewing from the adjacent property, there appears to be a horizontal block bonded connection between the pier and the party wall, as shown in Figure 16.

The root of the movement of the pier is concluded to be weakness and movement of the ground underneath the pier foundation.

The lean is too significant to do nothing due to the risk of collapse into the public highway, remedial works are critical. The following remedial works have been identified, and are outlined further in Section 5.2:

- The pier needs be stabilised and further overturning prevented.
- The open joint between the pier and the wall is to be repaired to prevent ingress of water or vegetation.
- The existing tie between the pier and connecting wall should be improved.
- Consideration should be given to stabilising the foundation by improving the ground conditions underneath it.

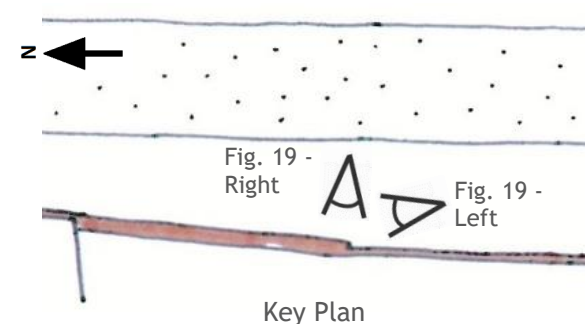
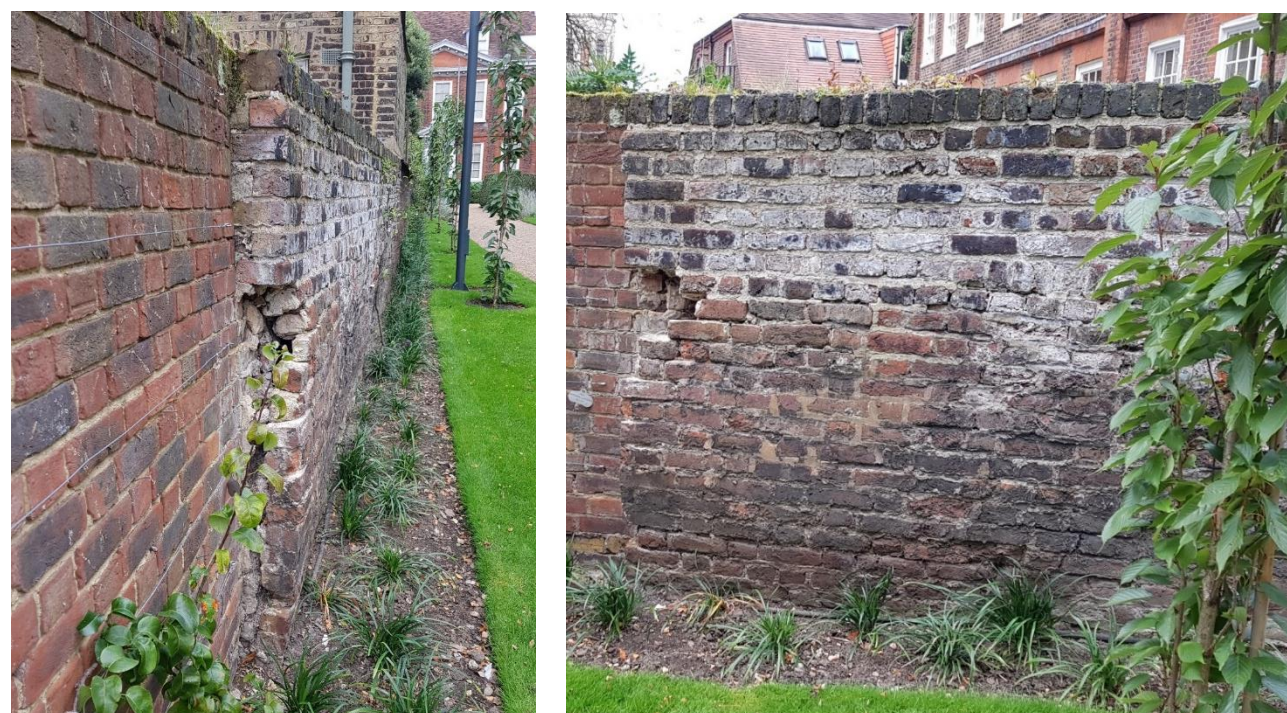
The double skin party wall as an approximate height of 1.8m, and width of 300mm. From the site survey, the double skin party wall appears to be delaminating, where the internal skin is breaking away from the rest of the wall.

The section of the wall where the change from a single skin to a double skin is where the worst of the delamination is, with an open joint at the intersection, as shown in Figure 19 below. As can be seen in Figure 19, this movement has also caused masonry loss.

Figure 19 - Opening from delamination of inner skin

It is believed the delamination occurring in the party wall is caused from plant roots initially, most likely ivy roots, that have now been removed. Further delamination has occurred from the internal cavity filling up with debris and broken mortar, alongside ingress and retention of water, which expands when freezing, causing an increase in pressure.

The following remedial works have been identified, and are outlined further in Section 5.3:

- Internal layer should be stabilised, by tying the layers together effectively.
- The cavity should be filled in and closed up to prevent water ingress.
- Vegetation should be monitored to prevent further delamination along the party wall.
