CATHOLIC CHAPLAINCY
for London's Universities

Window Condition Survey

Newman House, 111 Gower Street, London, WC1E 6AR

Newman House Window Condition Survey

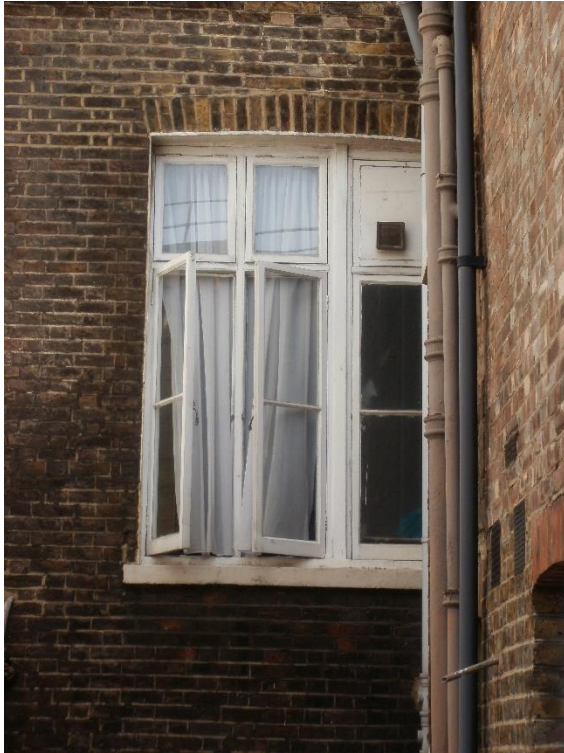
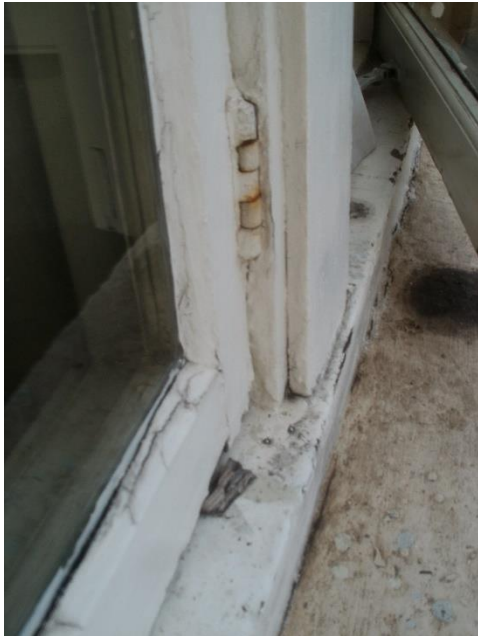
Sheet Number NH/01: - Rooms 106 and 108 – First Floor 111 Gower Street

This 6 panel softwood painted single glazed casement window serves First Floor student bedrooms 106 and 108.

- Frames and Opening casement leafs are twisted and the windows do not close properly.
- The Moisture content of the wood in the frames and cill range from 25% to 32%.
- The hinges supporting the casement leafs are rusty, unstable and fixed into decayed timber frames.

The oversized mullion to the right hand side of the open casement leafs in the photo, is in line with the position of the dividing partition between two rooms and would suggest these windows were manufactured and installed when the internal space was divided into two rooms and probably when the buildings were developed into a hotel circa 1932.

In our opinion like for like replacement in this instance would not unduly cause harm or significantly impede the historical importance of the building.

The woodwork is in an advanced state of decay necessitating replacement to maintain safety and security of the complete window.

There is a risk of casement leafs falling out and injuring persons below in the courtyard or risk of injuring a person as they open the window if new leafs are fitted into existing decayed timber frames.

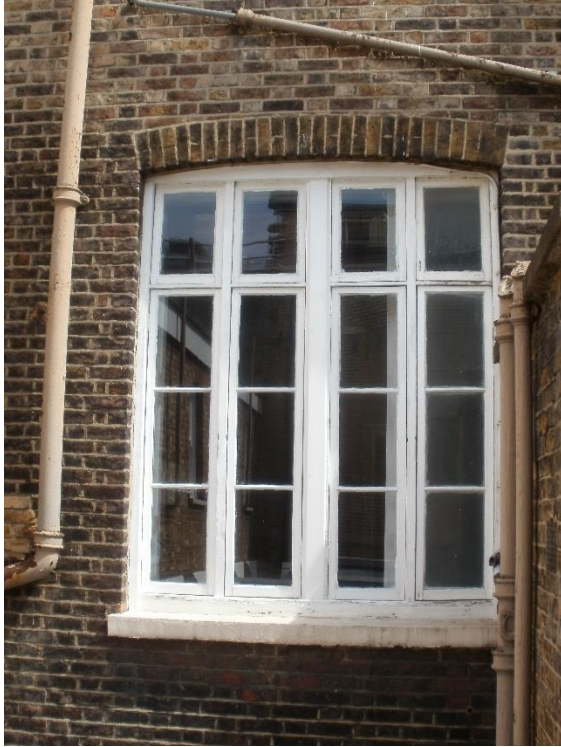
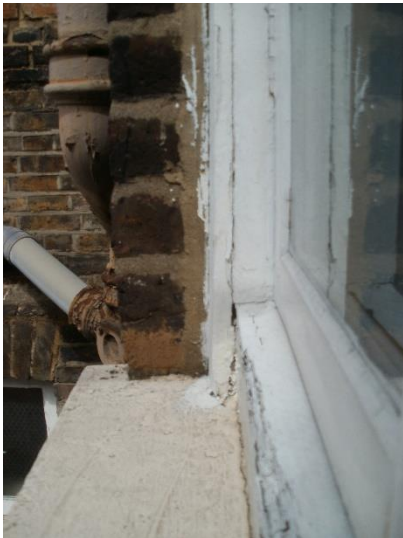
Sheet Number NH/02: - Room 109 – First Floor 109 Gower Street

This 8 panel softwood painted single glazed casement window serves First Floor student bedroom 109

- Frames and Opening casement leafs are twisted and the windows do not close properly.
- The Moisture content of the wood in the frames and cill range from 25% to 32%.
- The hinges supporting the casement leafs are rusty, unstable and fixed into decayed timber frames.

The oversized mullion on this window is in the centre of the opening differing also to the casement windows to the First floor elevations to 107 and 111 Gower Street.

In our opinion like for like replacement in this instance would not unduly cause harm or significantly impede the historical importance of the building.

The woodwork is in an advanced state of decay necessitating replacement to maintain safety and security of the complete window.

There is a risk of casement leafs falling out and injuring persons below in the courtyard or risk of injuring a person as they open the window if new leafs are fitted into existing decayed timber frames.

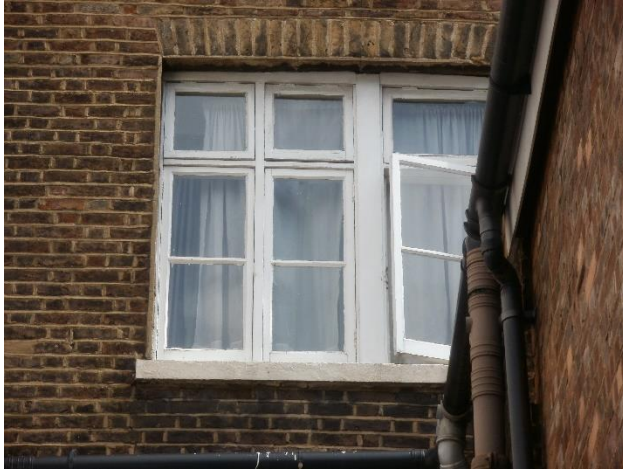
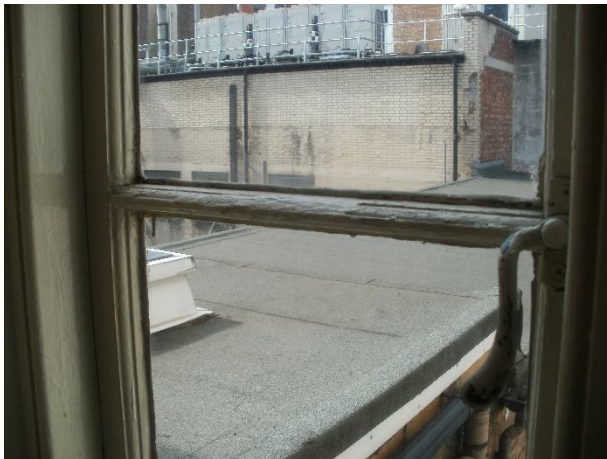
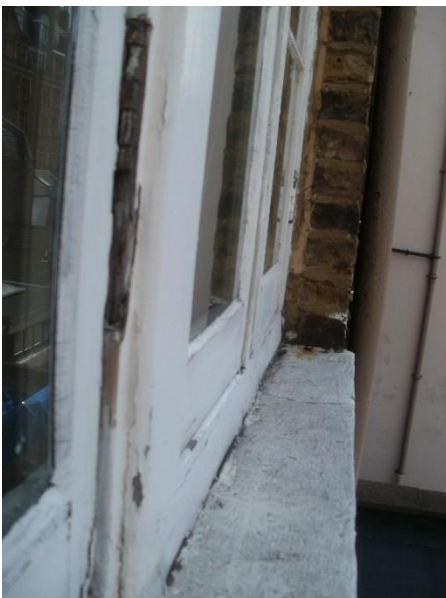
Sheet Number NH/03: - Room 206 -208 – Second Floor 111 Gower Street

This 6 panel softwood painted single glazed casement window serves Second Floor student bedrooms 206 and 208.

- Frames and Opening casement leafs are twisted and the windows do not close properly.
- The Moisture content of the wood in the frames and cill range from 25% to 32%.
- The hinges supporting the casement leafs are rusty, unstable and fixed into decayed timber frames.

The oversized mullion to the right hand side of the open casement leafs in the photo, is in line with the position of the dividing partition between two rooms and would suggest these windows were manufactured and installed when the internal space was divided into two rooms and probably when the buildings were developed into a hotel circa 1932.

The oversized mullion on this window also differs to the other casement windows to the second floor elevations. In our opinion like for like replacement in this instance would not unduly cause harm or significantly impede the historical importance of the building.

The woodwork is in an advanced state of decay necessitating replacement to maintain safety and security of the complete window.

There is a risk of casement leafs falling out and injuring persons below in the courtyard or risk of injuring a person as they open the window if new leafs are fitted into existing decayed timber frames

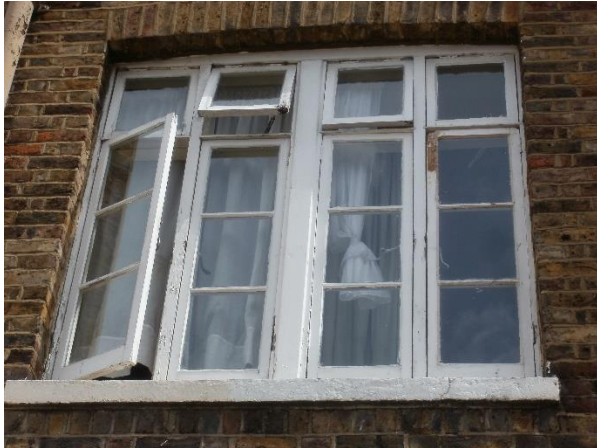
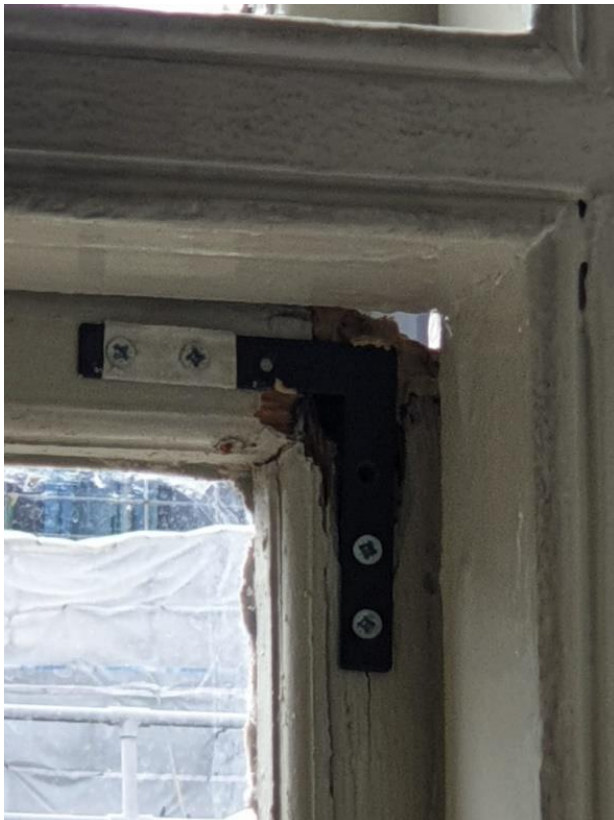
Sheet Number NH/04: - Room 212 -214 – Second Floor 109 Gower Street

This 8 panel softwood painted single glazed casement window serves Second Floor student bedrooms 212 and 218

- Frames and Opening casement leafs are twisted and the windows do not close properly.
- The Moisture content of the wood in the frames and cill range from 25% to 32%.
- The casement leafs are unstable and temporarily fixed together using L brackets.
- These windows are in a dangerous condition.

The oversized mullion in the photo is in line with the position of the dividing partition between two rooms and would suggest these windows were manufactured and installed when the internal space was divided into two rooms and probably when the buildings were developed into a hotel circa 1932.

The oversized mullion on this window also differs to the other casement windows to the second floor elevations.

In our opinion like for like replacement in this instance would not unduly cause harm or significantly impede the historical importance of the building.

The woodwork is in an advanced state of decay necessitating replacement to maintain safety and security of the complete window.

There is a risk of casement leafs falling out and injuring persons below in the courtyard or risk of injuring a person as they open the window if new leafs are fitted into existing decayed timber frames

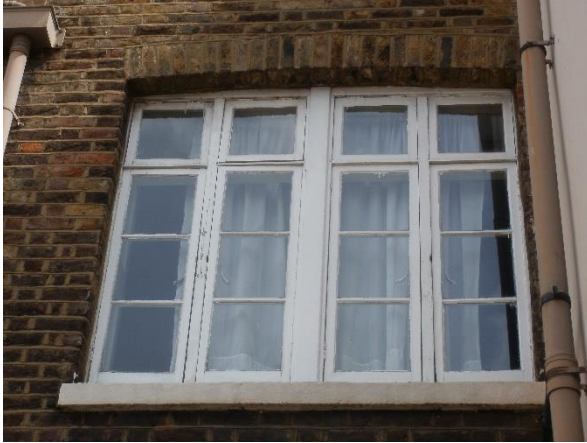
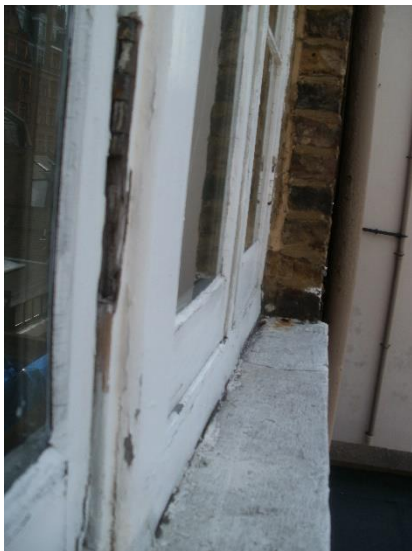
Sheet Number NH/05: - Room 217 -219 – Second Floor 107 Gower Street

This 8 panel softwood painted single glazed casement window serves Second Floor student bedrooms 217 and 218

- Frames and Opening casement leafs are twisted and the windows do not close properly.
- The Moisture content of the wood in the frames and cill range from 25% to 32%.
- The hinges supporting the casement leafs are rusty, unstable and fixed into decayed timber frames.

The oversized mullion in the photo is in line with the position of the dividing partition between two rooms and would suggest these windows were manufactured and installed when the internal space was divided into two rooms and probably when the buildings were developed into a hotel circa 1932.

The oversized mullion on this window also differs to the other casement windows to the second floor elevations.

In our opinion like for like replacement in this instance would not unduly cause harm or significantly impede the historical importance of the building.

The woodwork is in an advanced state of decay necessitating replacement to maintain safety and security of the complete window.

There is a risk of casement leafs falling out and injuring persons below in the courtyard or risk of injuring a person as they open the window if new leafs are fitted into existing decayed timber frames.

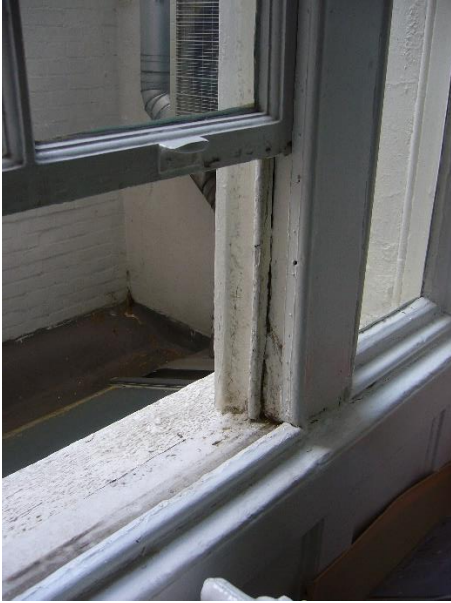
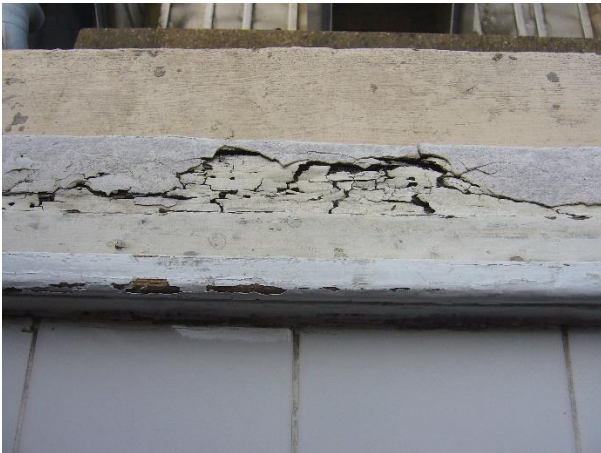
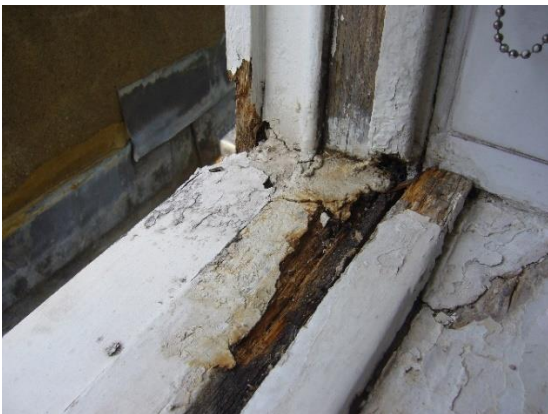
Sash Window Repairs

The Sash Windows to the rear of the buildings that make up 107 113 Gower Street are in a varying state of disrepair and require repair work as described on the window schedule issued as part of the Listed Building Consent application and supplemented with photos and general description of repair shown below.

- The Sash Windows have varying degrees of decay to the cills, sashes and frames.
- Some sliding sashes are seized or broken and need replacing on several windows.
- Pull cords and sash cords need replacing on several windows.

The sash window frames form part of the original building and will be retained.

The woodwork is in an advanced state of decay in parts and require repairs and splicing in of new timber grafts to the various components of the sash windows:

- Splicing in of new sections of cills.
- Splicing in new sections of sash runners.
- Replacement of sliding sashes where required all other components of the original window will be retained.
