Arboricultural Consultancy for Co-operative Insurance Society

Insured	Mr Ralph Carre	Address	31 Hillway, London, N6 6QB		
Client	Subsidence Management Services	Contact	Kellie Ball	Claim No.	
ES Ref		Consultant	Lewis Fraser	Contact No.	
Report Date	04/02/2019

Scope of Report: To survey the property and determine significant vegetation contributing to subsidence damage, make recommendation for remedial action and assess initial mitigation and recovery prospects. The survey does not make an assessment for decay or hazard evaluation.

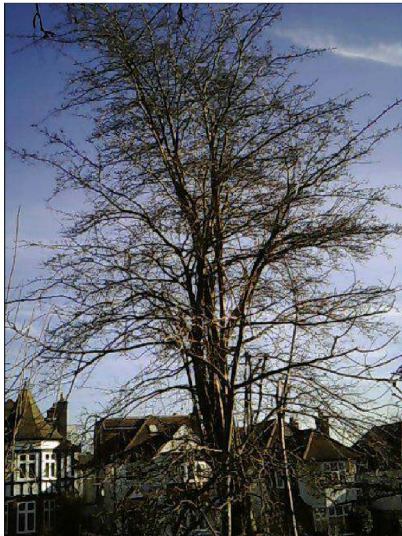
T3 - Hawthorn

In assessing the extent of damage, the potential drying influence of the vegetation on site and based on our site investigations, taking account of vegetation location, relative to the focal area of movement/ damage, it is our opinion that, T3 (Hawthorn) and H1 (Pyracantha) are considered the dominant features and accordingly we have identified them as the principal cause of the subsidence damage.

Removal of T3 (Hawthorn) and H1 (Pyracantha) will offer the most certain and reliable arboricultural solution likely to restore long-term stability.

Tree No.	Species	Age Cat	Approx. Height (m)	Distance to Building (m) *	Ownership	Action	Requirement
H1	Pyracantha	1	2	0.1	C - Insured	Remove	Remove close to ground level and treat stumps to inhibit regrowth.
T3	Hawthorn	1	8.3	5.2	C - Insured	Remove	Remove close to ground level and treat stump to inhibit regrowth.
