SJ Stephens Associates

23rd May 2019

Re: Lime tree at rear of garden of 32 Denning Road.

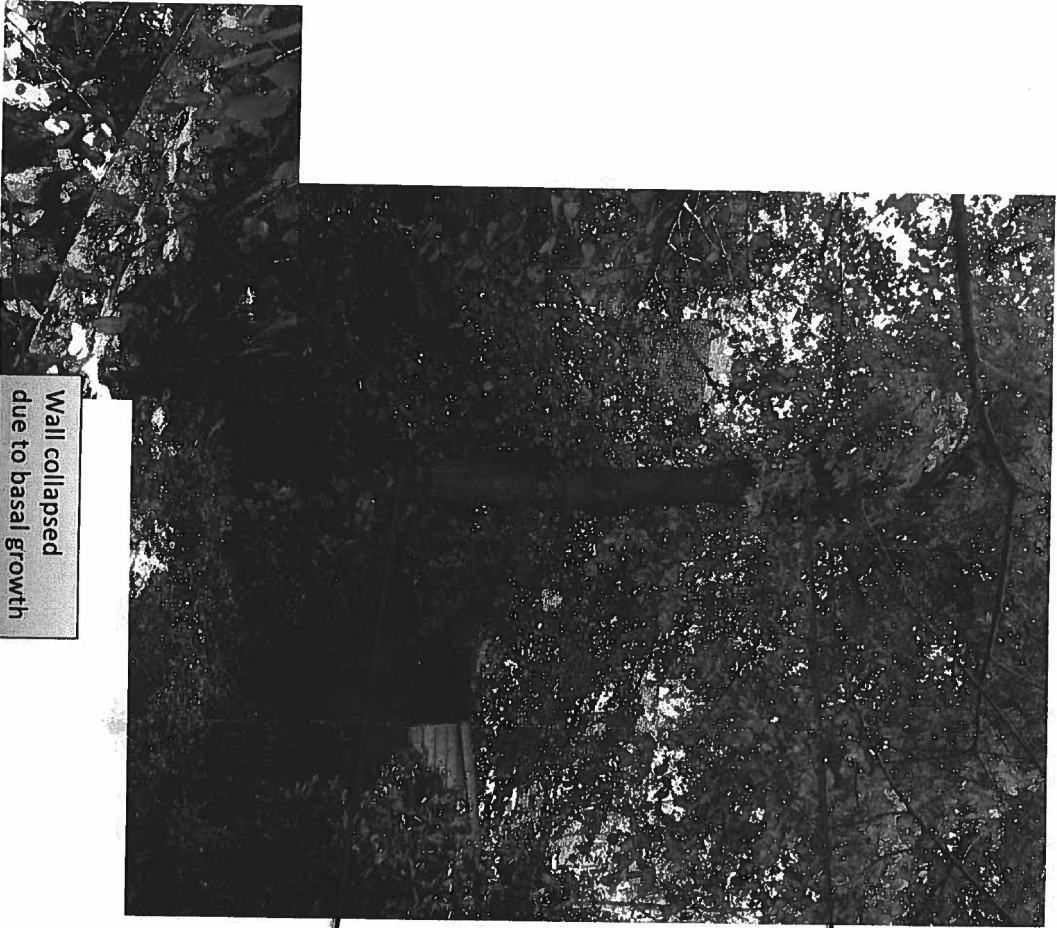
Although the basal growth prevents detailed inspection, it appears that there is approximately 250mm clearance between the main stem and the wall. It is, therefore, this basal growth, rather than expansion of the trunk, that has caused the wall to collapse. If the basal growth is removed, it should be possible to rebuild the wall on the existing footings. Basal regrowth should then be removed on an annual basis. This close to the tree, there may be roots growing under the foundations of the wall that could result in some movement. Your surveyor will be able to advise the best technique for rebuilding – possibly using lime mortar and incorporating an expansion gap.

Wall collapsed
due to basal growth

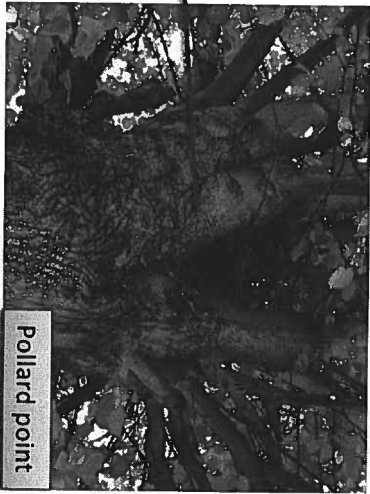
Pollard point

Because of the extensive basal decay, re-pollarding the tree, to the previous pollard points at approximately 5m, is recommend. This will significantly reduce the stress on the hollow stem and so allow the tree to be safely retained. Re-pollarding should then be repeated every 3 years and ongoing decay monitored. Since the tree is protected by a Tree Preservation Order, permission will be required from the Local Planning Authority. An application can be made online, attaching a copy of this letter.

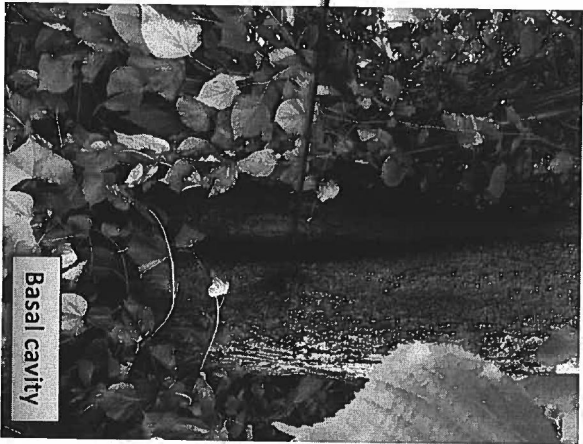
I inspected the lime tree, shown in the photos attached, on 16th May 2019. The tree is approximately 14.5m in height with a stem diameter of 540mm and crown spread of 12m. In the past, it was pollarded at 5m, but the crown has now grown out. The crown shows good vigour, however there is extensive basal decay, with an opening to the west from 0.2m-0.5m and to the east at 0.3-1.3m. The base is therefore almost entirely hollow, with a residual wall thickness of only 100-200mm. There is abundant basal growth, particular between the main stem and the 1.3m brick boundary wall, which has collapsed.

Basal cavity
