**FENTON HOUSE, HAMPSTEAD GROVE, HAMPSTEAD, LONDON, NW3 6SP**

**ALTERATIONS TO LEANING BOUNDARY WALL AND PIER**

**DESIGN AND ACCESS STATEMENT**

**MAY 2019 v2**

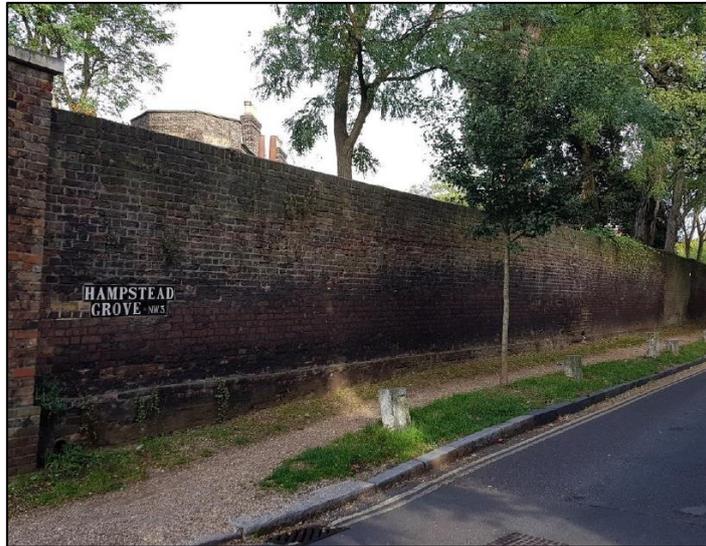
*Leaning boundary wall*

2.2 A section of the garden wall in the south garden, located next to the public highway of Hampstead Grove is deflecting out and is at risk of collapse if left unattended.

3.6 Part 1 involves removing some of the bricks around the base of the wall to provide space for the tree roots to grow. A brick arch will be created here with a bespoke metal grille installed to prevent unauthorised access. HeliBars will be installed in the section above the wall to prevent further cracking. The mortar will be soot washed to match the existing mortar colour. See drawings below for further details.

3.7 Part 2 involves installing five steel posts along the internal side of the wall. These will be secured in the ground by screw piles. The option to encase the steel in brick was considered but dismissed for a number of reasons.

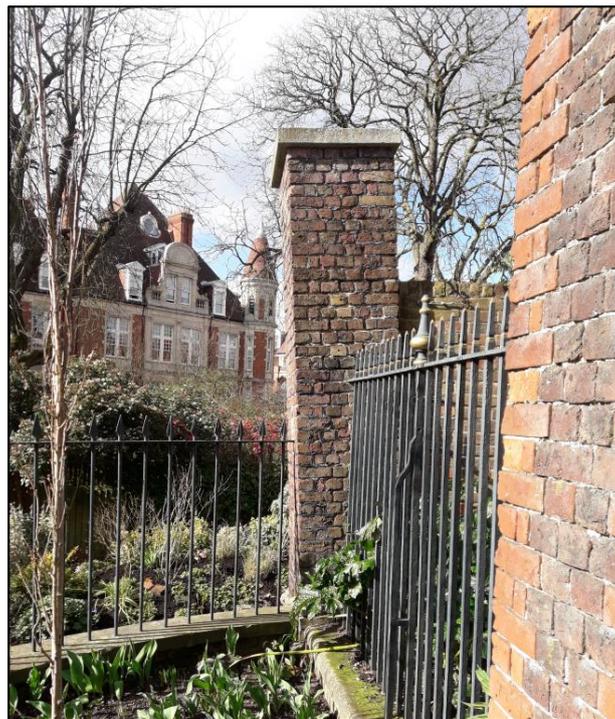
*Leaning pier*

2.3 The pier to the west of the southern entrance is leaning in a south-westerly direction into the adjacent property, Enfield House. This movement has caused cracking within the pier, and a joint to open between the pier and the attached brick party wall.

4.4 Rebuilding the pier will ensure the longevity of both the party wall and pier. Drawing "893-07-(AS)004 C01 - brick pier sequence of work" provides the full details but to summarise, the work involves:

1. Deconstructing the pier taking note of existing bricks and patterns
2. Stitching the cracks in the party wall using Helifix bars
3. Reconstructing the pier vertically and tying to the end of the party wall

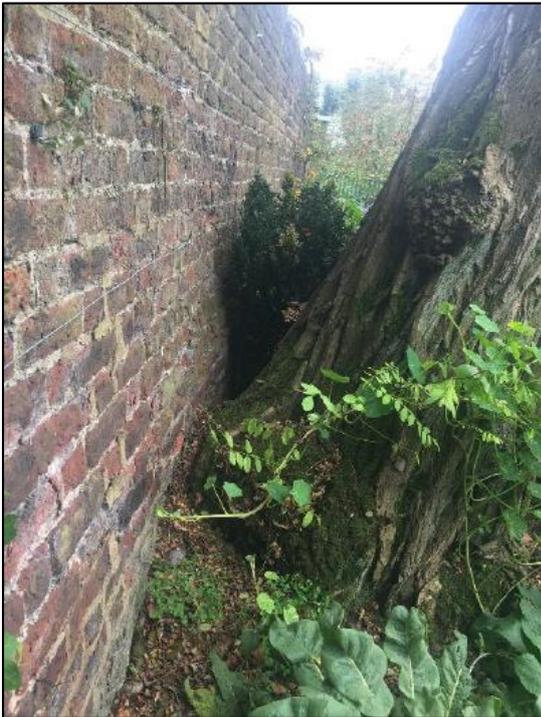
3.2 The report carried out by Civic Engineers (Civic Engineers, 2017, p8) indicates that the trunk of a large Robinia tree is growing against the inner face of the boundary wall, pushing out the bottom of the wall (Photo 1). There is evidence of sections along the base of the wall that have previously been reset and repointed, but continuous pressure has caused localised cracking and bricks to fall out onto the public footpath on Hampstead Grove (Photo 2).

*Photo 1: Robinia tree growing against the wall*

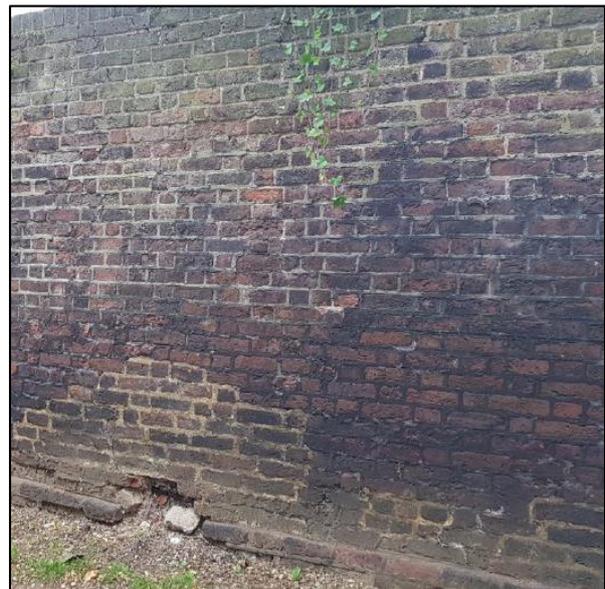
*Photo 2: Loose bricks on Hampstead Grove*

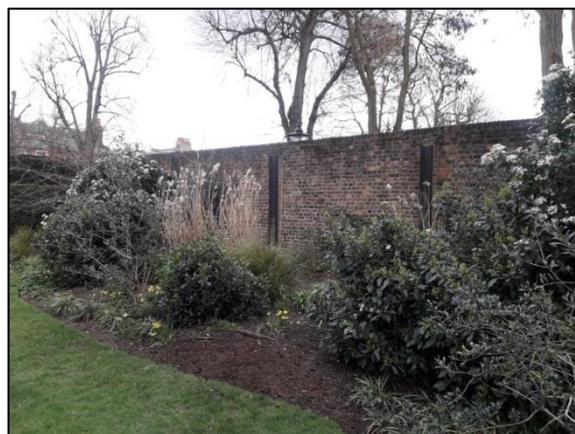
3.3 Further north along the same wall remedial work has previously taken place in the shape of steel 'L' supports on the internal face, secured below ground level to a concrete counterweight foundation (Photo 3). The work is assumed to have been carried out between 2002 and 2016.

*Photo 3: Steel supports securing the boundary wall*

3.4 This previous intervention has prevented the wall leaning any further and retains the wall in its position.

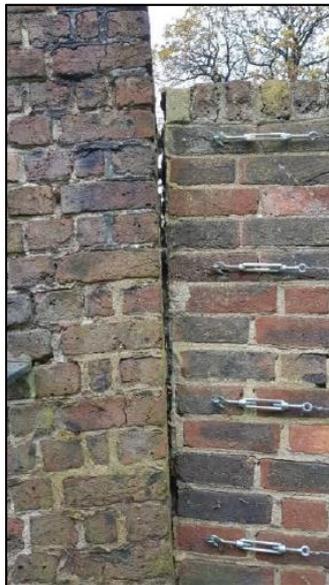
- 4.1 The pier described in this application is a masonry structure, 700mm by 700mm wide, and 3.9m at its tallest.
- 4.2 Civic Engineers Report (Civic Engineers, 2017, p12) indicates that the western party wall has been rebuilt and is leaning where it meets the pier. Since this reconstruction, the pier has displaced further, creating a larger joint between the wall and the pier as shown in photo 4. There is also mortar loss where the pier meets the single skin party wall.

*Photo 4: Open joint between pier and wall*

- 4.3 The lean of the pier is too significant to leave due to the risk of collapse onto the public highway and into the neighbour's garden. Therefore, remedial works to stabilise and prevent further

4.5 As many of the existing bricks as possible will be reused. Where the bricks are beyond their useful life, they will be replaced to match the material and colour using handmade Mulberry Stock bricks manufactured by Bulmer Brick and Tile Company. The existing mortar has been sent for analysis and the same mix will be used for rebuilding. The mortar will be soot washed to match the existing mortar colour.

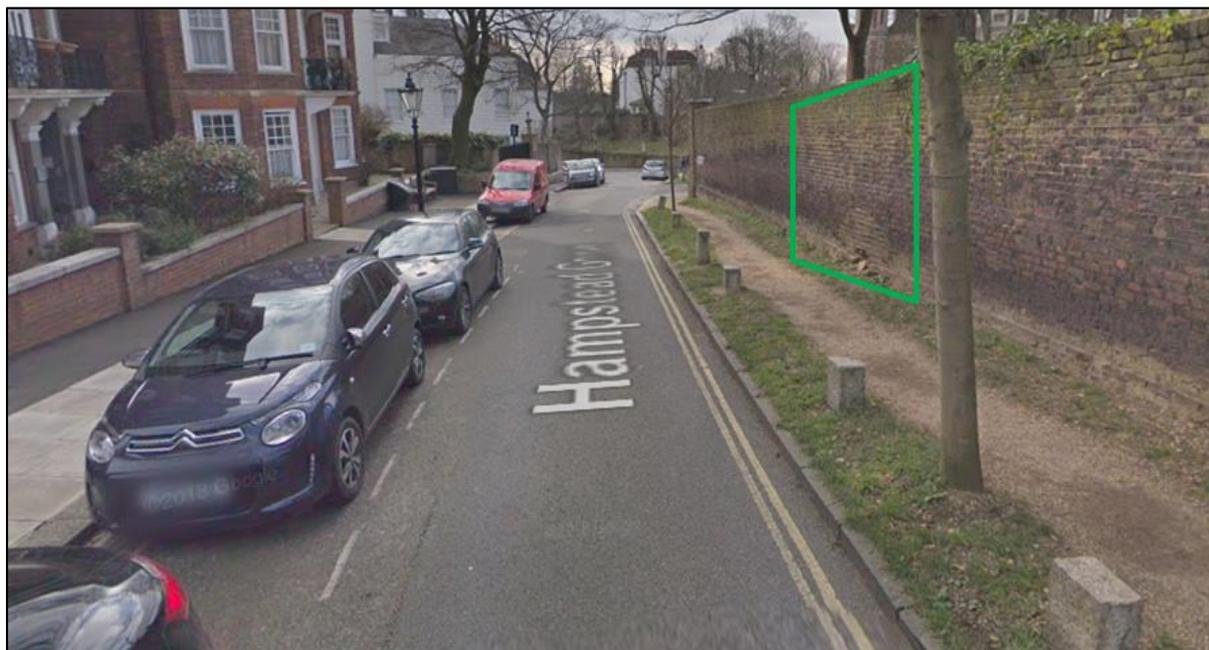
*Photo 5: Approximate location of props whilst the arch is created at the base of the wall*

5.4 Whilst the arch is created in the base of the boundary wall, propping will be required along the footpath of Hampstead Grove. This side of the road has double yellow lines however there is a pavement on the other side so cars and pedestrians will still be able to use the road. Permission from the council will be sought prior to establishing the propping. Photo 5 shows the location of the props.
