Decay Detection Investigation

Bedford Square
Fitzrovia
London
WC1B 3DR

April 2019

160523-DID-02

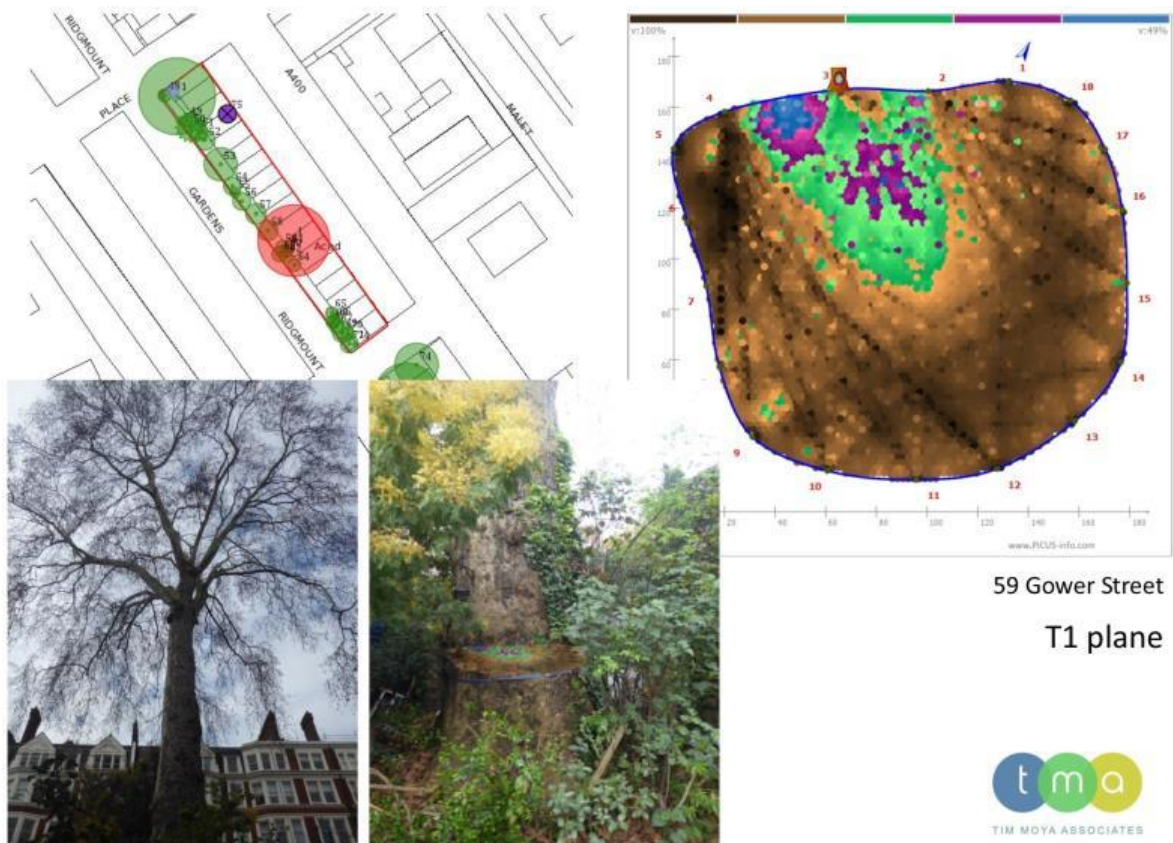
Decay detection investigation: Clockwise from the top left, map, tomogram, tomogram superimposed on the tree, the tree

- 3.7 The tomogram reveals a small area of decay (blue, pink) which is slowly developing (green, yellow) across the stem at the test height. The results indicate that the consistency of the wood at the test height is slightly compromised (light brown mixed with darker brown), however this is currently unlikely to be structurally significant.
- 3.8 The wood within the decayed area is still intact and not obviously degraded, so additional testing was undertaken using the RESI PD.

- 4.1 Some remedial tree work is required to reduce the risk of branch failure to acceptable levels and establish a smaller crown. Please see Appendix A for details. The tree should be re-inspected within 2 years or after storm force events which may weaken its condition.

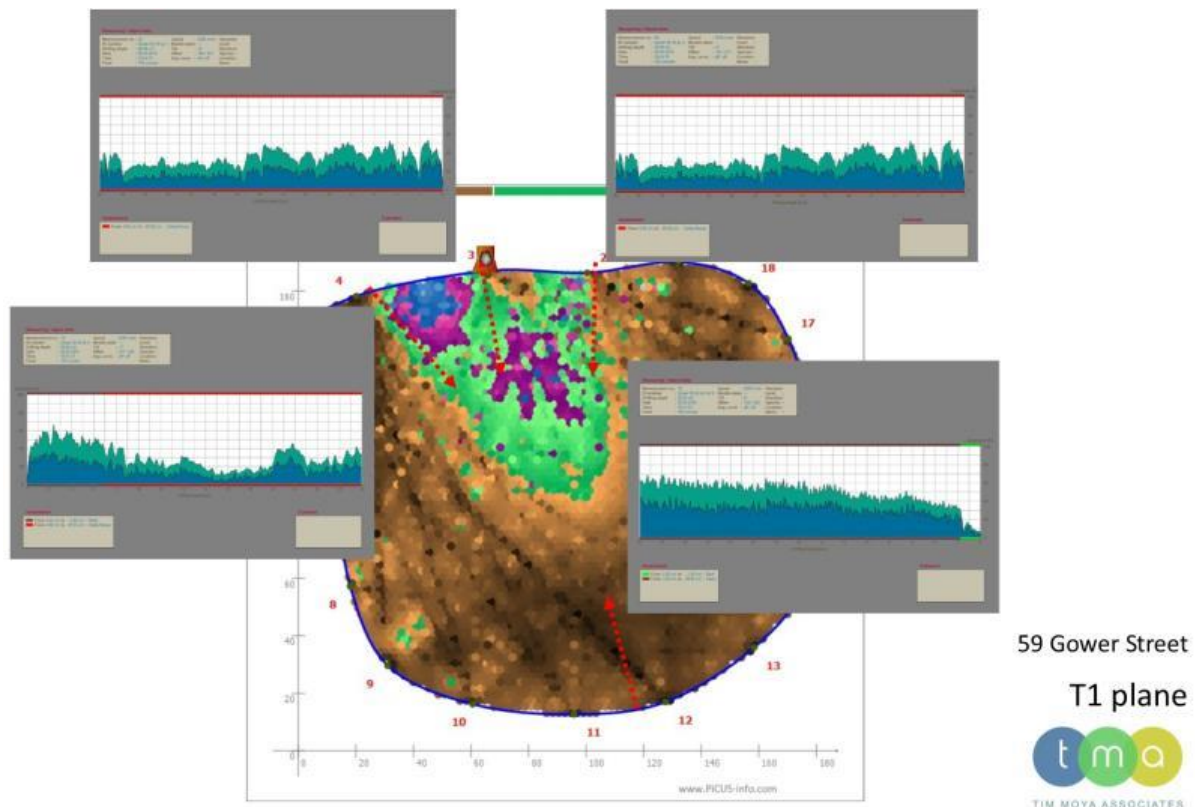
RESI PD traces superimposed on tomogram for reference: RESI PD traces at measuring points 4, 3, and 2 (clockwise from the left) with the reference trace for comparison on the right

- 3.9 The RESI PD traces by measuring points (mp) 4 (read from left to right) and mp's 3 and 2 (read from right to left) all show decayed and damaged wood. The reference trace from the south (read from right to left) shows intact wood throughout.
- 3.10 The decay revealed by the above testing does not currently present an unacceptable risk of tree failure. The development of decay will need to be monitored in the future.
- 3.11 Recommendations have been made to reduce the tree height and branch length for good arboricultural management purposes.
