# **Decay Detection Investigation**

**PiCUS / RESI PD**

Bedford Square  
Fitzrovia  
London  
WC1B 3DR

**160523-DID-02**

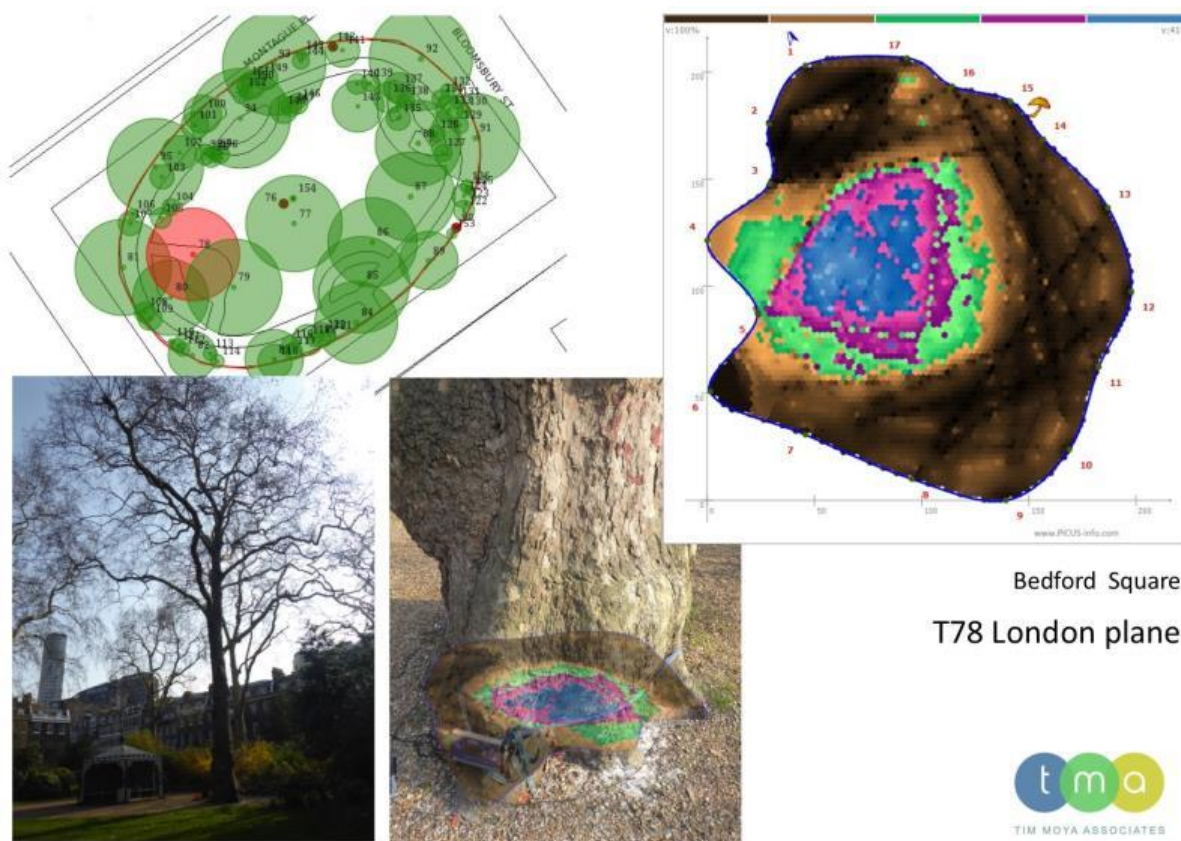
Bedford Square T78 decay detection: clockwise from the top left, map, tomogram, superimposed on tree, tree

- 3.7 The tomogram reveals a considerable area of decay (blue, pink) which is developing (green, yellow, light brown) with an acceptable proportion of sound wood (dark brown) remaining. *Meripilus giganteus* fungal fruiting bodies were identified earlier in the year. This species of fungus is known to affect the root plate of other tree species, however there is no information available regarding interactions between this fungus and tree species combination.
- 3.8 Crown reduction works are recommended as a precautionary measure to relieve wind loading in case of damage to the roots, and further decay detection testing will be necessary in the future, to monitor the development of decay and inform future management decisions (see Appendix A).

Tree / Group No.	No. of Trees	Species	Height (m)	DBH (cm)	Crown spread(m)	Tree type	Age Class	Physiological Condition	Structural Condition	Targets	Condition Notes / Recommendations	Re-inspection	Access for works	BS Category
T78	1	<i>Platanus x hispanica</i> London Plane	32.0	135	27.0	14	Mature	Fair	Fair	Footpath within crown spread. Building within crown spread. Seating area within crown spread.	Branch weight - Heavy. Bark wound - Minor. Decay / structural defect - Base. Foreign object. Lesion or fracture on limb / limbs - Minor. Physiological / cambial damage - Fungal. Pruning wounds - Historic. Reaction wood / Adaptive growth - Stem / stems. Decay- suspected <i>Meripilus giganteus</i> at base  Reduce crown by - Specified extent height and lateral branch length by up 3m, to relieve wind loading due to basal decay and establish smaller crown. All final cuts to be at suitable growth points. All work to be undertaken using hand saw WHICH MUST BE THOROUGHLY STERILISED after use and before use on another tree. Detailed investigation - Internal decay assessment PICUS and or RESI PD investigation at base to monitor development of decay and inform future management decisions  Within 6 months  Within 2 years	12	12	13

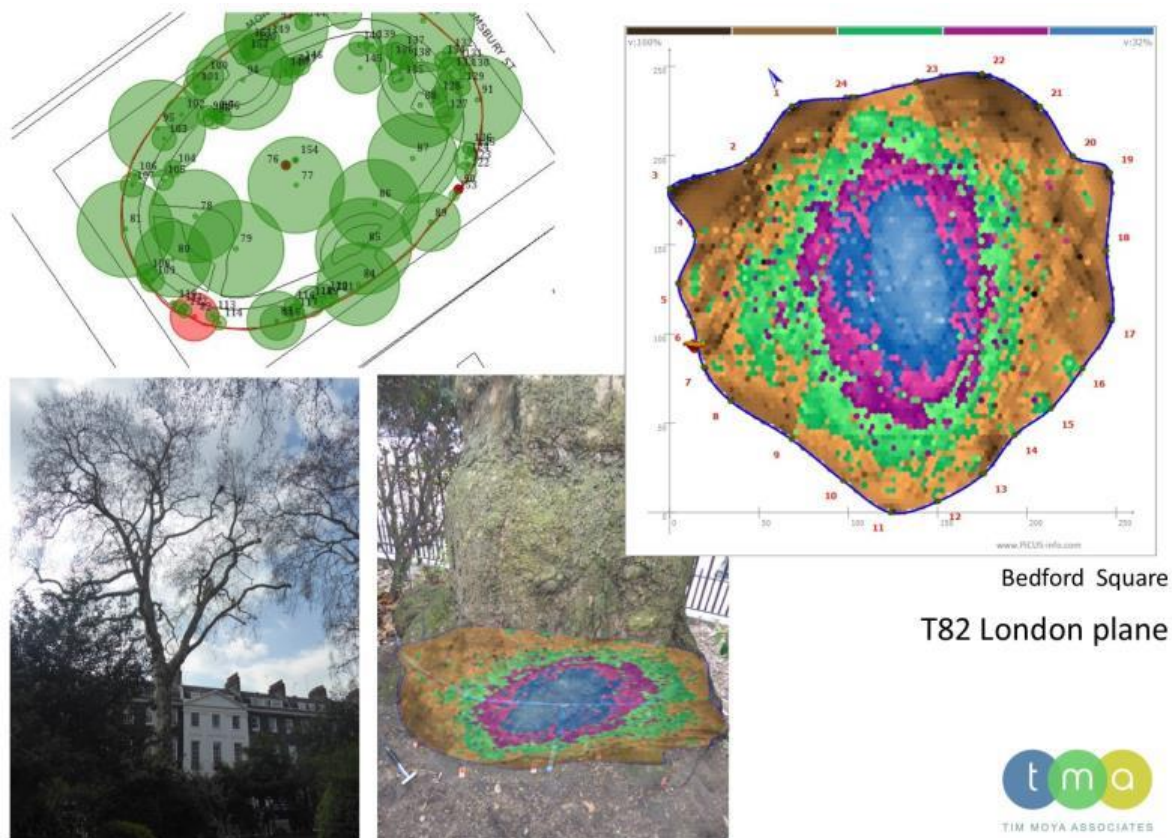
*Bedford Square T82 decay detection: clockwise from the top left, map, tomogram, superimposed on tree, tree*

- 3.9 The tomogram reveals a large area of internal decay (blue, pink) which is developing (green, yellow, light brown) across the stem. A *Rigidoporus ulmarius* fungal fruiting body is present and shown by the icon between measuring points 6 and 7.
- 3.10 The crown of the tree has previously been reduced and the extent of decay observed does not currently present an unacceptable risk of tree failure. Additional crown reduction and future decay detection investigation are recommended (see Appendix A).

T82	1	<i>Platanus x hispanica</i> London Plane	20.0	125	14.0	7	Mature	Fair	Fair	Footpath within crown spread. Seating area within falling distance of tree.	Crown reduction - Recent. Decay / structural defect in crown limb / limbs - Localised. Decay / structural defect - Base. Epicormic growth - Base. Epicormic growth - Crown. Fungal fruiting body - structural decay suspected. Form - Small sail area / crown extent. Lesion or fracture on limb / limbs - Minor. Decay - <i>Rigidoporus ulmarius</i> brackets at the base on the south and south-west side.  Reduce crown by - Specified extent reduce crown to epicormic shoots beyond previous reduction points to establish smaller crown continuing established management intentions of relieving loading on decayed base of tree. All work to be undertaken using hand saw WHICH MUST BE THOROUGHLY STERILISED after use and before use on another tree. Detailed investigation - Internal decay assessment PICUS and or RESI PD investigation at base (5cm) to monitor development of decay and inform future management decisions  Within 6 months  Within 2 years	6	6	7

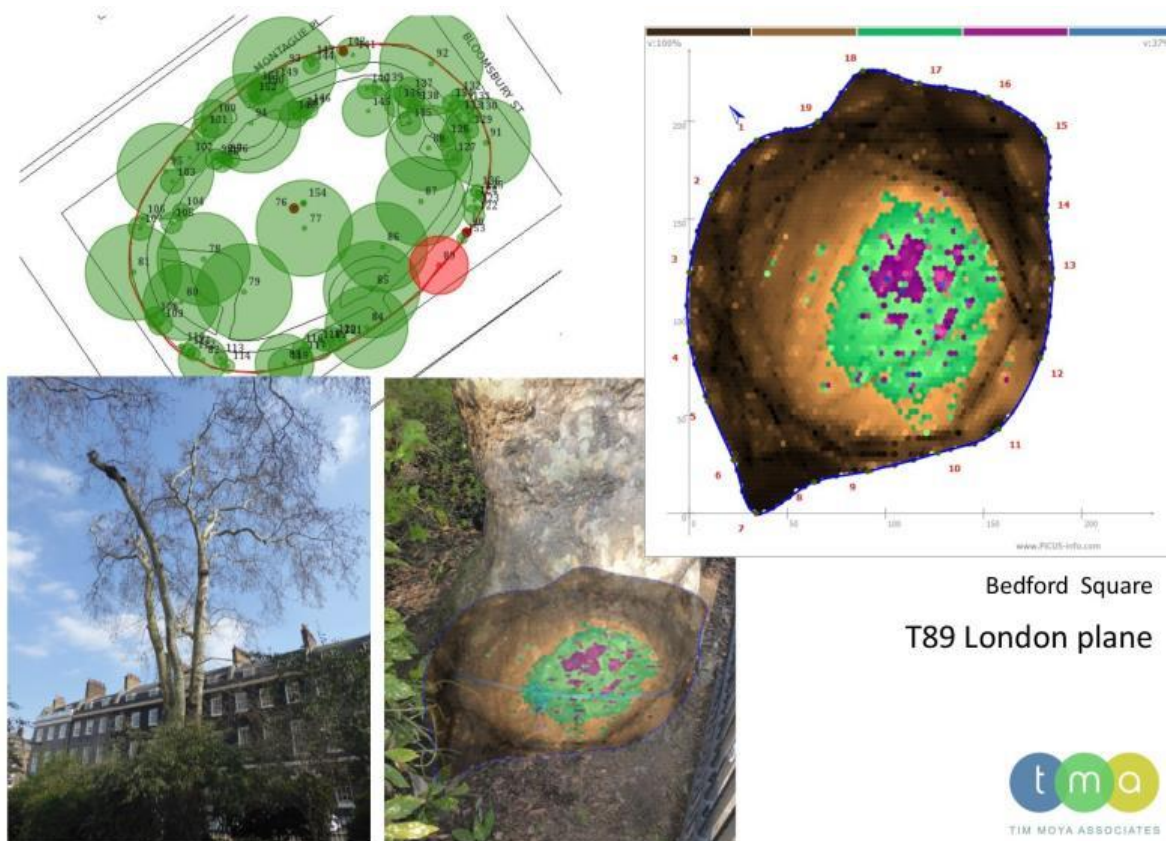
*Bedford Square T89 decay detection: clockwise from the top left, map, tomogram, superimposed on tree, tree*

3.11 The tomogram reveals a small area of decay (pink) which is developing (green, yellow, light brown) and a large proportion of sound wood (dark brown) remaining. No causal agent was observed. Crown reduction work and future decay detection investigations are recommended (see Appendix A).

Tree / Group No.	No. of Trees	Species	Height (m)	DBH (cm)	Crown spread(m)	Tree type	Age Class	Physiological Condition	Structural Condition	Targets	Condition Notes / Recommendations	Re-inspection	Access for works	BS Category
T89	1	<i>Platanus x hispanica</i> London Plane	22.0	135	17.0	6	Mature	Fair	Poor	Footpath within crown spread. Seating area within crown spread. Road within falling distance of tree.	<p>Access to inspect base - Restricted / obscured. Branch weight - Heavy. Crown reduction - Historic. Decay / structural defect - Base. Fungal fruiting body - structural decay suspected. Form - Small sail area / crown extent. Lesion or fracture on limb / limbs - Minor. Pruning wounds - Historic. Decay - Inonotus hispidus bracket on western leader Lichen at base to the south</p> <p>Reduce crown by - Specified extentheight and lateral branch length by up 3m, to relieve wind loading due to basal decay and establish smaller crown. All final cuts to be at suitable growth points. All work to be undertaken using hand saw WHICH MUST BE THOROUGHLY STERILISED after use and before use on another tree.</p> <p>Detailed investigation - Internal decay assessmentPicUS and or RESI PD investigation at base to monitor development of decay and inform future management decisions</p> <p>Within 6 months</p> <p>Within 2 years</p>	4	13	8

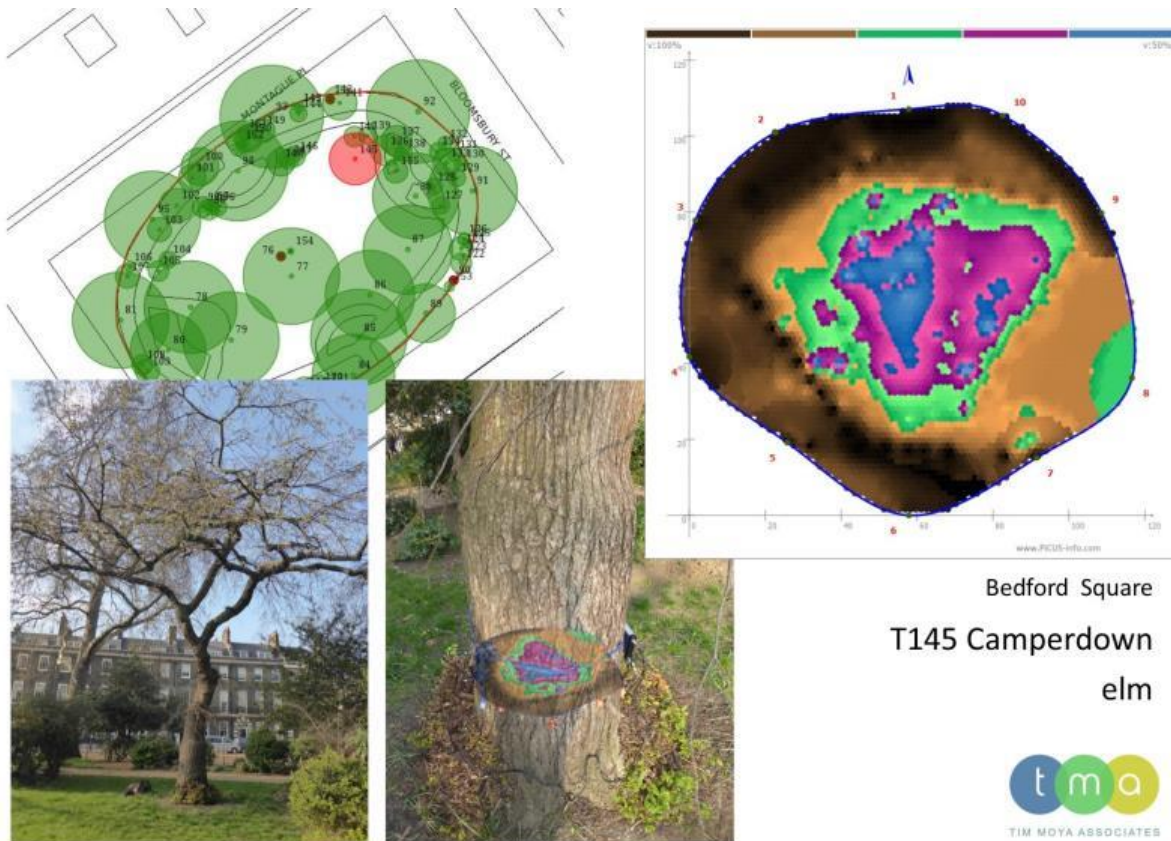
Bedford Square T145 decay detection: clockwise from the top left, map, tomogram, superimposed on tree, tree

- 3.12 The tomogram reveals a centralised area of decay (blue, pink) which is slowly developing (green, yellow, light brown) and a good proportion of sound wood (dark brown) remaining around the circumference. A *Rigidoporus ulmarius* fungal fruiting body and epicormic growth prevented PiCUS testing at ground level.
- 3.13 *Rigidoporus ulmarius* causes brown rot decay and can lead to tree failure, however this tree is growing in a sheltered position and crown reduction works have already been recommended to alleviate wind loading. The tree currently has an acceptable proportion of sound wood remaining around the circumference of the trunk, and the physiological condition of the tree does not indicate the presence of root decay.

T145	1	<i>Ulmus glabra</i> 'Camperdownii' Camperdown Elm	8.0	80	15.0	6	Late Mature	Fair	Poor	Footpath within falling distance of tree.	<p>Coalesced decay seam - Suspected. Decline - Suspected. Decay / structural defect in crown limb / limbs - Localised. Deadwood - Minor. Decay / structural defect - Extensive. Decay / structural defect - Open cavity / cavities. Decay / structural defect - Bole. Epicormic growth - Base / bole / principal stems. Rigidoporus ulmarius bracket at base on north side of stem. Tap tests around base and stem indicate significant hollowing.</p> <p>Reduce crown by - Specified extentlateral branch length by 1-2m to suitable growth points to establish a smaller crown and minimise risk of branch or stem failure, leaving furnishing growth to minimise visual impact</p> <p>Detailed investigation - Internal decay assessmentPicUS and RESI PD investigation at base and stem (55cm) to monitor development of decay and inform future management decisions</p> <p>Within 1 year</p> <p>Within 2 years</p>	6	9	7

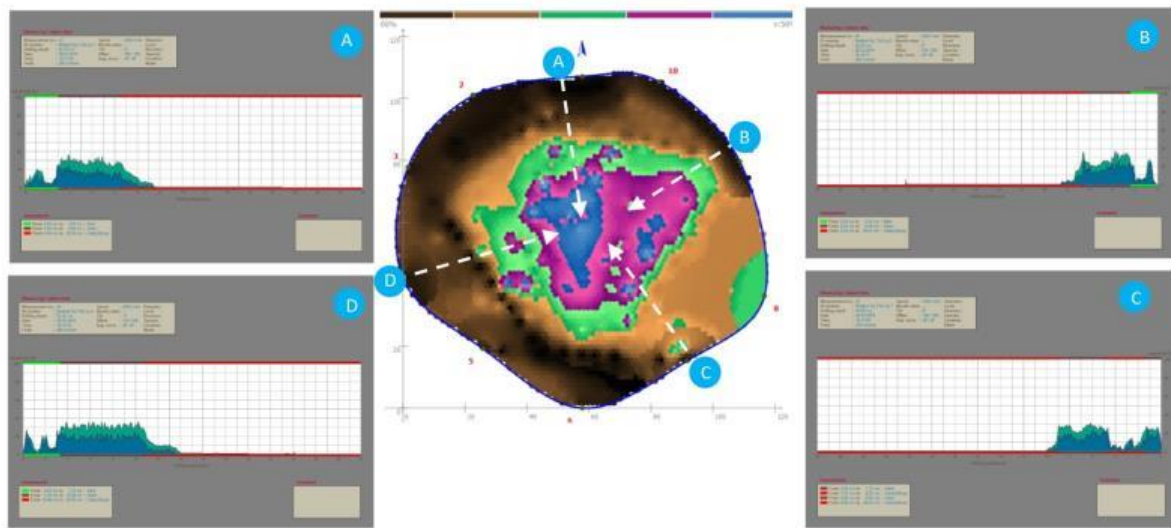
Bedford Square  
T145 Camperdown  
elm

*RESI PD traces superimposed on the tomogram for reference: read left traces left to right, and right traces right to left*

- 3.14 The RESI PD traces confirm the findings of the PiCUS tomogram. Additional testing to the east and west at ground level produced similar results. The tree is already due for crown reduction works, and further decay investigations are recommended to monitor the development of decay in the future. See Appendix A.
