## Arboricultural Appraisal Report

### Subsidence Damage Investigation at:

33 Langbourne Avenue  
London  
N6 6PS

| REPORT DATE: | 17-05-2019 |

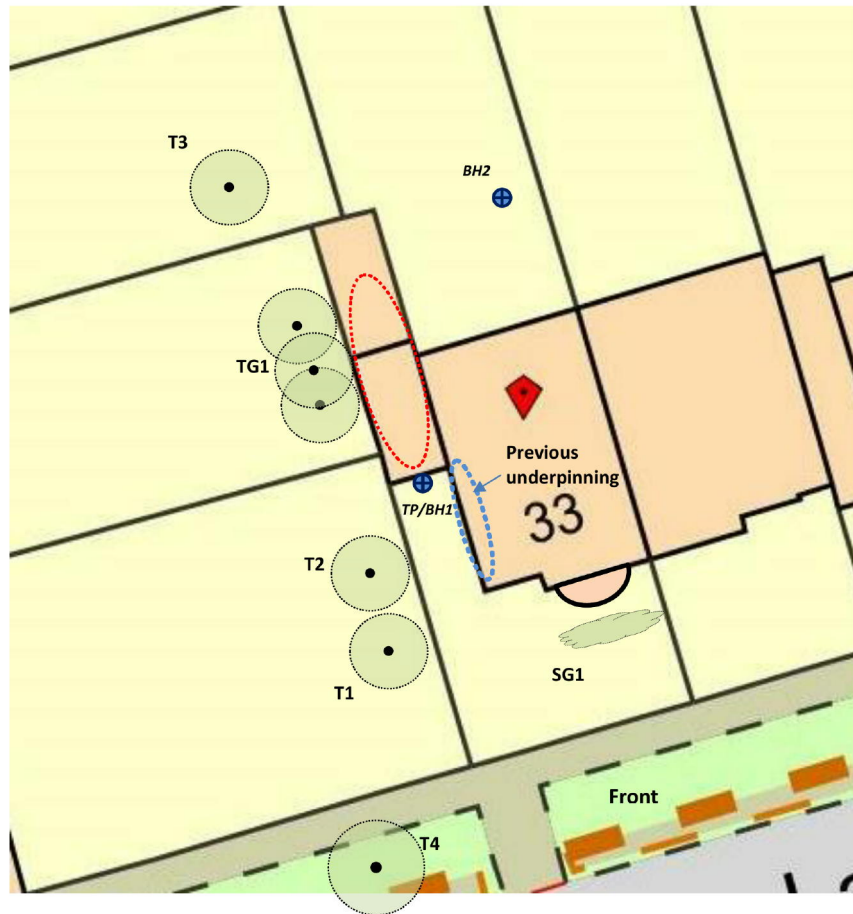
Site Plan

Approximate areas of damage

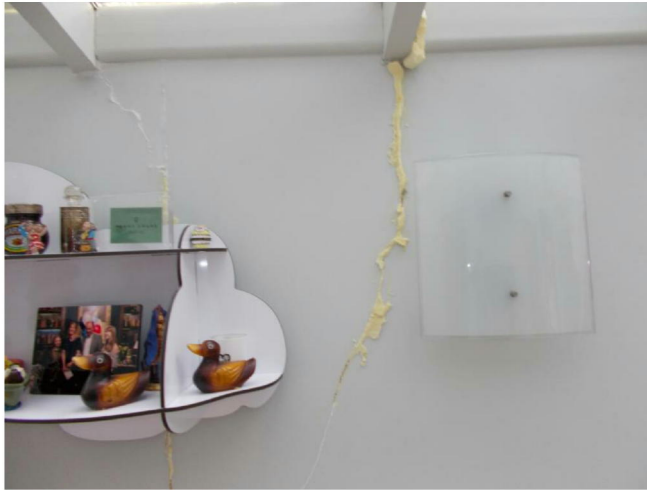
At the time of the building surveyor's inspection the structural significance of the damage was found to fall within Category 5 (very severe) of Table 1 of BRE Digest 251.

View of cracking to internal walls on left hand side of property

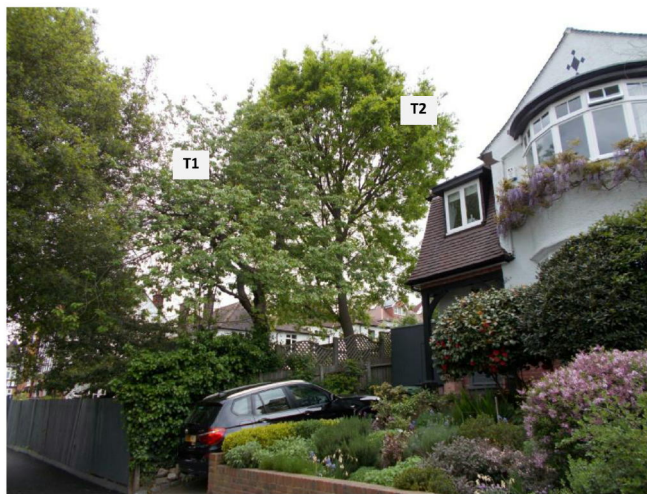
Quercus roots were observed to a depth of 2m in BH1, the origin of which is likely to be T2. The Syringa spp. or related shrub species roots recovered from BH1 do not correspond to any significant vegetation noted on site whilst the roots recovered from BH2 originate from the Ceanothus within the rear garden.

Irrespective of the identification of recovered root samples, the roots of T1 are also very likely to be present below foundation level in proximity to the area of movement/damage and influencing soil moisture and volumes.

Based on the technical reports currently available, engineering opinion and our own site assessment we conclude the damage is consistent with shrinkage of the clay subsoil related to moisture abstraction by vegetation. Having considered the information currently available, it is our opinion that T1, T2 and the trees within TG1 are the principal cause of or are materially contributing to the current subsidence damage.

View of T1 and T2

| Tree No. | Species | Ht (m) | Dia (mm) | Crown Spread (m) | Dist. to building (m) | Age Classification | Ownership |
|---|--|--|---|---|---|---|--|
| Recommendation | | Remove (fell) to near ground level. Owner to physically remove any regrowth (no chemical treatment due to translocation risk). | | | | | |

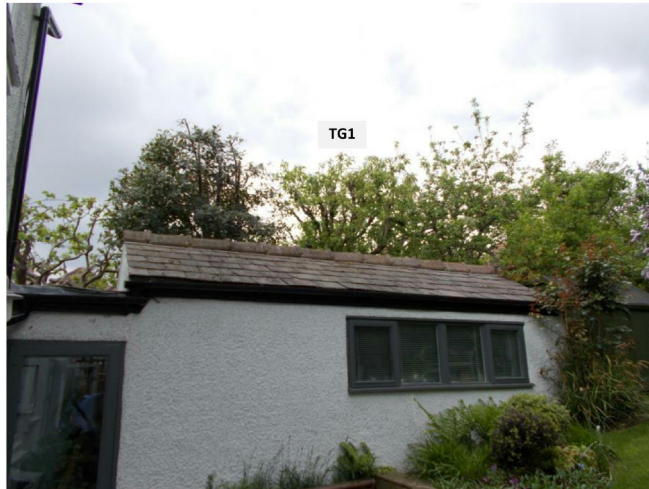
View of TG1

| Tree No. | Species | Ht (m) | Dia (mm) | Crown Spread (m) | Dist. to building (m) | Age Classification | Ownership |
|---|--|--|---|---|---|---|--|
| Recommendation | | Remove (fell) to near ground level. Owner to physically remove any regrowth (no chemical treatment due to translocation risk). | | | | | |

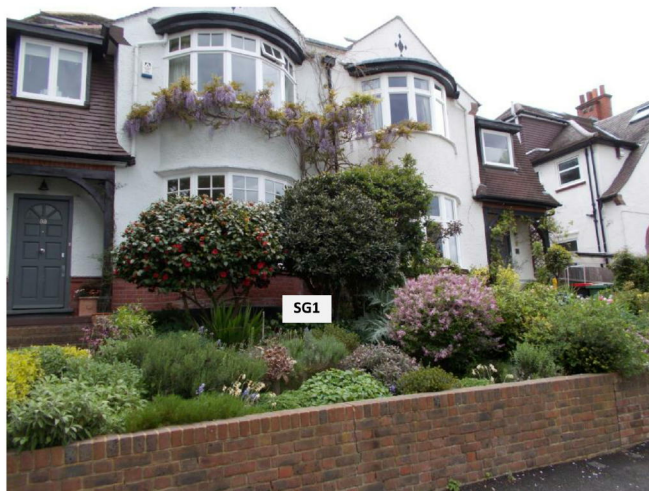
View of SG1

| Tree No. | Species | Ht (m) | Dia (mm) | Crown Spread (m) | Dist. to building (m) | Age Classification | Ownership |
|---|---|---|---|---|---|---|--|
| Recommendation | | Do not allow to exceed current dimensions. | | | | | |

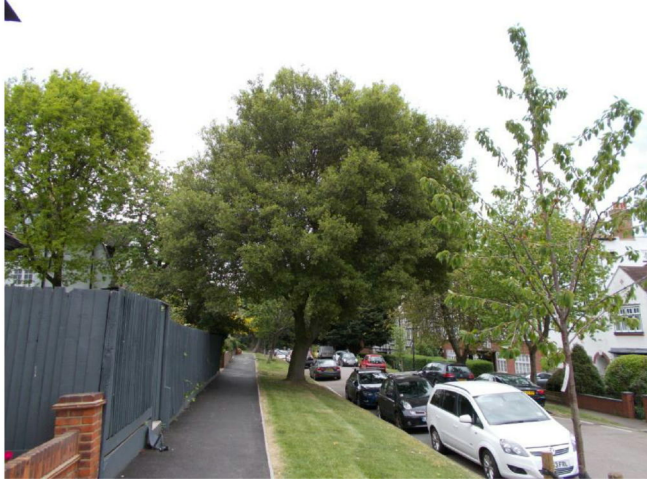
Other vegetation recorded presents a potential future risk to building stability. We note the presence of an oak to the front left of the property; should further movement occur following the implementation of the recommended remedial tree works, the removal of T4 may need to be considered.

View of T4

| Tree No. | Species | Ht (m) | Dia (mm) | Crown Spread (m) | Dist. to building (m) | Age Classification | Ownership |
|---|---|---|---|---|---|---|--|
| Recommendation | | Manage periodically to maintain at broadly no more than current dimensions. | | | | | |
